| Model: Martini-P2 | Date: 10-Aug-06 | No.: RG148001b |

| Subject: Firmware Release History (Engine) | | Prepared by: S. Watanabe | |

| Subject: Thread-cutting error on the LCT Connection Unit | | Prepared by: S. Watanabe | |

| Model: General | | Date: 12-Mar-08 | No.: RGene027 |

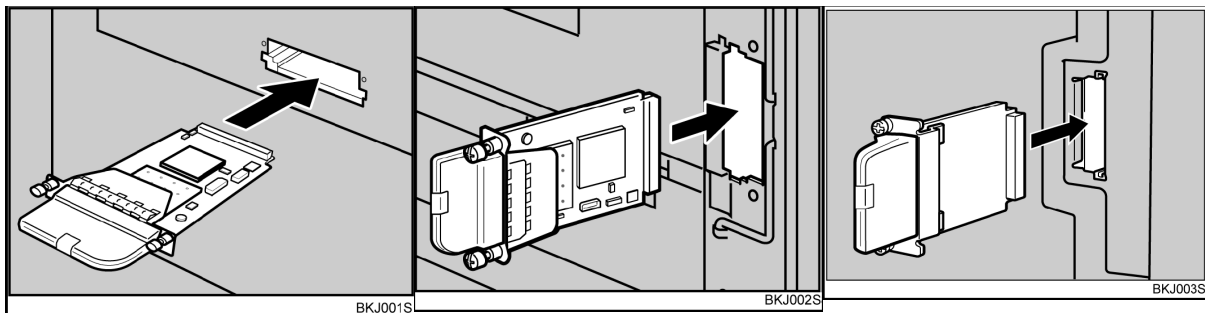
3. Attach the wireless LAN interface unit.

Insert the end of the wireless LAN interface unit into the slot.

Slot types vary according to device. For details, see the manual provided with your printer.

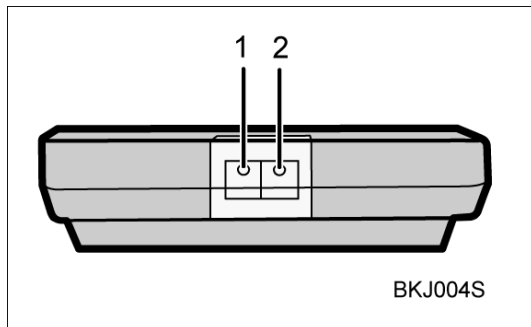
To check the connection, use the two lights on the optional wireless LAN interface unit.

1. The orange light indicates normal network connectivity.
2. The green light indicates that the optional wireless LAN interface unit is properly powered.

If both lights are lit, the wireless connection is fully operational.

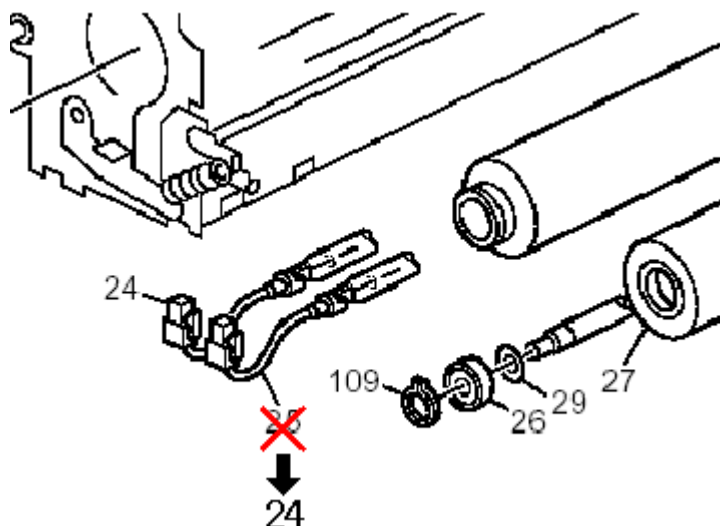
**Change/Reason:** The index and number were corrected.
