Model: Martini-C1		Date: 13-Sep-02	No.: RB064001
Subject: ROM History (Martini-C1 LCDC/Language)		Prepared by: K. Miura	
From: Technical Services sec. Service Planning Dept.			
Classification:	<input type="checkbox"/> Troubleshooting <input type="checkbox"/> Part information <input type="checkbox"/> Action required <input type="checkbox"/> Mechanical <input type="checkbox"/> Electrical <input type="checkbox"/> Service manual revision <input type="checkbox"/> Paper path <input type="checkbox"/> Transmit/receive <input checked="" type="checkbox"/> Retrofit information <input type="checkbox"/> Other ()

Model: Martini-C1		Date: 13-Sep-02	No.: RB064002
Subject: Service Manual Revision		Prepared by: K.Miura	
From: Technical Services sec. Service Planning Dept.			
Classification:	<input type="checkbox"/> Troubleshooting <input type="checkbox"/> Part information <input type="checkbox"/> Action required <input type="checkbox"/> Mechanical <input type="checkbox"/> Electrical <input checked="" type="checkbox"/> Service manual revision <input type="checkbox"/> Paper path <input type="checkbox"/> Transmit/receive <input type="checkbox"/> Retrofit information <input type="checkbox"/> Other ()

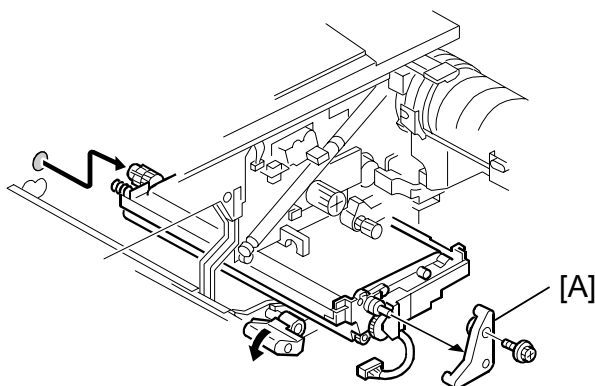
Due to a damaged special tool used on the production line, a 2.3mm gap developed between the positioning plate securing the transfer belt unit and the right edge of the machine frame (gap G₁ on next page, which should normally be about 1.5mm).

6. If the belt has contacted the front edge, decrease gap G_1 to 1.5mm or less. If it has contacted the rear edge, increase the gap starting at 1.5mm.

NOTE: Adjust the gap in increments of about 0.2mm. Then, repeat Steps 2 thru 6 until the transfer belt does not contact either edge through 100 sheets of duplex copies.

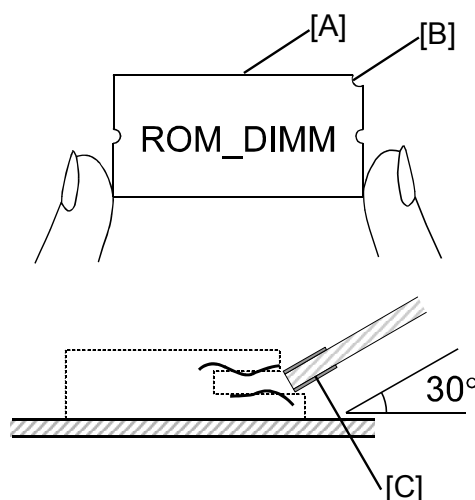
The following is the correct procedure for connecting ROM DIMMs to the controller board. Incorrect insertion can damage the controller board or cause a bad connection between the DIMM and controller contacts. If the upper contact is pressed in and bent, the resulting poor connection could cause the entire system not to operate.

1. Hold the ROM DIMM with the edge connector [A] pointing toward the slot and the notch [B] on the DIMM in the upper right-hand corner.
2. Insert the edge connector [C] into the slot at a 30-degree angle from the surface of the board.
NOTE: If the angle is too low, the upper contact could bend.
3. Move the outside edge of the ROM DIMM up and down slightly until it works into the connector, then gently press it down level with the controller board.

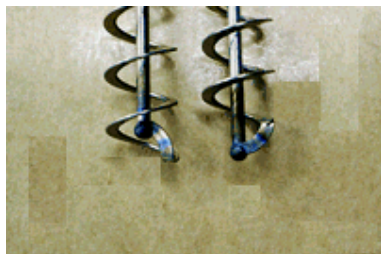
- Noise from the Toner Supply Unit (B0653110)
- Noise from the Toner Collection Assembly - Transfer (B0653551)
- Gears break (B0653138 and/or B0653139)
- Toner Collection Coil - Exit (B0653710) bends
- Toner leaks from the Development Filter (AA012060)
- Toner Collection Coil bends (AD043077)

The shape of the Transport Coil in the toner supply unit and the Transport Screw in the waste toner transport unit have been changed. Also, the steel ball in the lower waste toner transport unit has been deleted. In the photograph below, the old Transport Coil is shown on the right, and the new one on the left.

- Replace the Gear (B0653138 and/or B0653139), and
- Replace the Toner Supply Unit (B0653111) and Waste Toner Vertical Transport Unit (B0653554), and
- Remove the steel ball (A0963736).

Note: With gear replacement alone, the symptom will recur shortly thereafter. Also, individual replacement of the coil can allow waste toner to be blown out of the unit, so at the customer site, please be sure to replace the entire unit.

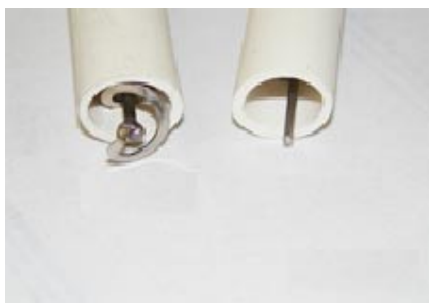
Note: The length of the coil in the Waste Toner Vertical Transport Unit has been increased as shown below (new coil on the left, old on the right). It is therefore necessary to remove the steel ball to prevent the loud noise that will occur if the coil contacts the ball.

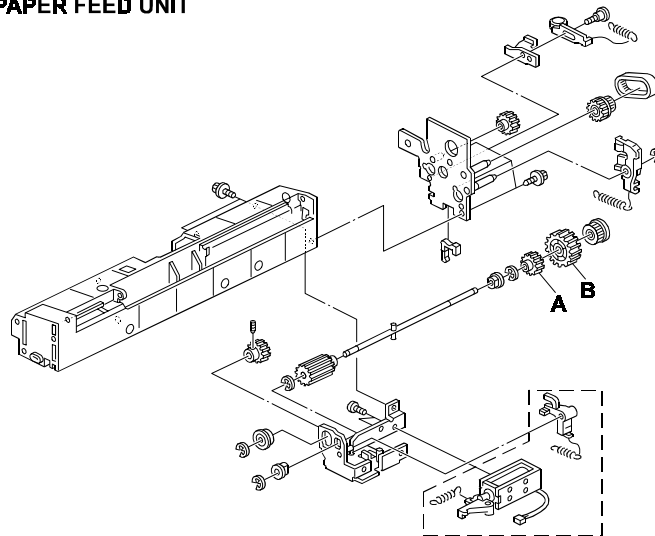
PAPER FEED UNIT

- (1) Using the following table, check the jam count values. For locations that show frequent occurrences, replace gears [A] and/or [B] below ***in which the arrow and cutout*** are as shown in the "NG" illustration.

As shown above, replace gears whose cutouts and arrows are in different positions.

- (2) Clean the shaft, then replace the gear(s).

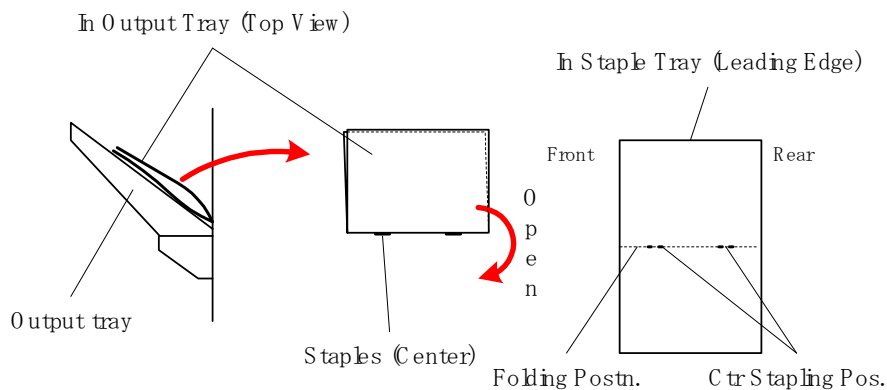
Fig. 1: The Stack in the Output and Staple Trays

The jogger fence gap is too wide, which prevents proper aligning of the stack's side edges.	<ul style="list-style-type: none"> Check the current width of the jogger fence gap ("Jogger Fence Gap Check" below), and if necessary adjust the gap using SP6120 (in the "-" direction). → See "Adjusting the Jogger Fence Gap" below.

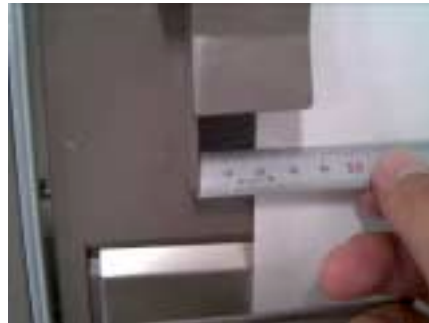
Photo 2

4. Measure the distance between the paper contact area on the front jogger fence and the front edge of the paper stack (Photo 2).
 - This distance should be **19mm** for all paper sizes.
 - This same 19mm should be used as the reference target in cases where the jogger fence gap is adjusted with SP6120 (procedure below).

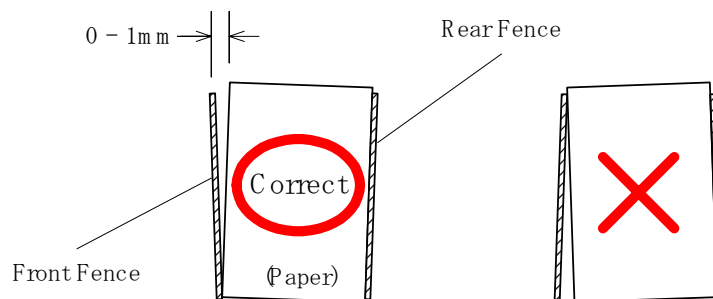
Fig. 2: Upper Area Paper-Fence Gap

2. Place the paper flush against the rear jogger fence, then slowly close the front fence to the edge of the paper manually by rotating the jogger motor pulley (black knob in Photo 4 above).
3. Make sure the lower area of the front jogger fence and paper stack are touching, then measure the distance between the paper contact area on the **upper area** of the front jogger fence and the front edge of the **upper area** of the paper stack.
 - It is essential to make the measurement on the upper part, as shown in Figure 2 below.
 - The allowable distance is **0-1mm**.

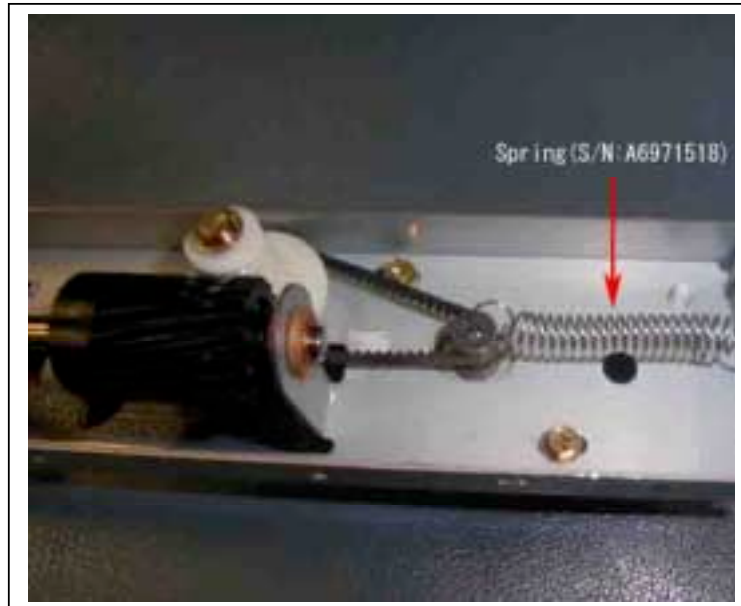
**Fig. 3**

Insufficient tension in the shift-transfer timing belt causes excess torque in the belt's motor

3. Attach the spring removed above to the area shown below (one end to the motor pulley, the other end to the edge of the stay). This spring will be used to apply the optimum tension in the belt ($6 \pm 3.5\text{N}/3\text{mm}$).

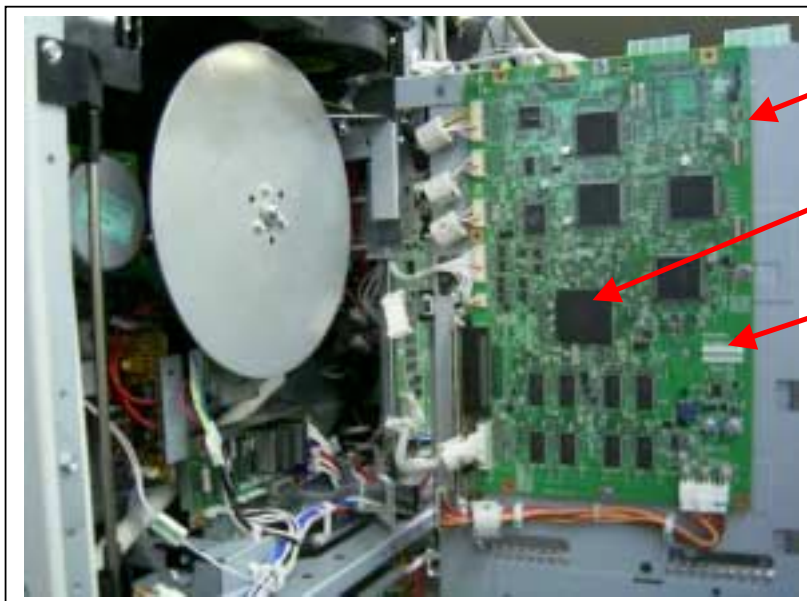
IPU Board

Note: The symptom described above is limited to IC104, because its unique shape requires unique soldering conditions compared to other IC elements on the board.

IC104

Replace the IPU board with P/N B1105140.

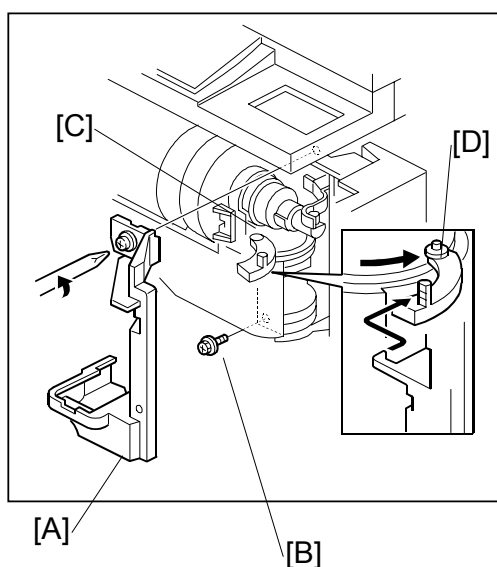
Note: If the toner bottle is in the machine when you do this procedure, the toner bottle holder can be damaged.

IMPORTANT: Before you begin, **remove the toner bottle** if it is installed.
