Model: Martini-C2	Date: 14-Oct-04	No.: RB140001d
-------------------	-----------------	----------------

Subject: Firmware Release History (BCU - Engine)		Prepared by: S. Watanabe	
From: 2nd Tech Support Sec. Service Support Dept.			
Classification:	<input type="checkbox"/> Troubleshooting	<input type="checkbox"/> Part information	<input type="checkbox"/> Action required
	<input type="checkbox"/> Mechanical	<input type="checkbox"/> Electrical	<input type="checkbox"/> Service manual revision
	<input type="checkbox"/> Paper path	<input type="checkbox"/> Transmit/receive	<input type="checkbox"/> Retrofit information
	<input checked="" type="checkbox"/> Other (      )

This RTB has been issued to announce the firmware release information for the Engine.

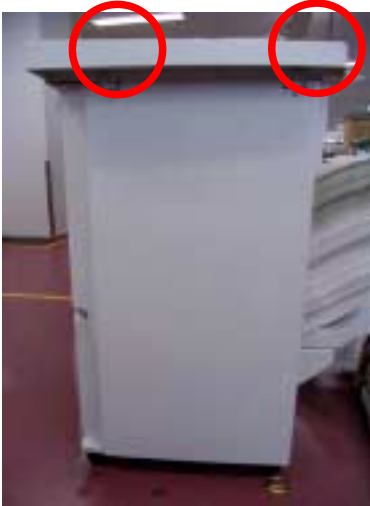
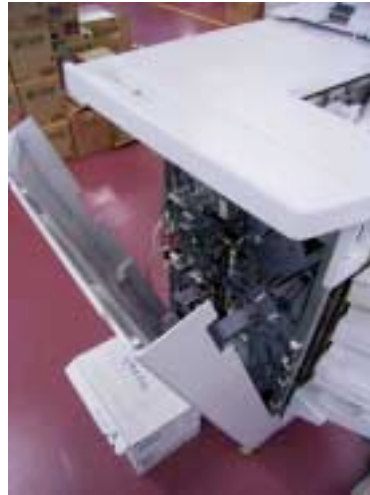
1. Remove the two screws shown in the left photo.
2. Remove the I/F cable from the mainframe.
3. Remove the front cover and remove the I/F cable from the cutout in the front cover.

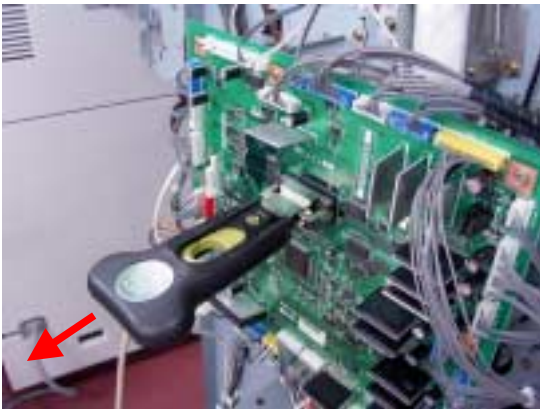
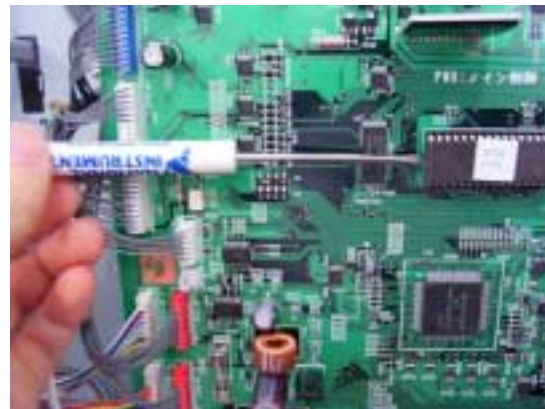
4. Remove the ROM (IC134) from the IC socket on the finisher main board.

**Important:** Use an IC extractor (left photo) or small standard screwdriver (right photo).

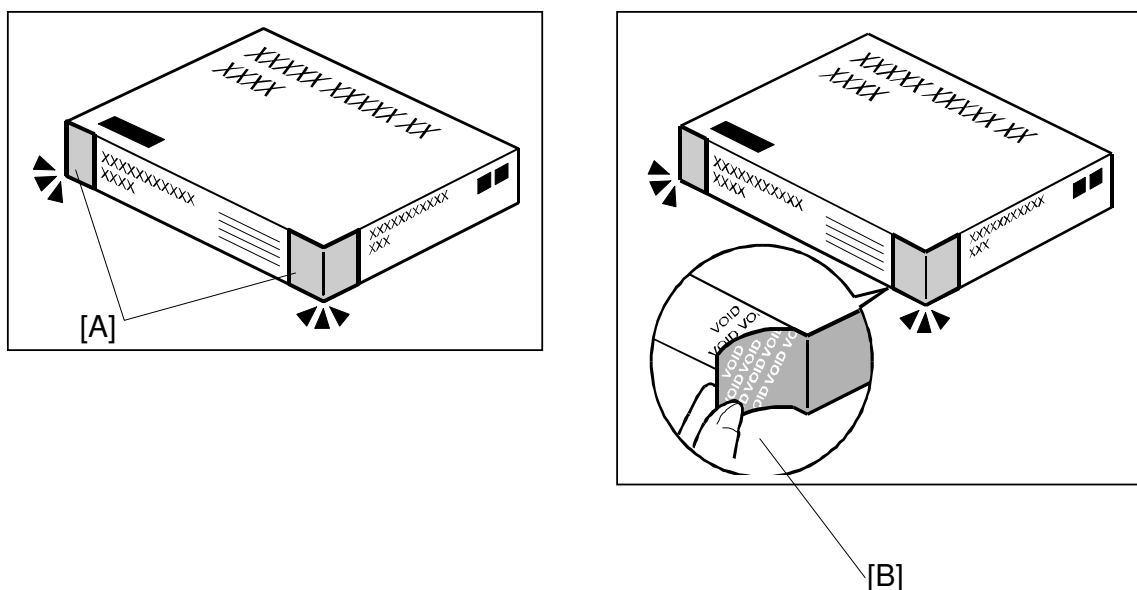
#### Seal Check And Removal

- Make sure that:
  - The box has **two pieces of tape** [A] attached to the corners in the photo, **AND**
  - These two tapes are **blank**.
    - If you can see "VOID" on the surface of the tape, DO NOT install the components in the box. Stop this procedure and contact your Sales division.
- If the results of Step 1 are OK, remove the two pieces of tape from the box.

**Note:** After you remove the tapes, you will see "VOID" written on the box under the tape [B]. This is normal.

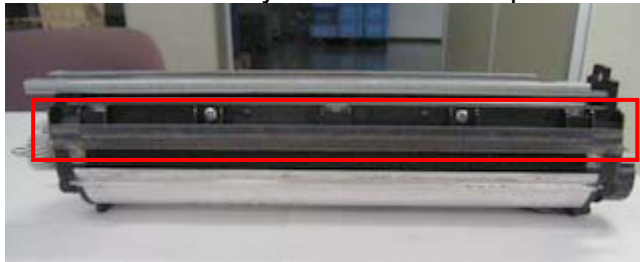
1. Remove the Mylar shown in the photo below.

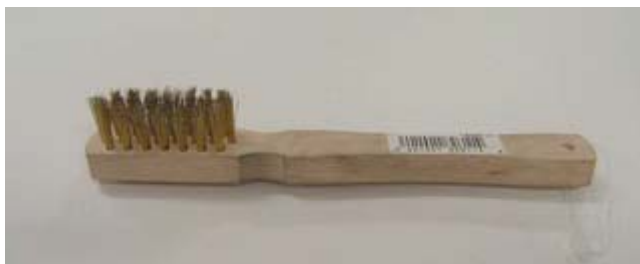
3. Clean the development roller sleeve by sliding the brush shown in the photo firmly along the entire length of the sleeve.

**Important:** Do not press the brush too hard, since this may scratch the sleeve.
