Model: Martini-C3.5	Date: 07-Feb-08	No.: RD052001a
----------------------------	-----------------	----------------

Subject: Firmware Release Note: Engine		Prepared by: S.Watanabe	
From: 2nd Tech. Support Sec. Service Support Dept.			
Classification:	<input type="checkbox"/> Troubleshooting	<input type="checkbox"/> Part information	<input type="checkbox"/> Action required
	<input type="checkbox"/> Mechanical	<input type="checkbox"/> Electrical	<input type="checkbox"/> Service manual revision
	<input type="checkbox"/> Paper path	<input type="checkbox"/> Transmit/receive	<input type="checkbox"/> Retrofit information
	<input checked="" type="checkbox"/> Other ()

Model: General		Date: 12-Mar-08	No.: RGene027
Subject: New Wireless LAN Option		Prepared by: H.K.	
From: 1st Tech. Support Sec. Service Support Dept.			
Classification:	<input type="checkbox"/> Troubleshooting <input type="checkbox"/> Mechanical <input type="checkbox"/> Paper path <input type="checkbox"/> Product Safety	<input type="checkbox"/> Part information <input type="checkbox"/> Electrical <input type="checkbox"/> Transmit/receive <input type="checkbox"/> Other ()	<input checked="" type="checkbox"/> Action required <in

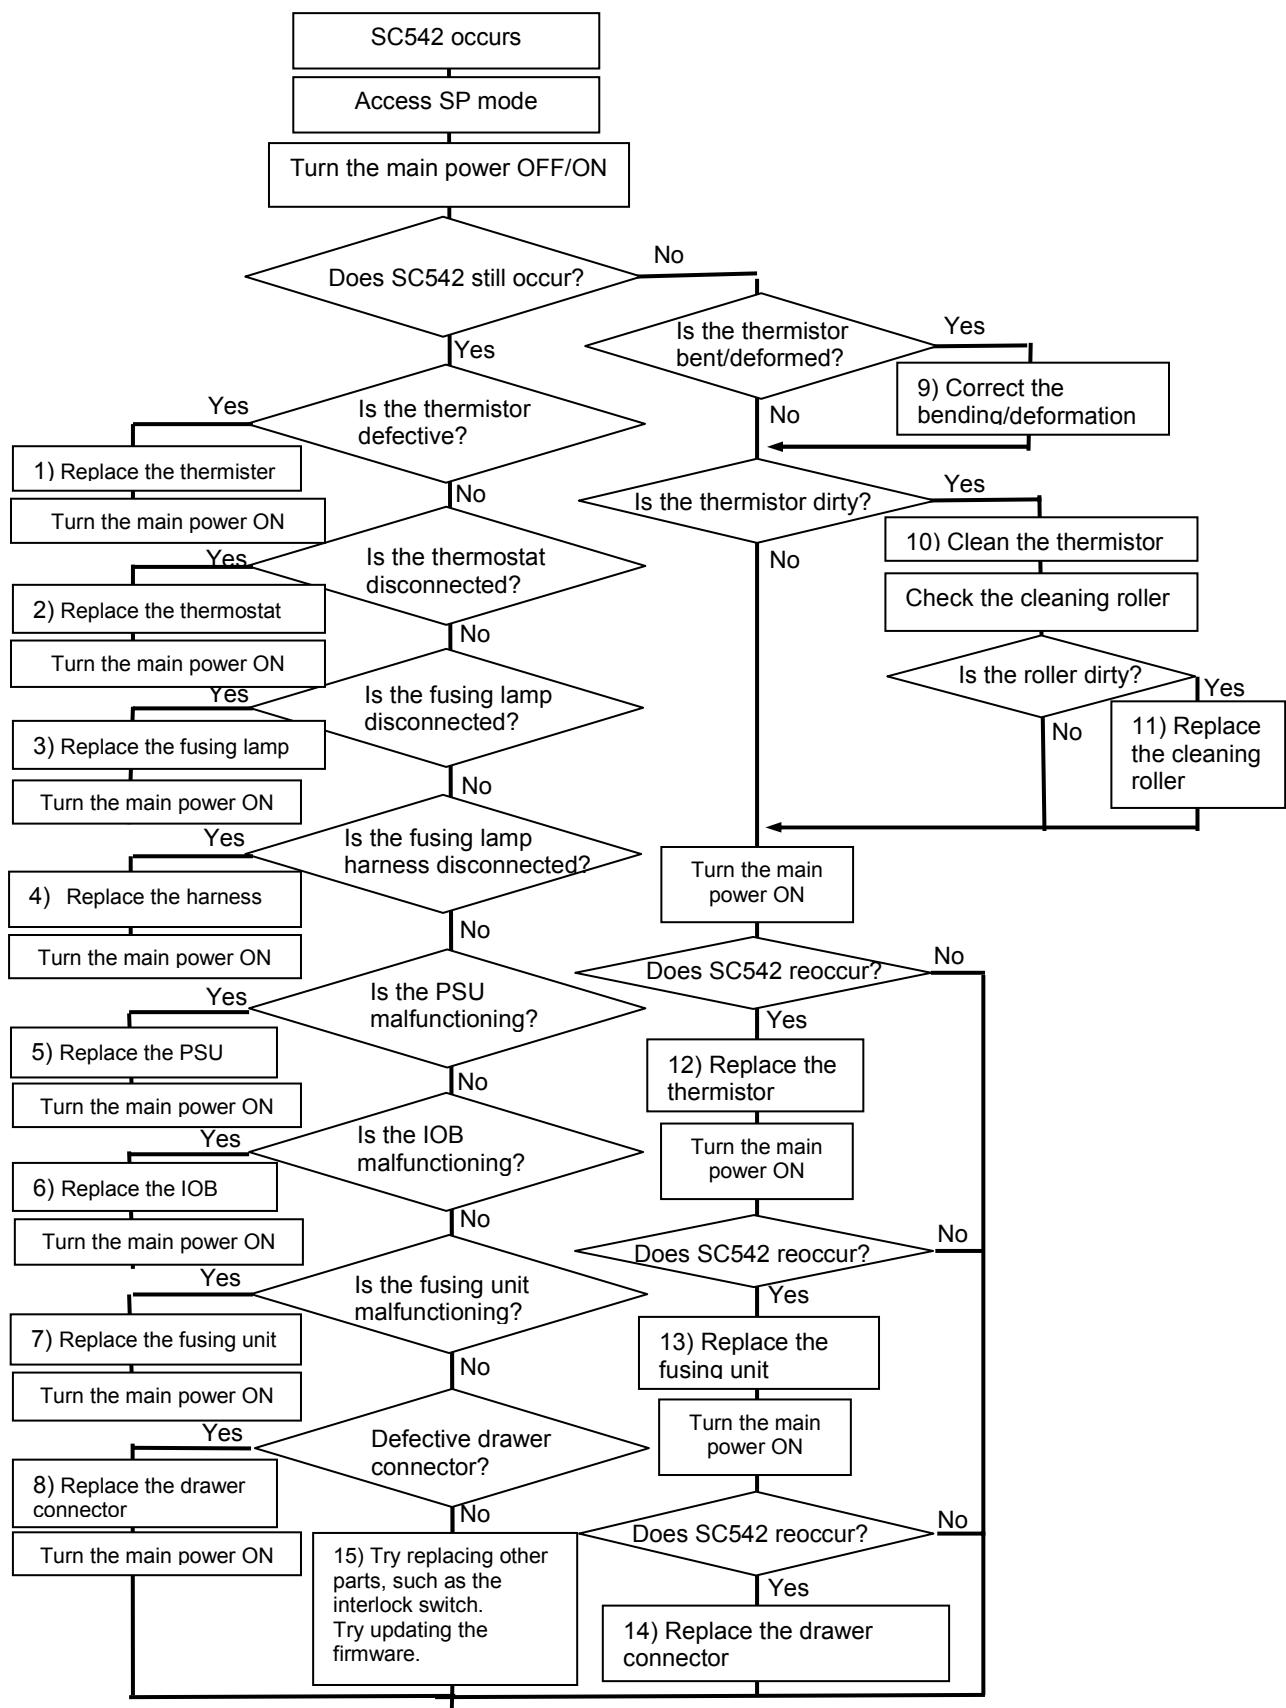
Flowchart for SC542 occurrences

These tips contain a summary of the multiple causes for SC542, and a flowchart for determining the cause of a specific occurrence and taking the right action. There are many cases in the field in which a great deal of time is spent on analysing the cause. These troubleshooting tips can greatly improve the efficiency and speed of this process.

6. PSU malfunction
7. IOB malfunction
8. Deformation/damage to the fusing unit as a result of the unit being dropped or mishandled at machine maintenance
9. The drawer connector is not connected properly

Use the flowchart on the next page to determine the cause of the SC and take the recommended action.

Keep a record of the cause of the SC that you determined in this procedure (write down the corresponding number). At the next occurrence, check to see if the cause is the same.

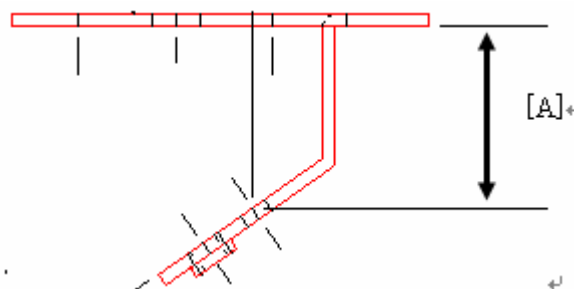
B1404196/7: 14.8mm

D0624196/7: 15.3mm

1. Clean the middle and rear thermistors.
2. If the SC still occurs even after cleaning the thermistors, replace the thermistor brackets with the new parts in the table below.
