Model: Bellini-C1		Date: 28-Aug-03	No.: RA294000b
Subject: Troubleshooting		Prepared by: M. Matsuda	
From: 2nd Tech Support Sec. Service Support Dept.			
Classification:	<input checked="" type="checkbox"/> Troubleshooting <input type="checkbox"/> Part information <input type="checkbox"/> Action required <input type="checkbox"/> Mechanical <input type="checkbox"/> Electrical <input type="checkbox"/> Service manual revision <input type="checkbox"/> Paper path <input type="checkbox"/> Transmit/receive <input type="checkbox"/> Retrofit information <input type="checkbox"/> Other (      )

This bulletin is a troubleshooting guide for Bellini-C1.

# **Troubleshooting Guide for Bellini-C1**

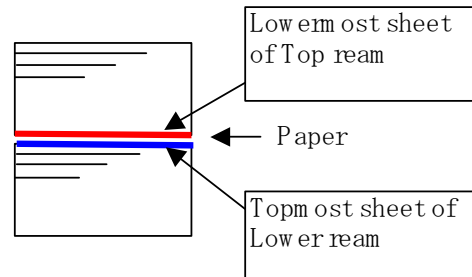
Fig.1

- 1) Fan the leading edges of the top and bottom 50-100 sheets of the paper ream gently.
- 2) As shown in Fig. 1, remove the lowermost sheet of the top ream, as well as the topmost sheet of the lower ream.
- 3) Then, place the paper in the tray.

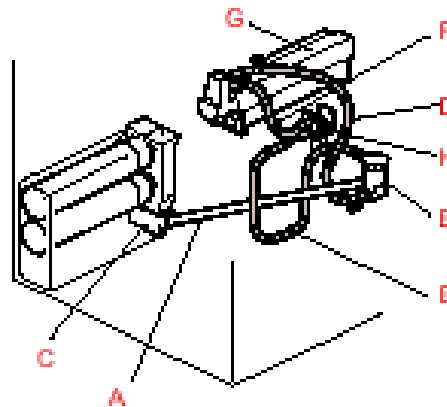
Parts	Remarks	Possible Failure	Note
Toner Transport Coil [A]	Do not remove the toner transport tube [A] while the toner supply cylinder [B] is in.	The toner transport coil [A] may be damaged.	Remove the toner supply cylinder [B] first.
Toner Transport Tube [A]	Do not deform the toner transport tube [A] and coil [A] while the coil rotates to remove the toner in the tube.	The toner transport coil [A] may be damaged.	Use either a vacuum cleaner or a vinyl bag.
Toner Transport Coil [A]	Do not strongly grasp the toner transport tube [A] and coil [A] while the coil rotates to remove the toner in the tube.	The toner transport coil [A] may be damaged.	Use either a vacuum cleaner or a vinyl bag.

Parts	Remarks	Possible Failure	Note
Toner Transport Tube [A]	Firmly install the toner transport tube [A] on the toner transport coil case [C] when replaced.	Toner leakage may occur if the toner transport tube [A] is out of the case [C] when the toner in the tube is blocked.	The gap between the edge of tube [A] and the case [C] should be less than 1 mm.
Toner Supply Cylinder [B]	Do not clean the toner supply cylinder [B] using a vacuum cleaner when any of the air tubes [D, E, F] are connected between the development unit and the cylinder.	The toner in the toner hopper [G] flows backward and the air pump [H] and/or the tubes [D, E, F] may be blocked with the toner.	Remove the development unit first.
Air Tubes [D], [E], [F]	Clean the toner in the air tubes [D, E, F].	The air pump [H] and/or tubes [D, E, F] may be blocked with toner when doing SP2-207-2 (Toner bank toner supply).	—
	Do not clean the air tubes [D, E, F] using a vacuum cleaner when the tubes are connected to the development unit.	The air pump [H] and/or tubes [D, E, F] may be blocked with toner.	Remove the development unit first.

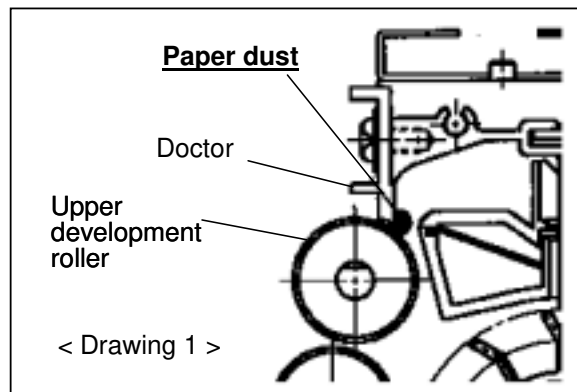
Paper dust gathers at the front and rear sides of the doctor blade gap in the development unit, causing the gap to become narrower which decreases the airflow from the lower development casing.

**CAUTION:** Do not remove the doctor blade or loosen any screws on the development unit, as this will make it impossible to readjust the doctor gap in the field and lead to image quality problems. ***If the blade has already been removed or screws loosened, contact the key person for this model at the Ricoh regional headquarters in your field.***

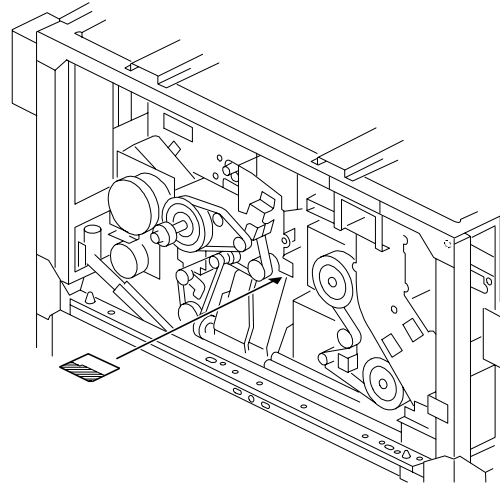
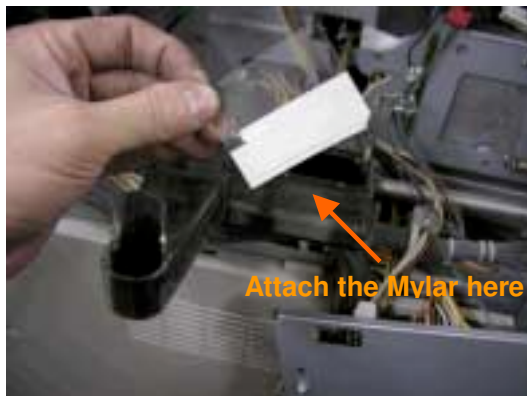
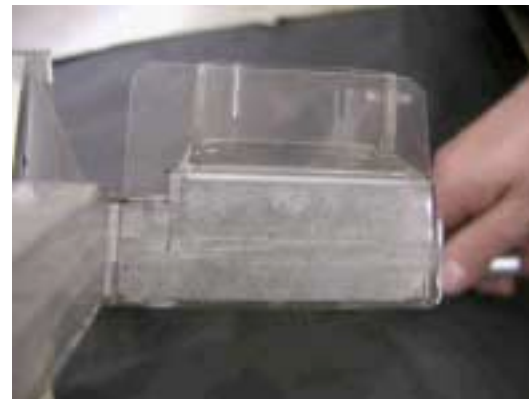
**Attaching position: Rear side view**

- b) Attach the Mylar (B0703618) to the top of the toner recycling case as shown below. This will prevent toner scattering at the connection between the transfer unit toner collection pipe and recycling case.

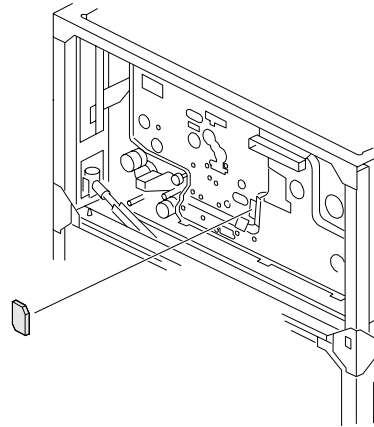
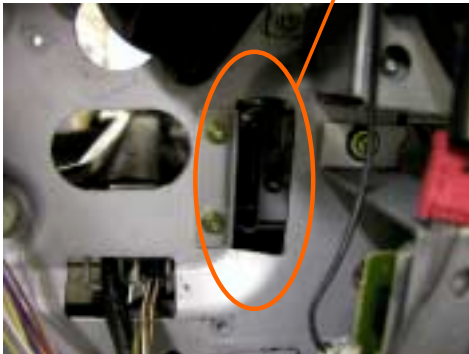
**Rear side view**

- c) Attach the new seal (B0703619) as shown below to the opening in the rear side plate. This will prevent toner scattering in the fusing and duplex areas.

**Cover this opening with the seal**

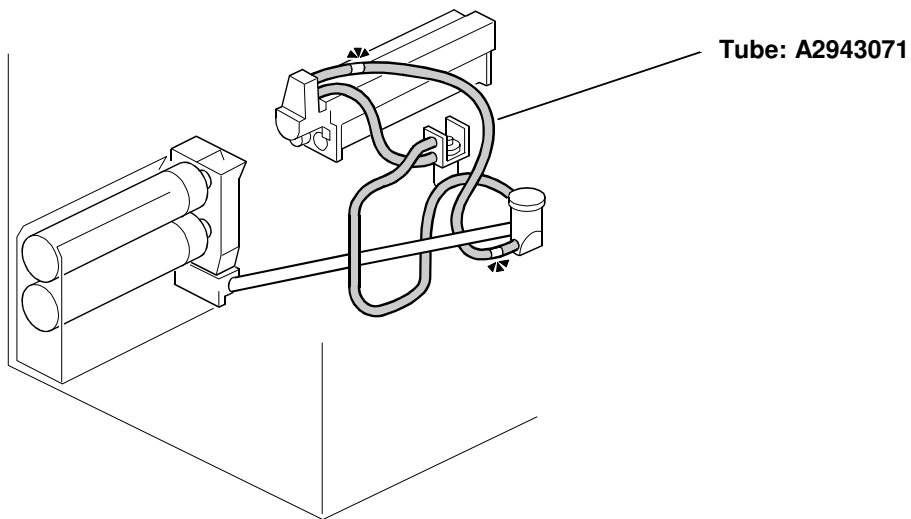
- b) Clean the tube (A2943071) between the toner hopper and the cylinder case (procedure below).

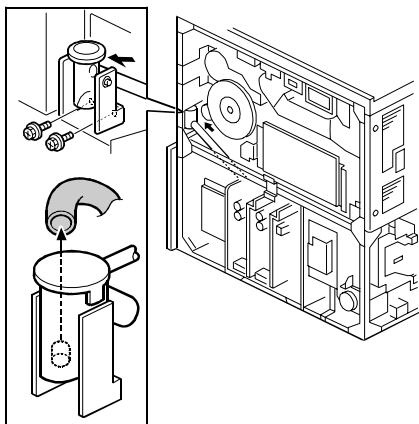
### Tube Cleaning Procedure

1. Remove the development unit.
2. Remove the right upper cover and cylinder case bracket.
3. Disconnect the tube (A2943071) from the cylinder case.

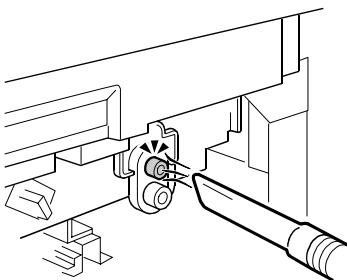
4. Remove any clogged toner through the upper hole of the tube joint using a vacuum cleaner.

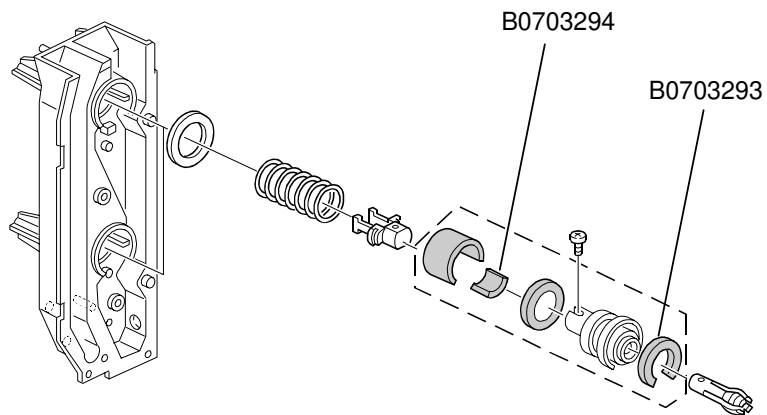
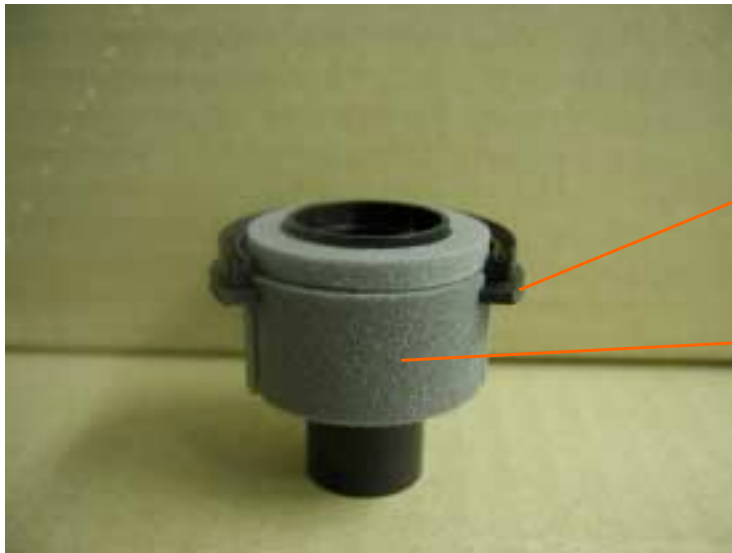
Toner may scatter to the outer portion of the toner bank unit when the toner bottle chuck opens the bottle. The split toner covers the detection area of the toner over flow sensor, causing it to mis-detect the waste toner bottle full condition.

Two kinds of the shields have been added to ensure toner does not leak out from the toner bottle.

- P/N: B0703293 (Shield Slider), B0703294 (Shield Slider Short)
- Attachment position:

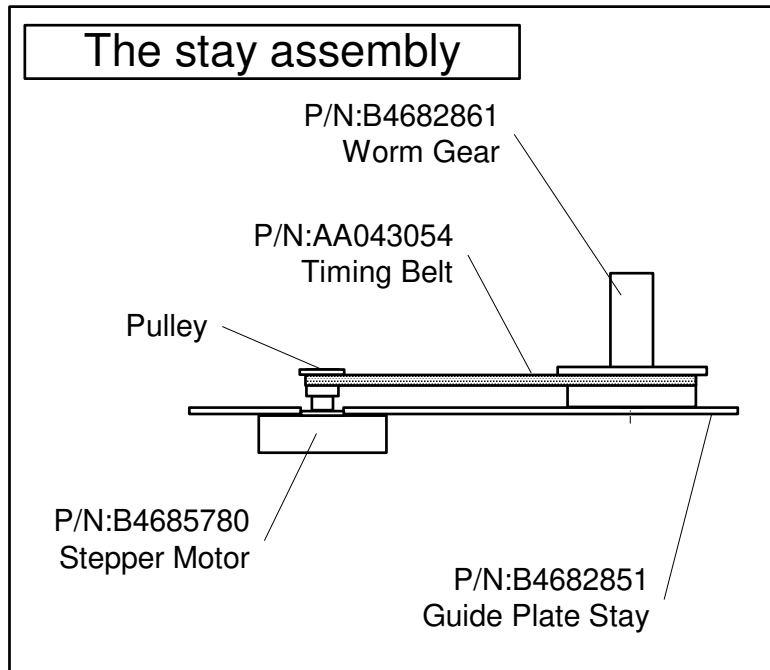
**Fig. 1**

1. Remove all of the following shift-transfer section components (P/C: pg. 13).

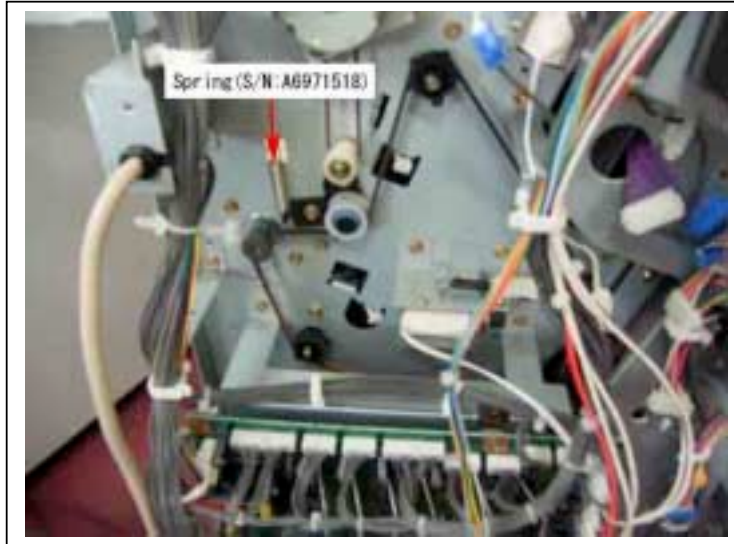
**Fig. 2**

2. Remove the spring (P/N: A6971518) located in drive section 2 (P/C: pg. 41, index 12).

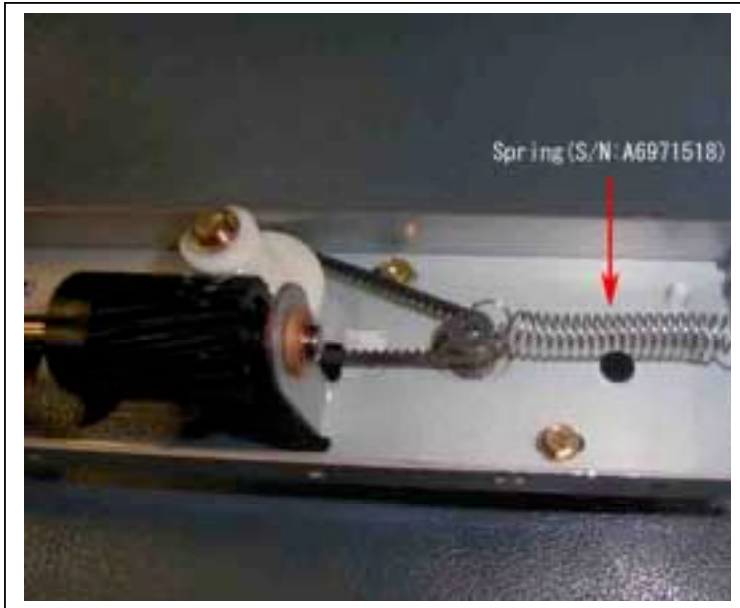
**Fig. 3**

Insufficient tension in the shift-transfer timing belt causes excess torque in the belt's motor when the paper passes, resulting in a motor lock and paper jam in the finisher exit section.

3. Attach the spring that was removed above to the area shown below (one end to the motor pulley, the other end to the edge of the stay). This spring will be used to apply the optimum tension to the belt ( $6 \pm 3.5\text{N}/3\text{mm}$ ).

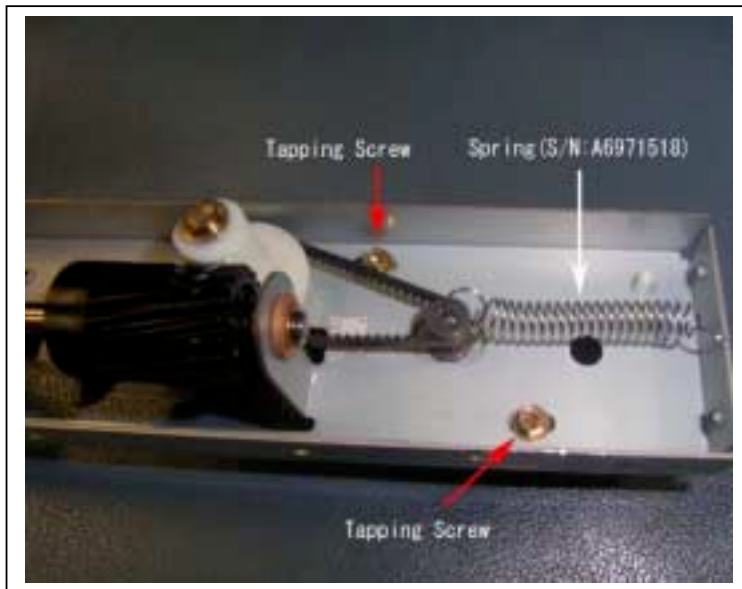
**Fig. 4**

4. Loosen the two tapping screws shown below (P/N: 04513006B) and allow the belt to settle to its new position (pulled by the spring).

5. Tighten the screws while the belt is in the new position.

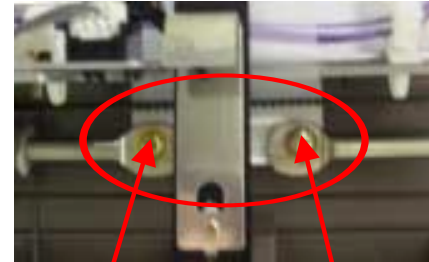
8. Adjust the rear jogger shaft position until the top edge of the upper stay and the upper edge of the board are parallel to one another.

Left edge height + Right edge height = 0.5mm or less.

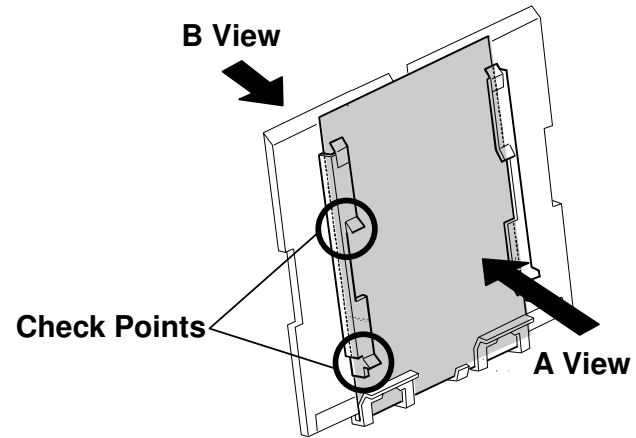
10. Bring the front jogger fence flush against the edge of the board, then adjust the front fence shaft until the board/fence gaps on both sides are:  
Board/fence gap (top + bottom) = 0 - 0.5mm.

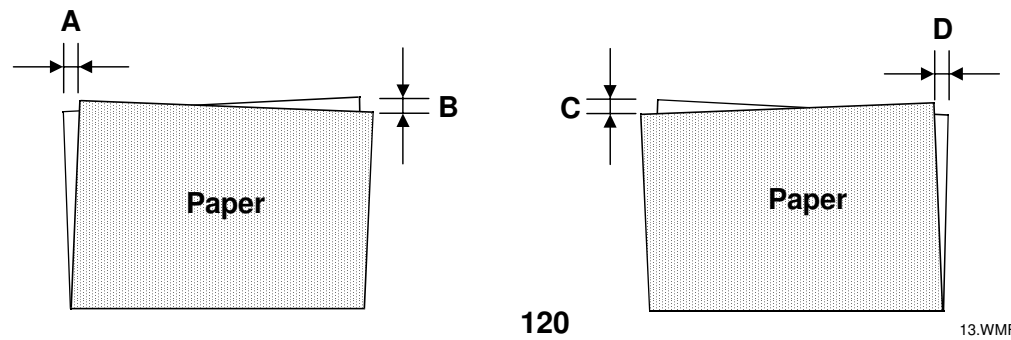
12. Print out 3 Booklet sets (2-3 sheets each) and check for folding skew.

All distances shown below (A, B, C, D): **2mm or less**.

**Note:** As mentioned on pg. 1, measure this from the edges of the **innermost sheet**.

13. If A, B, C or D is over 2mm, do the following.

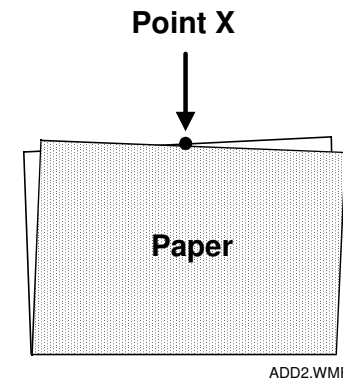
15. Adjust the folding position using SP6902 until the two edges intersect in the middle (point X). This will minimize vertical folding skew, i.e. bring the leading/trailing edges of the sheets closer together.

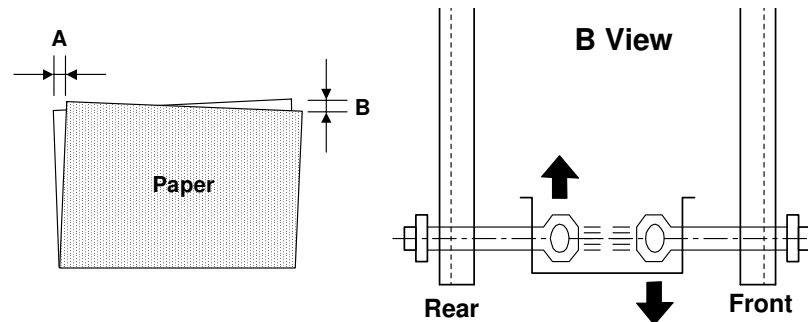
- 1) If A/B are over 2mm, **raise** the rear jogger fence shaft and re-secure the shaft in place. Then, loosen the screw for the front jogger fence shaft, **lower** the shaft to bring the front jogger fence flush against the paper, and re-secure the shaft in place.

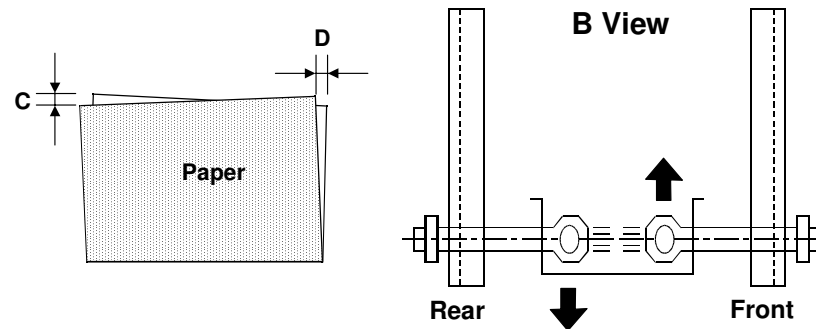
- 2) If C/D are over 2mm, **lower** the rear jogger fence shaft and re-secure the shaft in place. Then, loosen the screw for the front jogger fence shaft, **raise** the shaft to bring the front jogger fence flush against the paper, and re-secure the shaft in place.

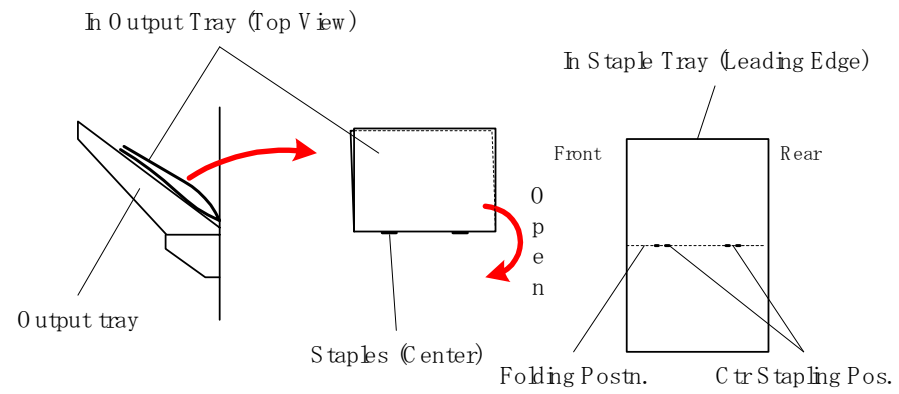
**Fig. 1: The Stack in the Output and Staple Trays**

Symptom	Cause	Check/Adjustment
<p><b>5. Jams with Center Stapling II</b> The center stapling position is shifted toward the upper edge, and there is vertical shifting within the stack itself.</p>

<p>The jogger fence gap is too wide, which prevents proper aligning of the stack's side edges.</p>	<ul style="list-style-type: none"> <li>● Check the current width of the jogger fence gap (<b>“Jogger Fence Gap Check” below</b>), and if necessary adjust the gap using <b>SP6120</b> (in the “–” direction). → See <b>“Adjusting the Jogger Fence Gap” below</b>.</li> </ul>
