Model: General RTB	Date: 4-Feb-03	No.: RGene013b
--------------------	----------------	----------------

Subject: Service remarks at installation		Prepared by: T. Itoh	
From: Technical Service Sec. Service Planning Dept.			
Classification:	<input type="checkbox"/> Troubleshooting	<input type="checkbox"/> Part information	<input type="checkbox"/> Action required
	<input type="checkbox"/> Mechanical	<input type="checkbox"/> Electrical	<input type="checkbox"/> Service manual revision
	<input type="checkbox"/> Paper path	<input type="checkbox"/> Transmit/receive	<input type="checkbox"/> Retrofit information
	<input checked="" type="checkbox"/> Other (Specification change)

Model: Bellini-C2		Date: 1-Sep-03	No.: RB070024
Subject: File Format Converter supports DTB V2 from v3.0.0.0, error message unclear		Prepared by: K. Ichihara	
From: NS Support Sec. Service Support Dept.			
Classification:	<input type="checkbox"/> Troubleshooting	<input type="checkbox"/> Part information	<input type="checkbox"/> Action required
	<input type="checkbox"/> Mechanical	<input type="checkbox"/> Electrical	<input type="checkbox"/> Service manual revision
	<input type="checkbox"/> Paper path	<input type="chec

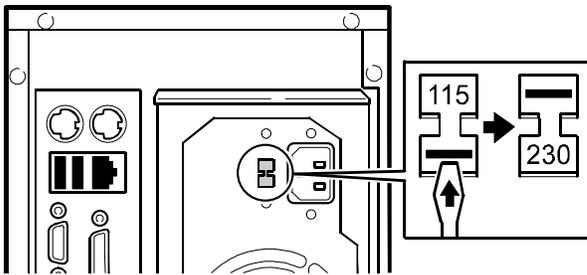
Input Voltage

As mentioned in the Service Manual, before connecting the AC power cord to the EB105EX controller, be sure to check that the 115V/230V switch on the rear of the unit has been set to the proper input voltage. If it has not, use a screwdriver to change the setting. Please note that if this setting is not checked, the controller power supply unit can be damaged.

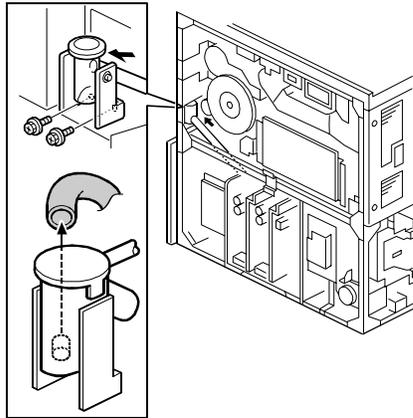
CAUSE

1. Remove the development unit.
2. Remove the right upper cover and cylinder case bracket.
3. Disconnect the tube (A2943071) from the cylinder case.
