Model: Model J-C1		Date: 26-Jan-04	No.: RB149001
Subject: Firmware Release History (Engine)		Prepared by: H. Someya	
From: 1st Tech. Support Sec. Service Support Dept.			
Classification:	<input type="checkbox"/> Troubleshooting <input type="checkbox"/> Part information <input type="checkbox"/> Action required <input type="checkbox"/> Mechanical <input type="checkbox"/> Electrical <input type="checkbox"/> Service manual revision <input type="checkbox"/> Paper path <input type="checkbox"/> Transmit/receive <input type="checkbox"/> Retrofit information <input checked="" type="checkbox"/> Other ()

This RTB has been issued to announce the firmware release information for the engine.

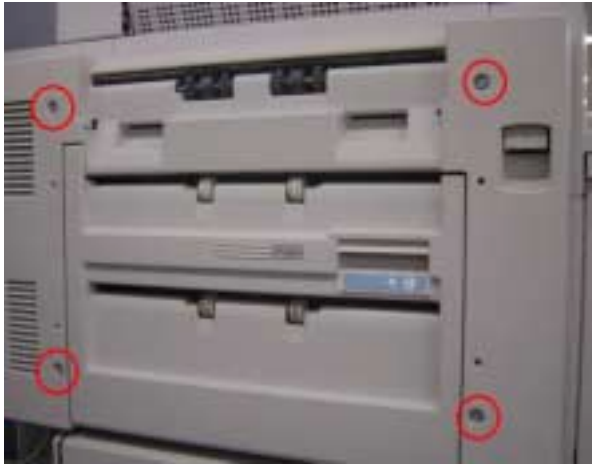
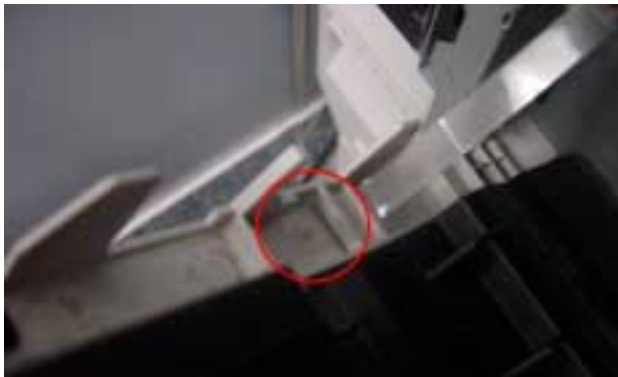
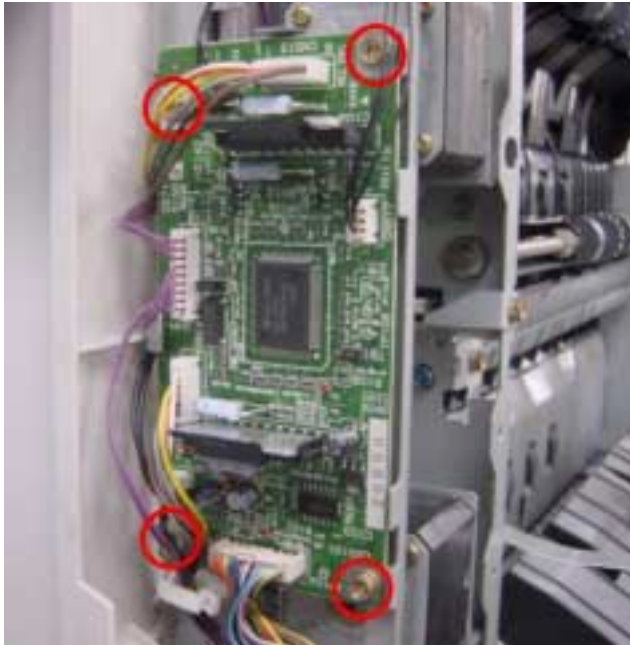
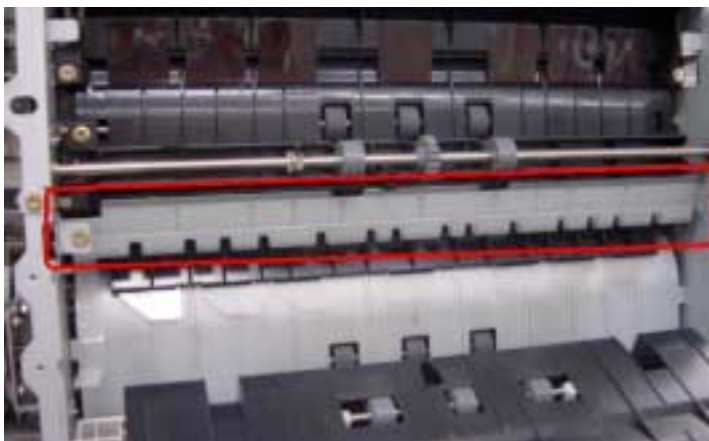
Replace the seven Mylars shown below (P/N G3484682, Sheet: Gate: 2).

1. Open the duplex left cover [A].
2. Remove the top cover (screw x 4).

3. Remove the stopper.

4. Remove the duplex control board (screw x 4, harness x 7).

5. Remove the left middle guide plate (screw x 2).

6. Replace the 7 Mylars shown in the photo (red circles).

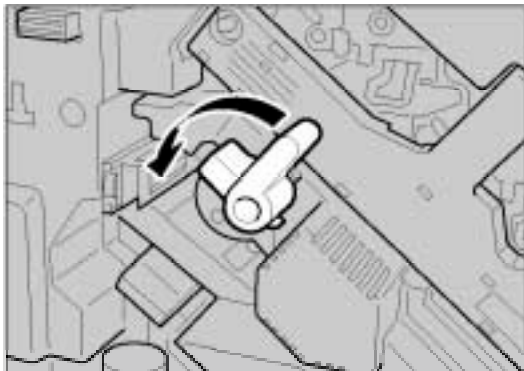
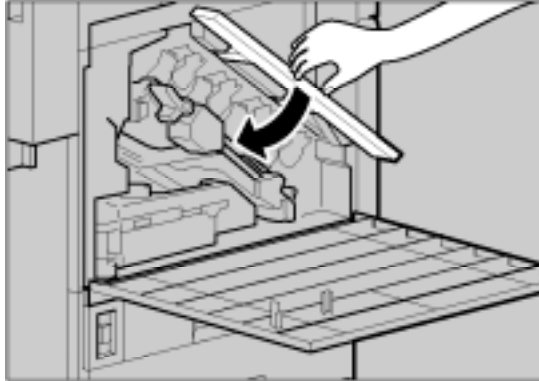
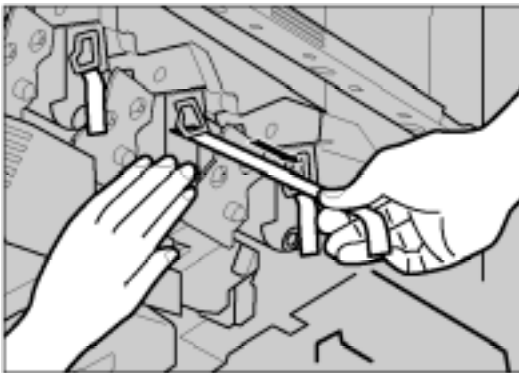
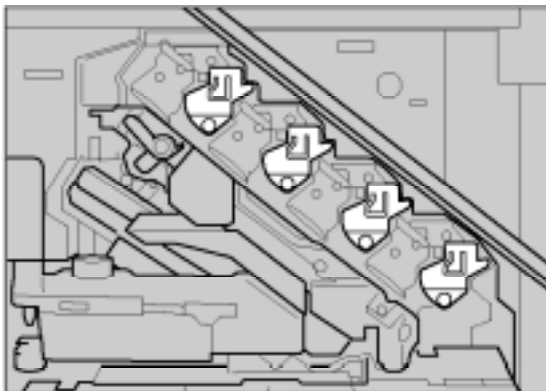
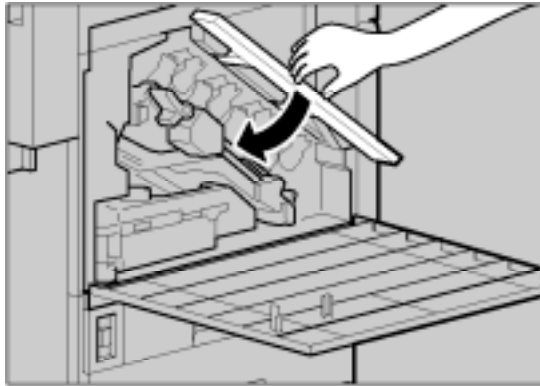
SC386, SC387, SC388 **or SC389** may occur when you install the machine **or replace the development unit**.

- *The unit is not installed correctly at the factory*
- *A new unit is not installed correctly in the field at developer replacement*

1. Turn the transfer belt release lever counterclockwise.

2. Loosen the two screws on the drum plate.
3. Open the drum plate until you hear a click.

4. While you hold the development unit with one hand, pull out the tape gently as shown.

5. Push in the four development units all the way to the rear.

6. Close the drum plate.
7. Tighten the upper-left screw for the drum plate.
8. Tighten the lower-right screw for the drum plate.

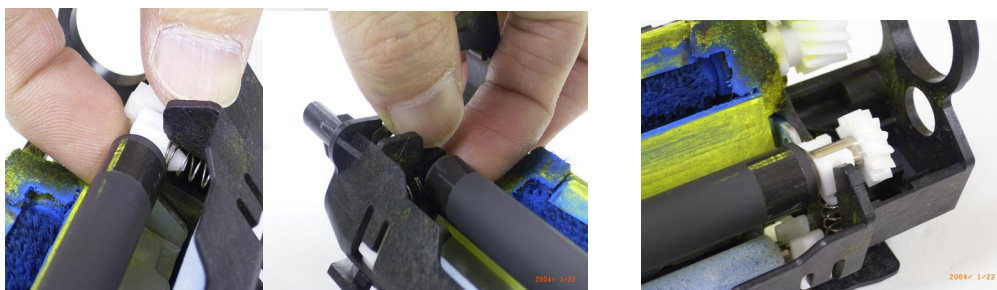
- Make sure to attach the charge roller as shown below, i.e. parts B and D should both fit into their respective guide ribs on the unit frame.
- Make sure that: 1) the spring is properly aligned (straight; not bent), 2) the gears on both sides are attached properly to the shaft, and 3) the charge roller cleaner is properly secured in its bushings at both ends.

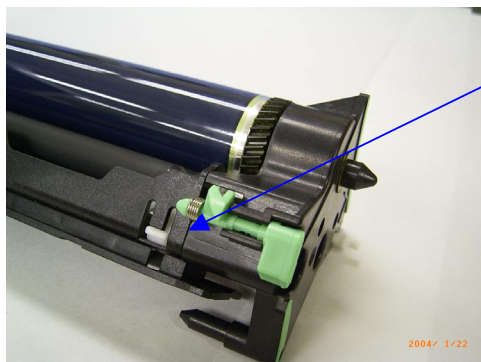
Make sure there is no gap between the cover and the frame.

- When reattaching the front cover, make sure there is no gap between the cover and the frame.

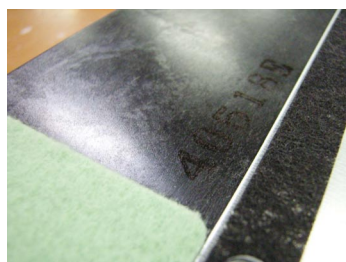
Unit for **normal ACV** (black):

Note: On the new unit, the lot number is white (see the photos below).

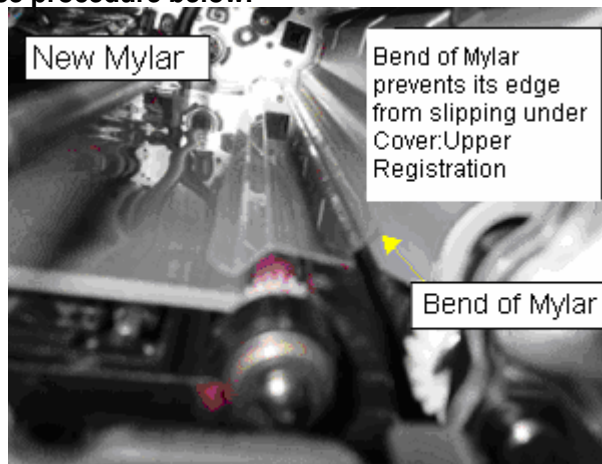
Note: This new guide Mylar is bent, which prevents the edge of the guide Mylar from slipping under the Cover: Upper Registration.

Replace the guide Mylar at the entrance of the transfer unit with P/N **B1803908**.

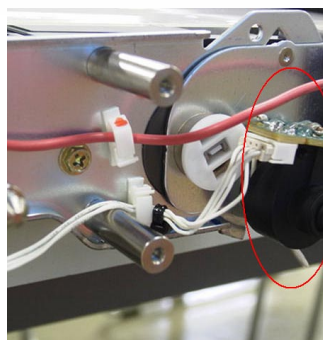
The shape circled by black was changed.
