## Technical Bulletin

Reissued: 23-Jun-04 Model: Neptune-C1

Subject: BICU & SCU Firmware Modification History			Prepared by: F.Noguchi		
From: 2nd Tech. Support Sec. Service Support Dept.					
Classification:	<ul> <li>Troubleshooting</li> <li>Mechanical</li> <li>Paper path</li> <li>Other ()</li> </ul>	Part informat     Electrical     Transmit/rec	ion eive	<ul> <li>Action required</li> <li>Service manual revision</li> <li>Retrofit information</li> </ul>

Model: Neptune-C1			Dat	e: 23-Jun-04	No.: RB125002	
Subject: Black Spots				Prepared by: F.Noguchi		
From: 2nd Tech Support Sec. Service Support Dept.						
Classification:	Troubleshooting	Part info	ormat	tion 🗌 Ac	tion required	
	Mechanical	Electric	al	🗌 Se	ervice manual revision	
	Paper path Transmit/re		it/rec	eive 🗌 Re	etrofit information	
	Other ()

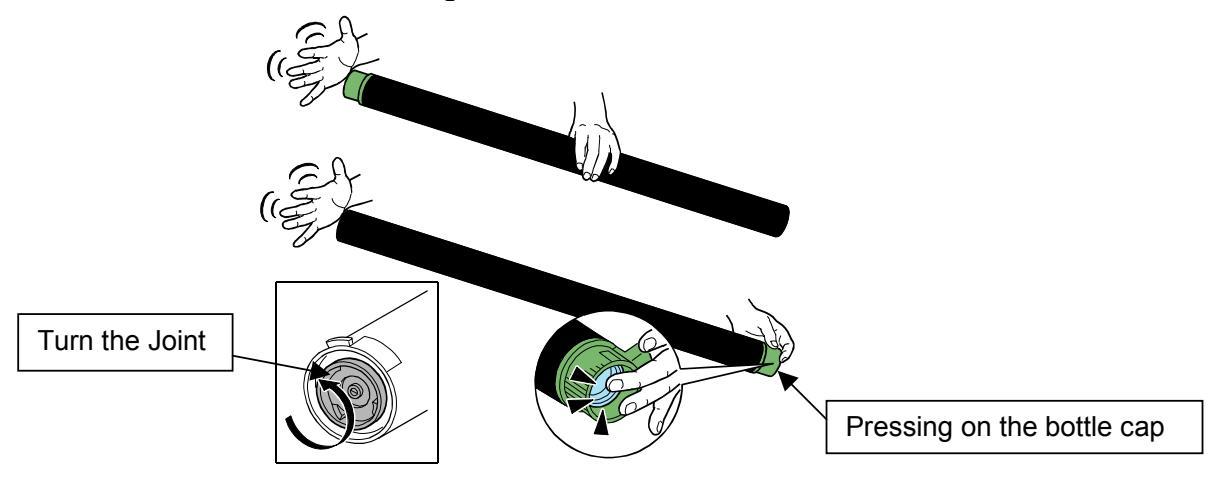
The mechanism in the N-C1 development unit is designed to prevent damage to the gears and toner cartridge joints.

- 1. Hold the middle of the new toner cartridge and tap the joint (green end) 4 or 5 times.
- 2. Hold the joint with 2-3 fingers and tap the other side 4 or 5 times.
- 3. Hold the bottle horizontally and shake it briskly side-to-side 5 or 6 times.
- 4. Turn the joint one time around (in the direction of the arrow). **Important:** If you cannot turn the joint, do Steps 1 thru 3 again.
- 5. Install the new toner cartridge.

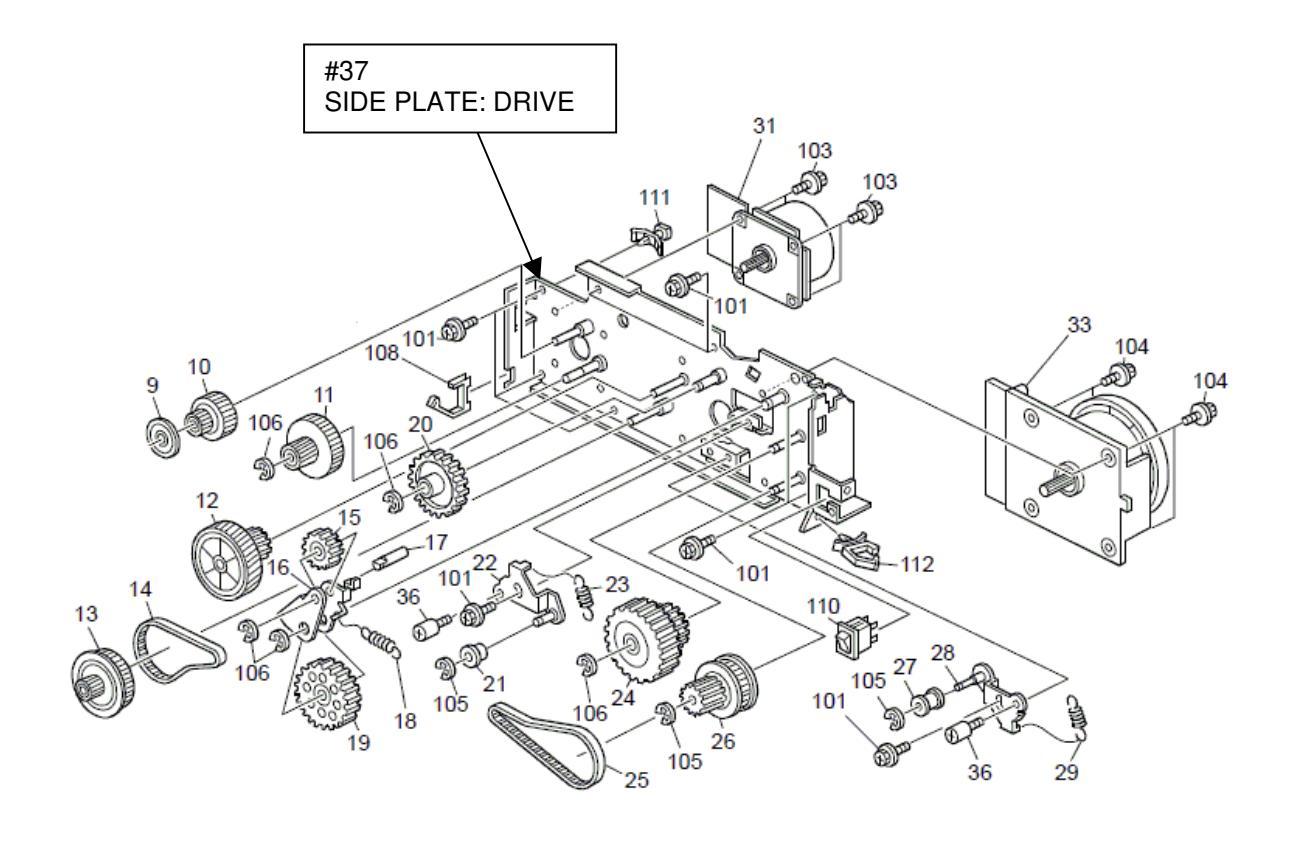
**Change:** The side plate was added. **Reason:** In accordance with requests from the field.
