Model: Russian-C4	Date: 6-Sep-05	No.: RB205001n
-------------------	----------------	----------------

Subject: Firmware Release History (Controller)		Prepared by: S. Tomoe	
From: 2nd Tech Support Sec. Service Support Dept.			
Classification:	<input type="checkbox"/> Troubleshooting <input type="checkbox"/> Mechanical <input type="checkbox"/> Paper path <input checked="" type="checkbox"/> Other ()	<input type="checkbox"/> Part information <input type="checkbox"/> Electrical <input type="checkbox"/> Transmit/receive	<input type="checkbox"/> Action required <input type="checkbox"/> Service manual revision <input type="checkbox"/> Retrofit information

Model: Russian-C4		Date: 28-Sep-05	No.: RB205005
Subject: Rotate Sort		Prepared by: S. Tomoe	
From: 1st Tech. Support Sec. Service Support Dept.			
Classification:	<input checked="" type="checkbox"/> Troubleshooting	<input type="checkbox"/> Part information	<input type="checkbox"/> Action required
	<input type="checkbox"/> Mechanical	<input type="checkbox"/> Electrical	<input type="checkbox"/> Service manual revision
	<input type="checkbox"/> Paper path	<input type="checkbox"/> Transmit/receive	<input type="checkbox"/> Retrofit informat

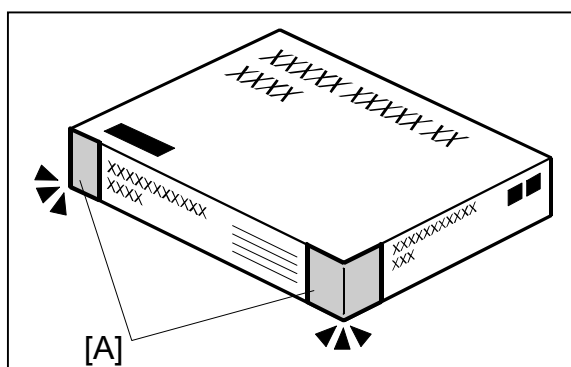
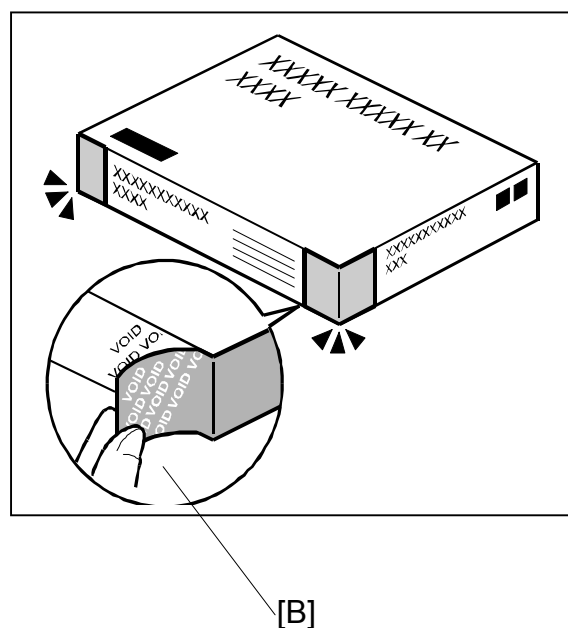
Note: After you remove the tapes, you will see "VOID" written on the box under the tape [B]. This is normal.

1. Make sure that:
 - 1) The box has **two pieces of tape** [A] attached to the corners in the photo, **AND**
 - 2) These two tapes are **blank**.
- If you can see "VOID" on the surface of the tape, DO NOT install the components in the box. Stop this procedure and contact your Sales division.
2. If the results of Step 1 are OK, remove the two pieces of tape from the box.

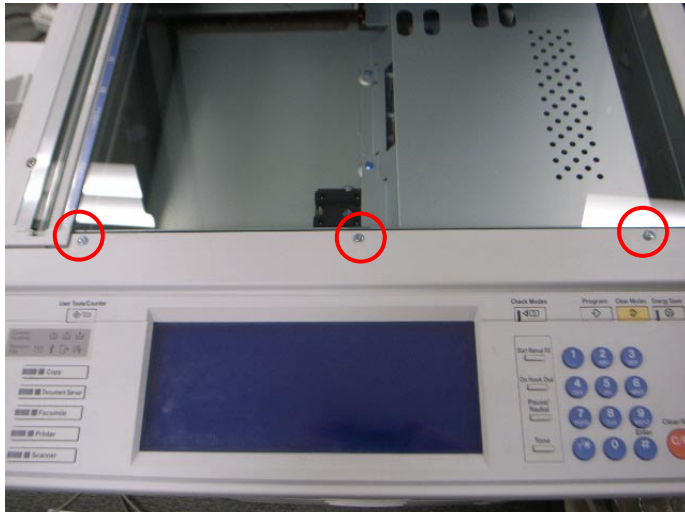
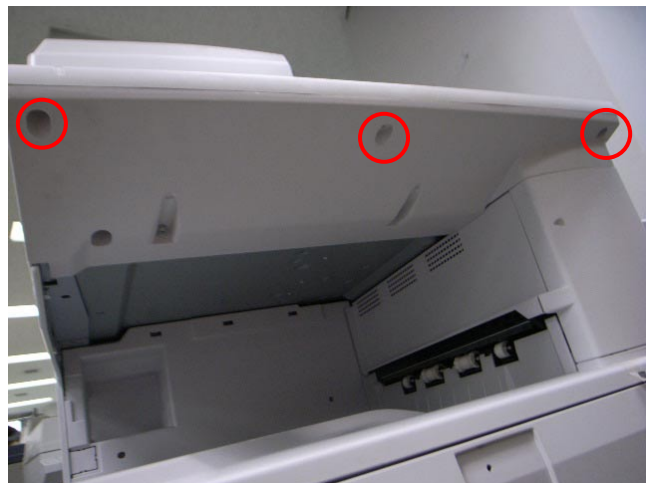
Note: Visual difference between the old and new touch panels:

Old (B2135222): The tip [A] of the electrode attached to the touch panel is **brown**.

IMPORTANT: Therefore, if the tip [A] is white, do not replace the touch panel.

1. Remove the operation panel (6 screws, 1 connector).
