Model: Russian-C4.5	Date: 05-Sep-06	No.: RD007001g
---------------------	-----------------	----------------

Subject: Firmware Release History (Controller)		Prepared by: S. Tomoe	
From: 2nd Tech Support Sec. Service Support Dept.			
Classification:	<input type="checkbox"/> Troubleshooting	<input type="checkbox"/> Part information	<input type="checkbox"/> Action required
	<input type="checkbox"/> Mechanical	<input type="checkbox"/> Electrical	<input type="checkbox"/> Service manual revision
	<input type="checkbox"/> Paper path	<input type="checkbox"/> Transmit/receive	<input type="checkbox"/> Retrofit information
	<input checked="" type="checkbox"/> Other ()

Model: Russian-C4/C4.5		Date: 15-Feb-07	No.: RB205023
Subject: Leaking developer causes PCU gear damage		Prepared by: S. Tomoe	
From: 1st Tech. Support Sec. Service Support Dept.			
Classification:	<input checked="" type="checkbox"/> Troubleshooting <input type="checkbox"/> Mechanical <input type="checkbox"/> Paper path <input type="checkbox"/> Product Safety	<input type="checkbox"/> Part information <input type="checkbox"/> Electrical <input type="checkbox"/> Transmit/receive <input type="checkbox"/> Other ()	<input type="chec

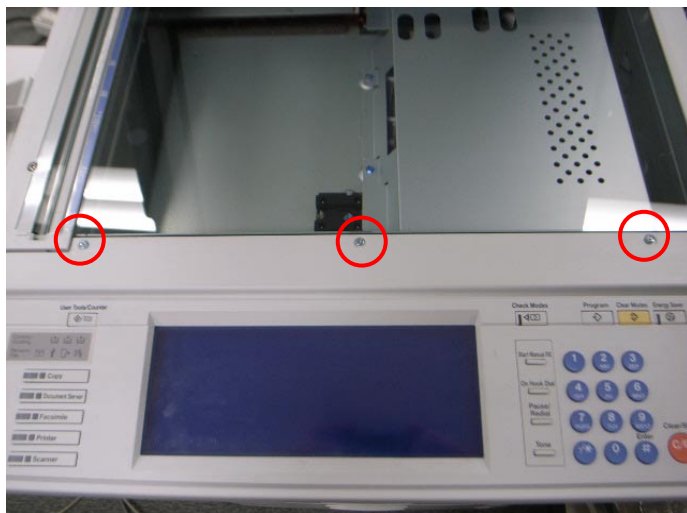
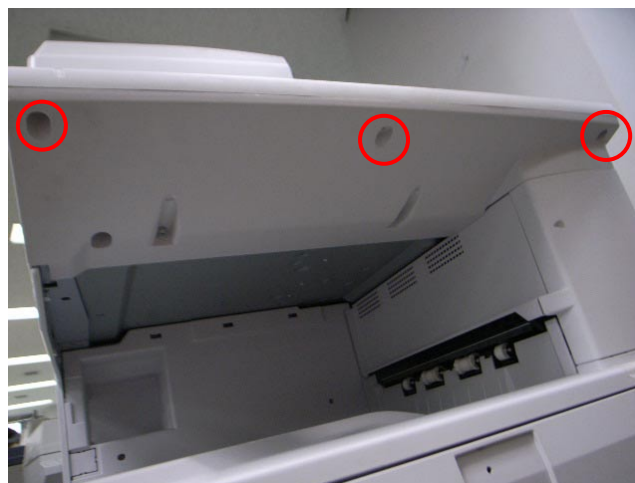
Note: Visual difference between the old and new touch panels:

Old (B2135222): The tip [A] of the electrode attached to the touch panel is **brown**.

New (H3106173): This tip [A] is **white**.

1. Remove the operation panel (6 screws, 1 connector).

IMPORTANT: Therefore, if the tip [A] is white, do not replace the touch panel.
