Model: <b>Adonis-C4.5</b>	Date: 08-Nov-06	No.: RB296001a
---------------------------	-----------------	----------------

Subject: Firmware Release Note: Engine		Prepared by: K.Takagi	
From: 1st Tech. Support Sec. Service Support Dept.			
Classification:	<input type="checkbox"/> Troubleshooting <input type="checkbox"/> Part information <input type="checkbox"/> Action required		
	<input type="checkbox"/> Mechanical <input type="checkbox"/> Electrical <input type="checkbox"/> Service manual revision		
	<input type="checkbox"/> Paper path <input type="checkbox"/> Transmit/receive <input type="checkbox"/> Retrofit information		
	<input checked="" type="checkbox"/> Other (      )

Model: Adonis-C4.5		Date: 5-Oct-07	No.: RB296017
Subject: Platen cover sheet damage		Prepared by: K. Takagi	
From: 1st Tech. Support Sec. Service Support Dept.			
Classification:	<input type="checkbox"/> Troubleshooting <input type="checkbox"/> Mechanical <input type="checkbox"/> Paper path <input checked="" type="checkbox"/> Product Safety	<input type="checkbox"/> Part information <input type="checkbox"/> Electrical <input type="checkbox"/> Transmit/receive <input type="checkbox"/> Other (     )	<input type="c

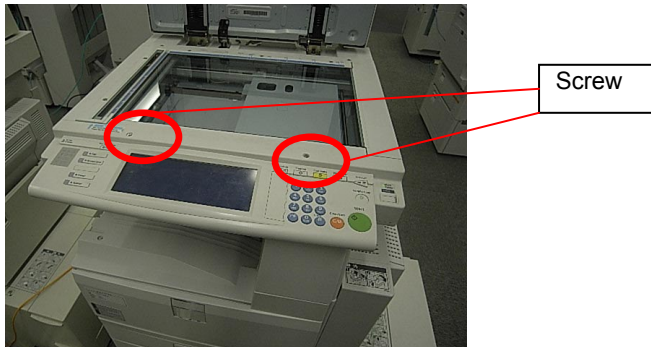
The adhesive that binds electrodes to the touch panel surface contains a polymer that tends to expand under normal office environmental conditions.

Replace the touch panel (**see the procedure below**).

1. Remove the operation panel (screw x 2, harness x 1).

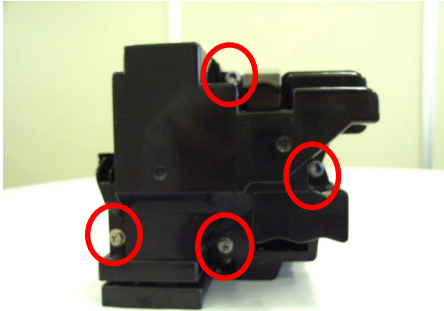
When one of the following conditions is met, the chargeability of the toner is decreased, and the machine responds by increasing the toner concentration (TC). As a result, toner filming on the development roller is accelerated, and poorly-charged toner is easily transferred onto the non-image areas of the OPC surface.

1. Turn the machine main power OFF.
2. Remove the PCU.
3. Remove the four screws shown in the photo.
