Model: Model TH-C1	Date: 12-Apr-05	No.: RB156001a
--------------------	-----------------	----------------

Subject: Firmware History - PS3		Prepared by: H.K.	
From: 1st Tech. Support Sec. Service Support Dept.			
Classification:	<input type="checkbox"/> Troubleshooting	<input type="checkbox"/> Part information	<input type="checkbox"/> Action required
	<input type="checkbox"/> Mechanical	<input type="checkbox"/> Electrical	<input type="checkbox"/> Service manual revision
	<input type="checkbox"/> Paper path	<input type="checkbox"/> Transmit/receive	<input type="checkbox"/> Retrofit information
	<input checked="" type="checkbox"/> Other (Firmware History)

Model: Model TH-C1		Date: 17-May-05	No.: RB156002
Subject: Notes for Installation		Prepared by: H.K.	
From: 1st Tech. Support Sec. Service Support Dept.			
Classification:	<input type="checkbox"/> Troubleshooting	<input type="checkbox"/> Part information	<input type="checkbox"/> Action required
	<input type="checkbox"/> Mechanical	<input type="checkbox"/> Electrical	<input checked="" type="checkbox"/> Service manual revision
	<input type="checkbox"/> Paper path	<input type="checkbox"/> Transmit/receive	<input type="checkbox"/> Retr

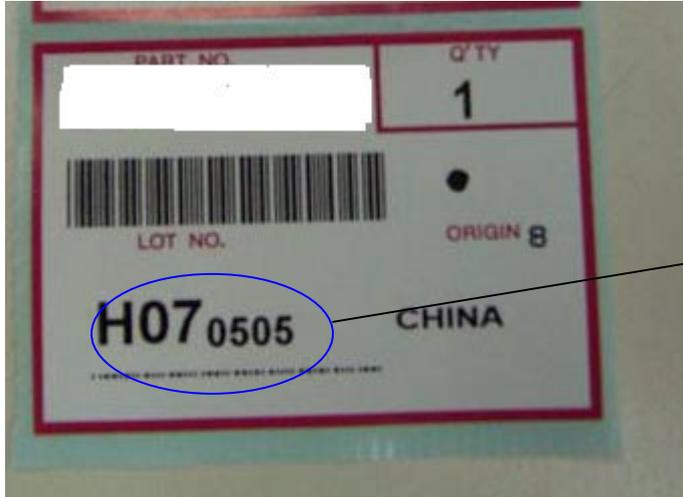
Spare part lot numbers on the part number label
From February production until April 21 production

X 01 02 05 to X 21 04 05

How to read the lot numbers on the part label
H070505 indicates 2005 May 07 production. (Xddmmyy).

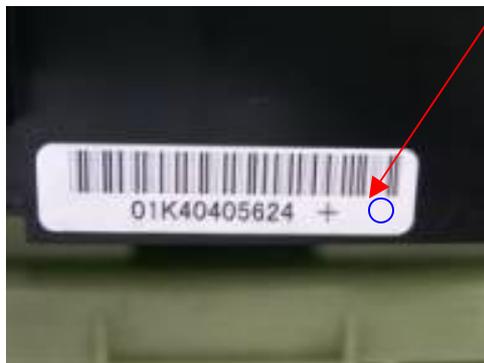
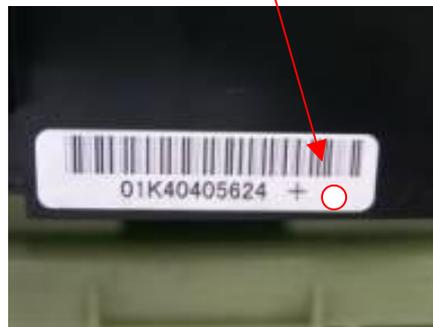
Some units in service parts stock have already been modified.

Blue decal, or blue
dot (ink)

Some units have a blue circle,
OR

Some units have a red circle

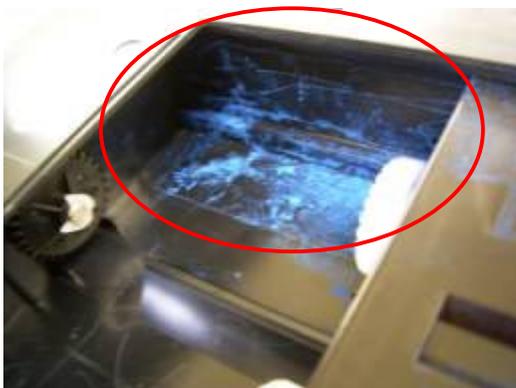
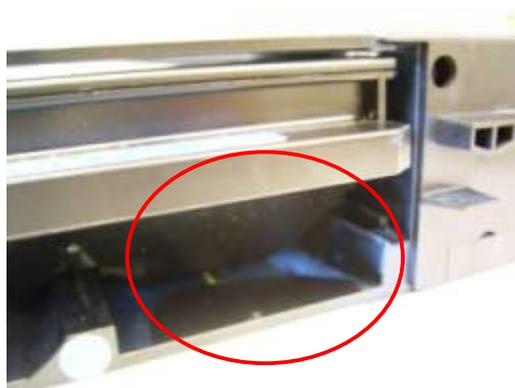
Do not pull out the toner cartridge too far. If you do, toner can leak out of the cartridge (circled in red in the photos).

If this happens, remove the leaked toner.

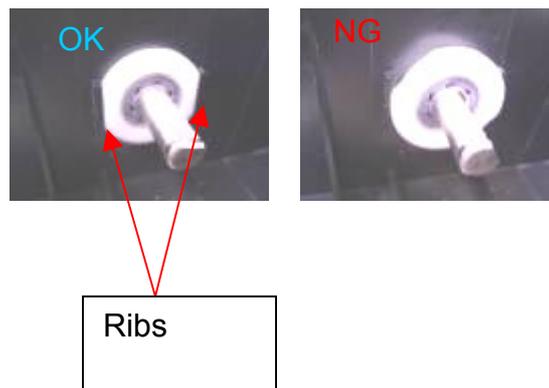
4. Make sure the flat sides of the bearing are parallel with the ribs (see the left photo).

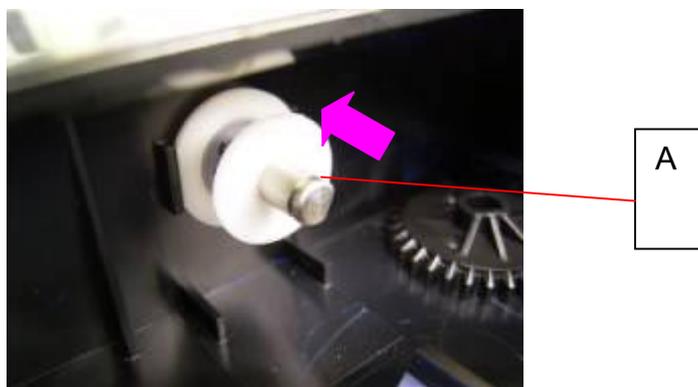
5. Attach the new washer (A) to the shaft.

Important: The washer fits tightly around the shaft, but **DO NOT** change the size of the D-cut.

B0519911: Washer – 20 pcs/set

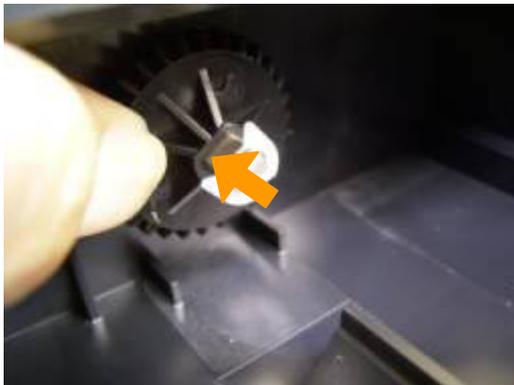
NG

NG: The gear does not move when you push it.

If the gear does not move, remove the gear and reattach it.

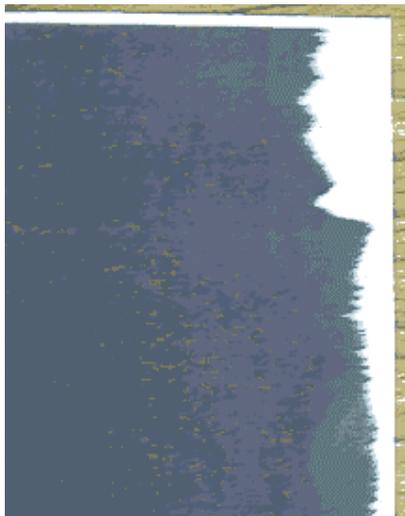
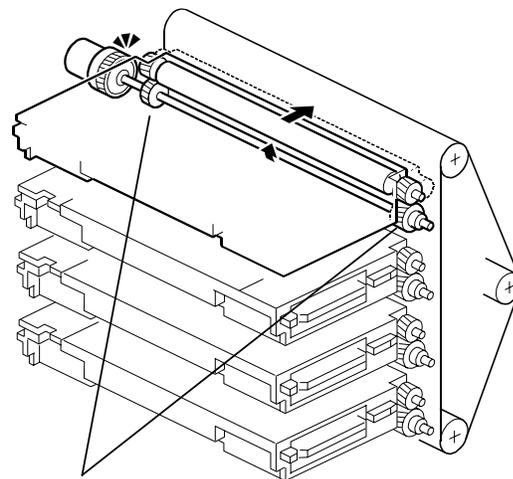
Sample 1

Note: Also, because of this problem, the ID sensor pattern on the OPC is blank. If the machine reads this, it can change the process control conditions.

Note: This can occur at toner cartridge replacement, when the old toner cartridge is not pulled out correctly.

Mainframe gears

1. Try and pull the development unit toward you along the rail.
Important: Do not remove the unit.
2. If the unit moves, there is a gap between the tab on the development unit and the rail stopper (see the photo below). In this case, do the following procedure:
 - Remove the development unit.
 - Rotate the mainframe gears manually.
 - Reinstall the development unit.

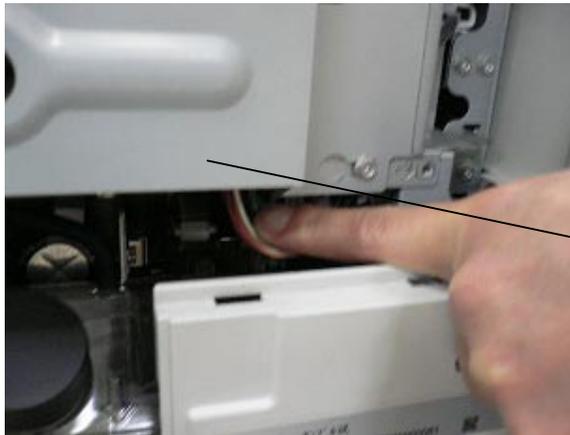
Photo No.3

FU11 (+5V) was open on the PSU because the harness connected to the BICU may be pinched by the bracket. This can cause the harness and the bracket to short circuit.

Controller box cover

Replace the PSU and correct the pinched harness. Replace the harness if it is damaged.

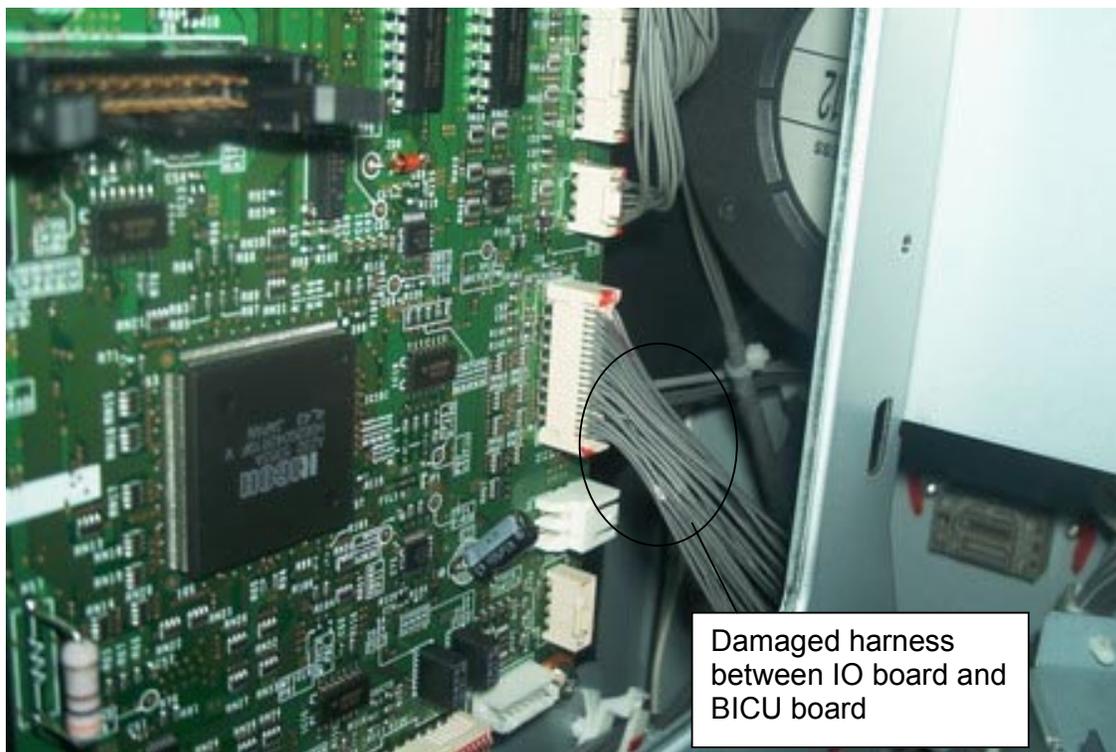
The BICU board is defective, or the controller board is defective and SC838 occurs (Verification Error).

- +5VE short-circuit: The controller board may be defective and SC838 occurs
- +5VF short-circuit: The BICU board may be defective

Note: The short circuit can be caused at the factory or in the field (see **Solution**).

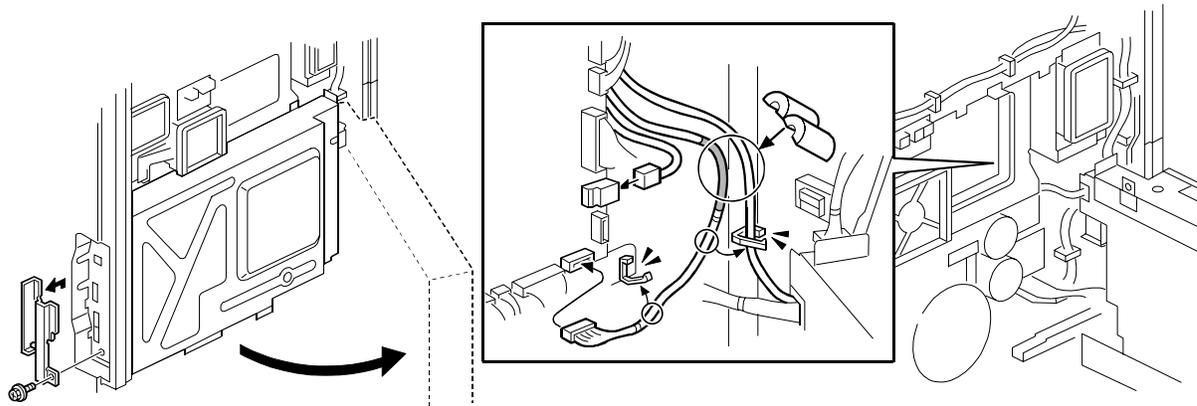
Note: Sometimes, the harness can be damaged if it is stored near rotating equipment.

Do the following when you install the shift tray, install the bridge unit, or do maintenance on the controller box:

1. Be careful not to damage the B1545408 harness.

2. Check the B1545408 harness for damage
 - If it is damaged, cover the damaged part with electrical tape (see the photo on the next page).
3. If SC838 occurs, follow the instructions in the Service Manual.
4. If the BICU board or controller board is defective, replace it.

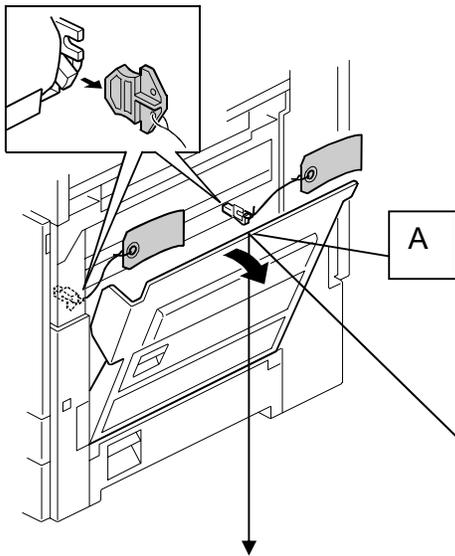
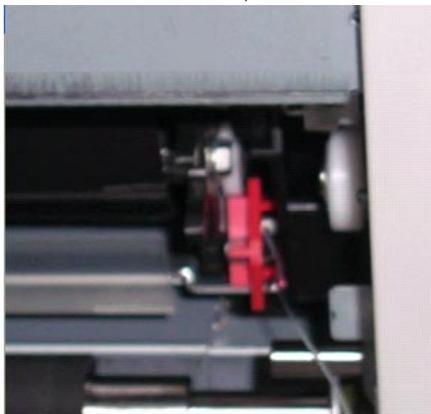
Correct

At installation, the shipping retainer [A] on the rear side of the PCU ITB cannot be removed by hand.

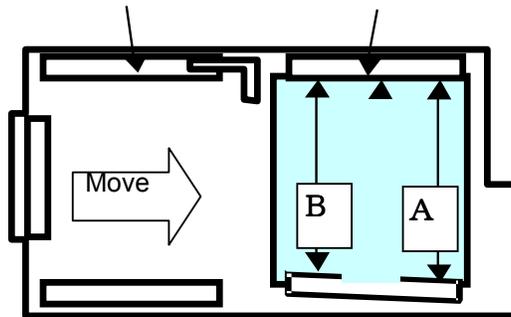
One or more of the following:

- The distance between the side fences is narrow. As a result, the paper is not moved correctly to the right side of the LCT, and the timing belt is overloaded.
- The paper is wider than specification or has burrs on its edge

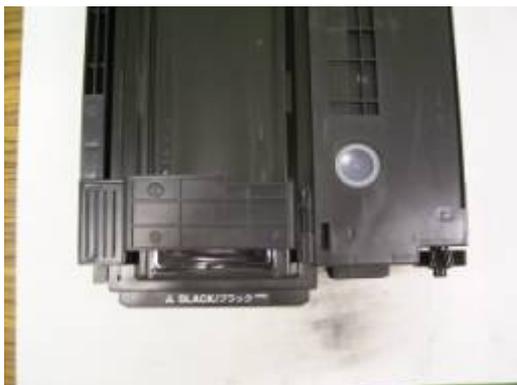
The shutter release position is only 12mm from the edge of the cartridge. As a result, the cartridge cannot be removed easily.

BK toner cartridge
Shutter release position: 12 mm

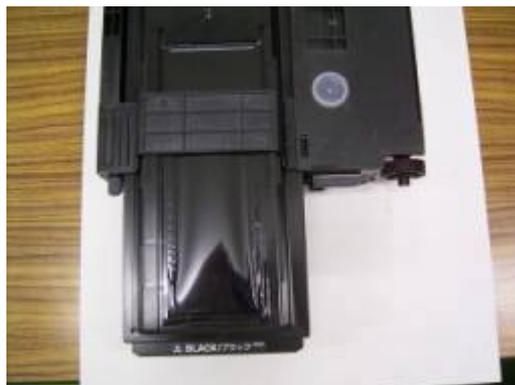
Note: The shutter release position on color toner cartridges and black toner cartridges on previous models is about 108mm from the edge of the cartridge.

Color toner cartridge and predecessor model BK cartridge
Shutter release position: 108 mm

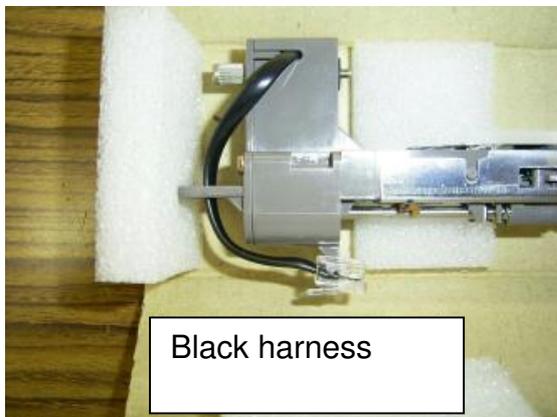
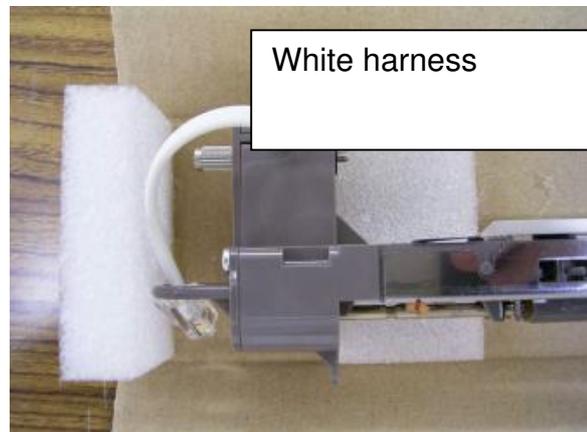
- When you install the charge corona unit, **do not straighten** the cleaner motor harness if this harness is **white**.
 - From May 2006 production, the material of the harness was changed to a more environmentally-friendly type. The new harness is **white** and the material is harder than the black harness.
 - The new harness is bent at the factory. This is to make sure that harness does not push the quenching lamp (QL).
 - If you straighten the white harness, SC305 can occur.

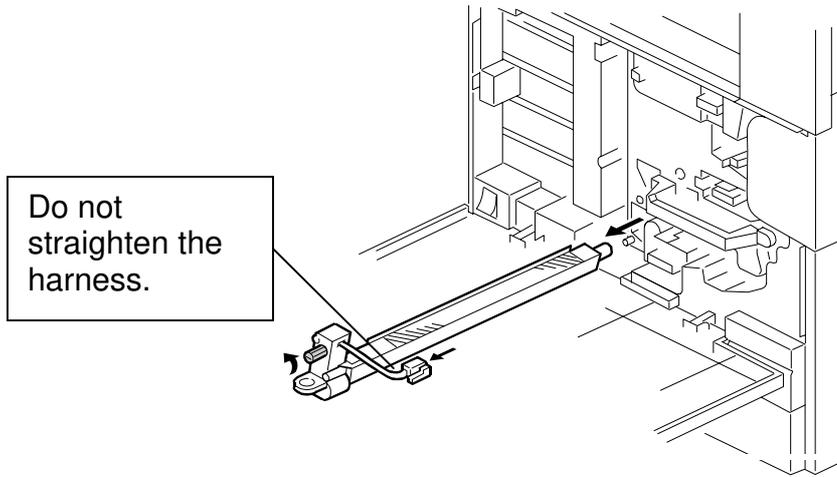
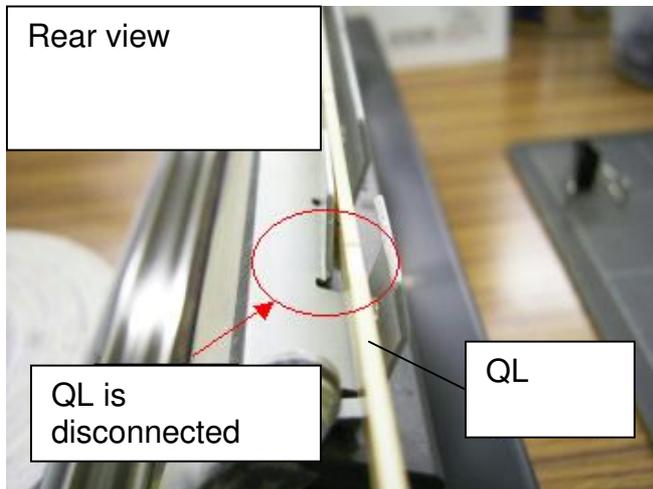
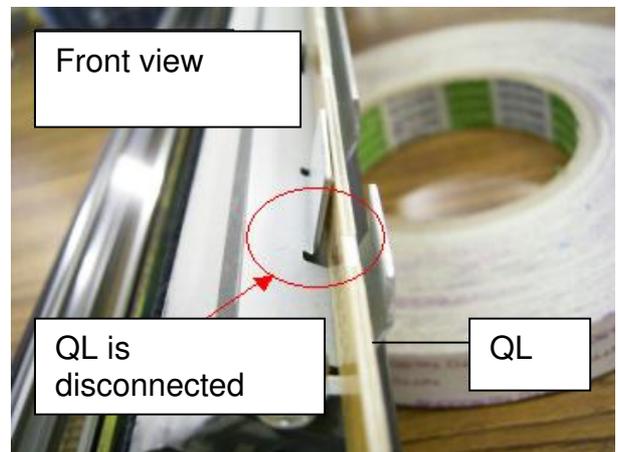
This means the white harness is straight, and is pushing on the QL/holder connection (see the photos on the next page).

Action: Correct the QL position and bend the white harness so that it does not push the QL.

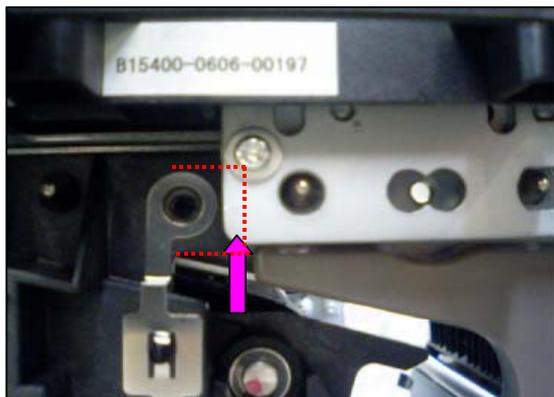
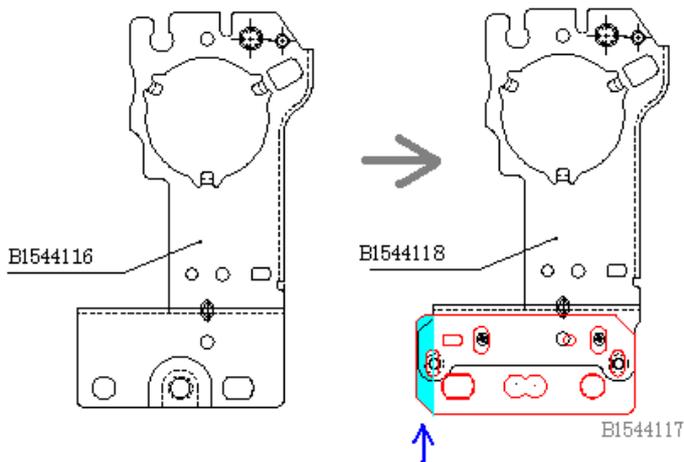
The front side plate (B1544118) of the fusing unit overlaps with the PCU as shown.

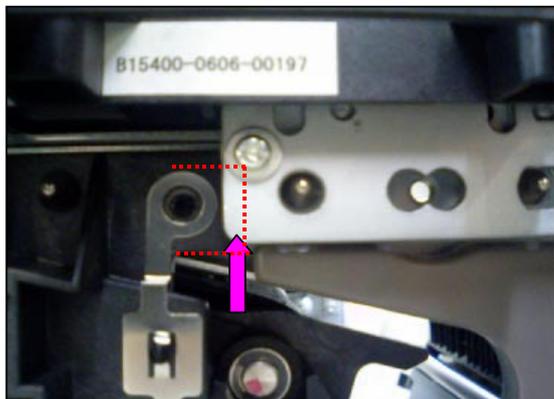
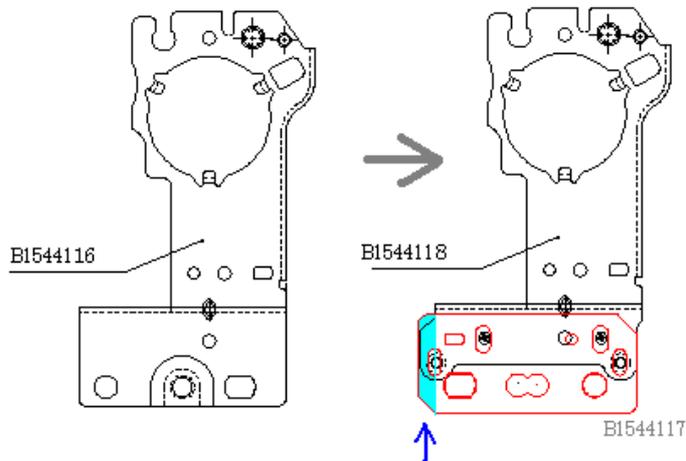
The front side plate (B1544118) of the fusing unit overlaps with the PCU as shown.

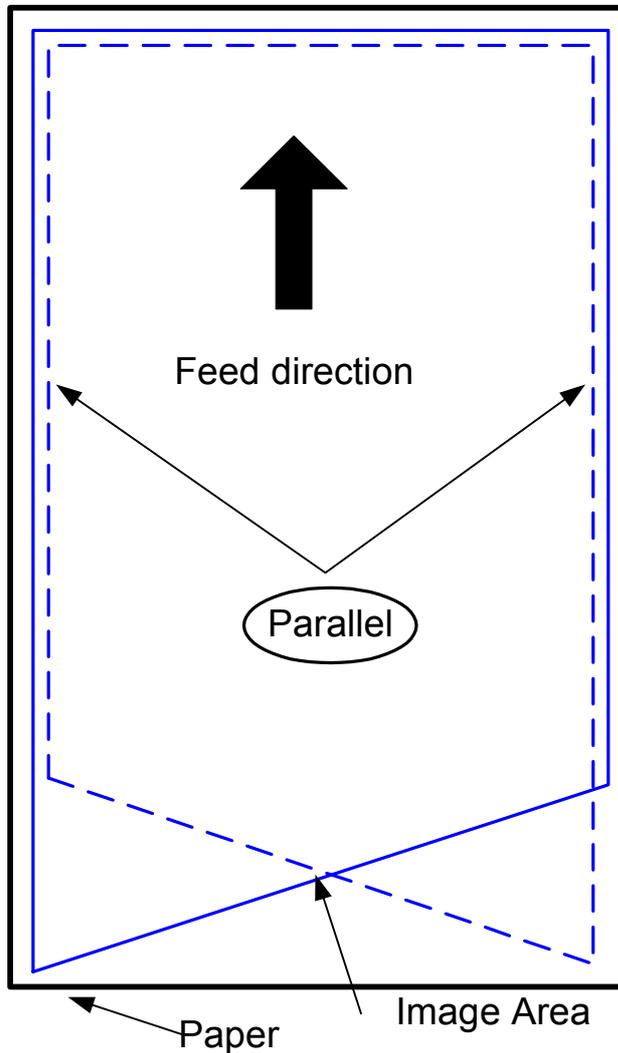
Image shown by the **dotted line**:
 → **Raise** the front side of the unit

Image shown by the **solid line**:
 → **Lower** the front side of the unit

- If the image shown by the **dotted line** occurs:
 Attach the new Adjust Plate (B1544122, 2 screws, inside out), and secure the screws at the **upper** position.
Note: This will raise the front side of the fusing unit.
- If the image shown by the **solid line** occurs:
 Attach the new Adjust Plate (B1544122, 2 screws, inside out), and secure the screws at the **lower** position.
Note: This will lower the front side of the fusing unit.

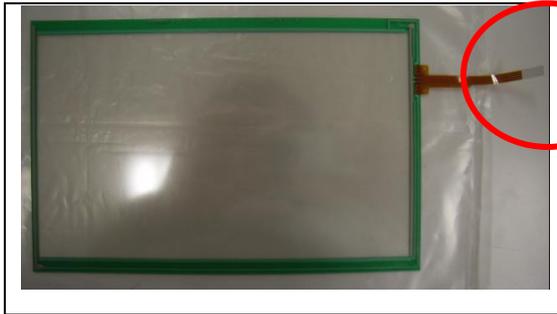
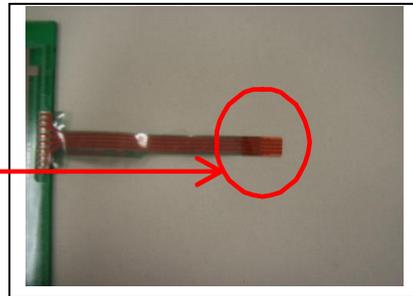
Old parts:
The tip of the electrode is **brown**.

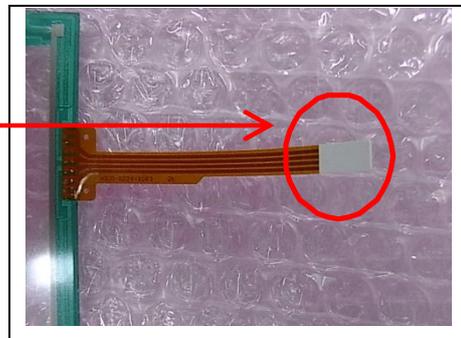
New parts:
The tip of the electrode is **white**.

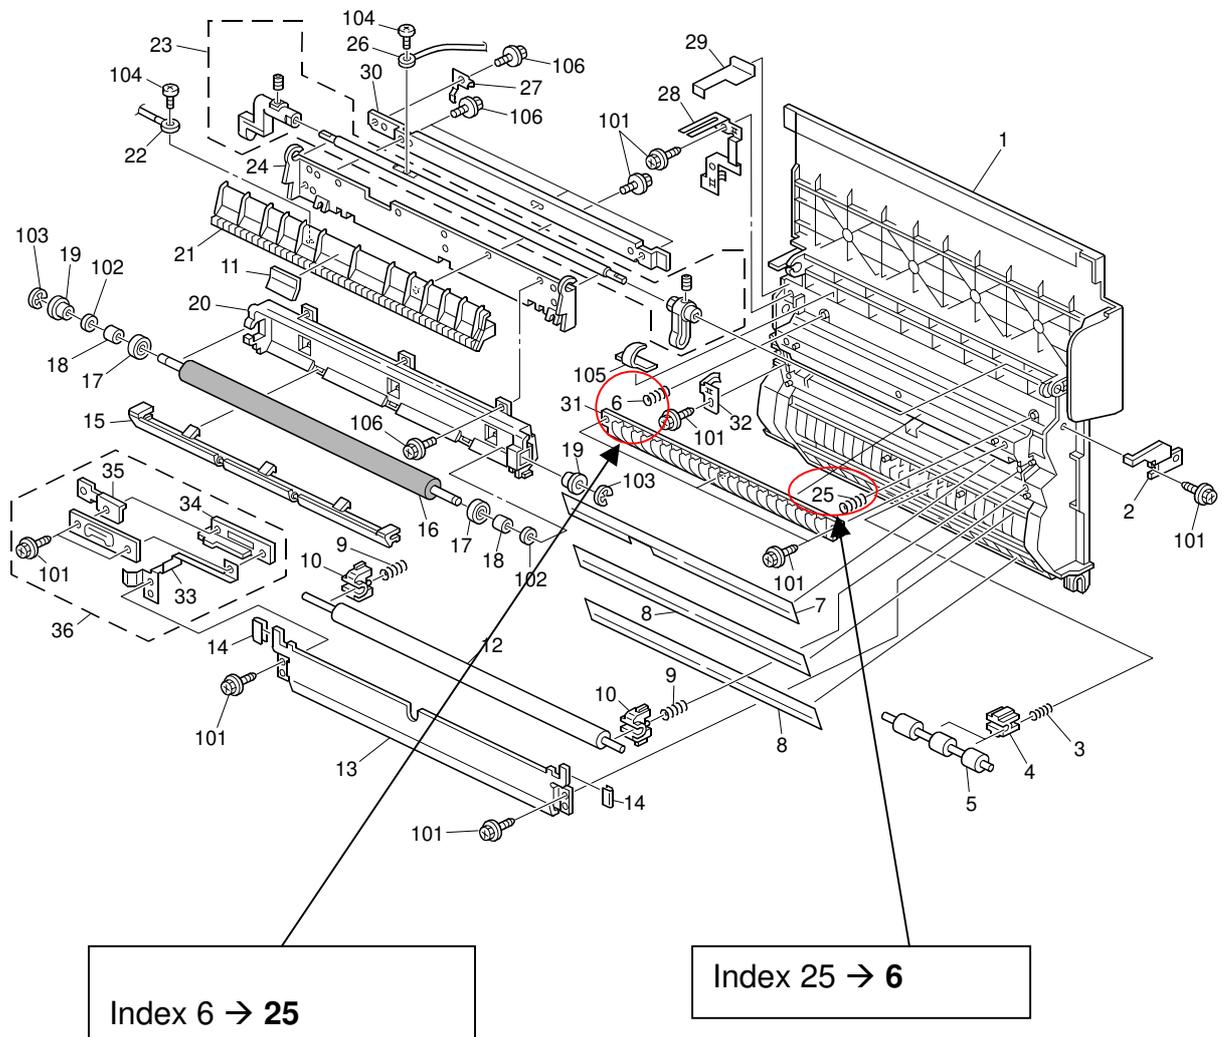
Transfer Section 3 (pg. 28)

Change/Reason: The index numbers in the illustration were corrected.
