| Model: Model J-C2 | | Date: 29-Mar-05 | No.: RB178001 |
| Subject: Firmware Release History (Engine) | | Prepared by: H.Taguchi | |

This RTB has been issued to announce the firmware release information for the engine.

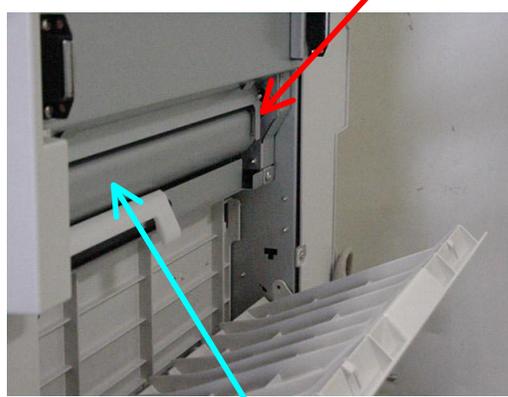
[A]: Grounding plate

[C]: Guide plate

- At machine installation:**
Do not press [B] the grounding plate when you remove the shipping tape.
 - If the symptom occurs in the field:**
 - 1) Check the grounding plate to see if it is bent.
 - 2) If the plate is bent:
 - 1) Bend it back as follows:
 - Direction: Away from the paper path
 - Amount: Target **2-3mm** (max. 5mm)
- OR**
- 2) Replace the grounding plate.

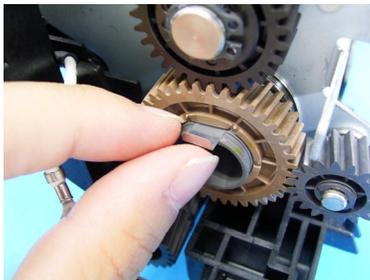
The space between the pressure roller and the gear for the pressure roller causes the sound under a specific condition.

6. Insert the spacer (P/N B1809004) all the way.

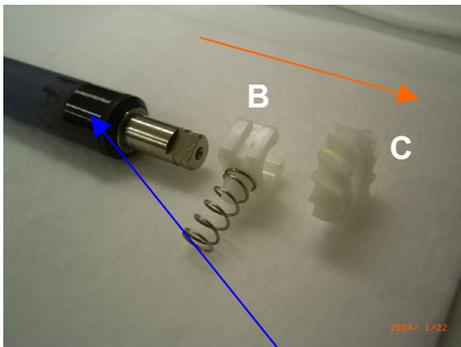
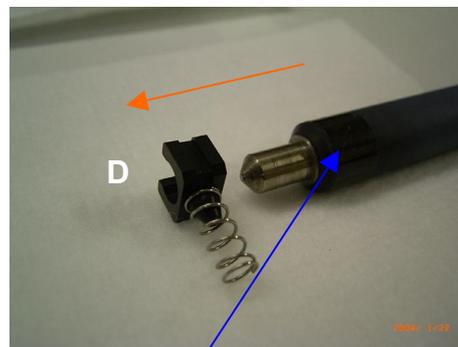
Tape-covered areas.
Do not remove this tape.

9. Hold the charge roller **by the tape-covered edges only**, and then remove parts B, C and D.

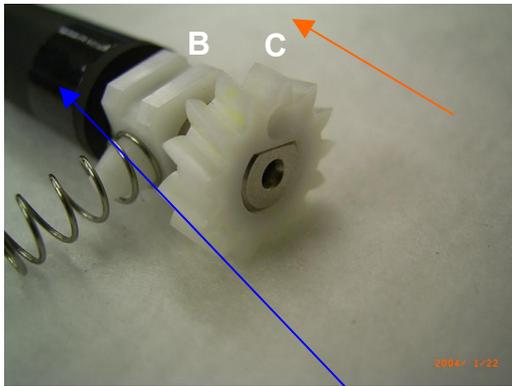
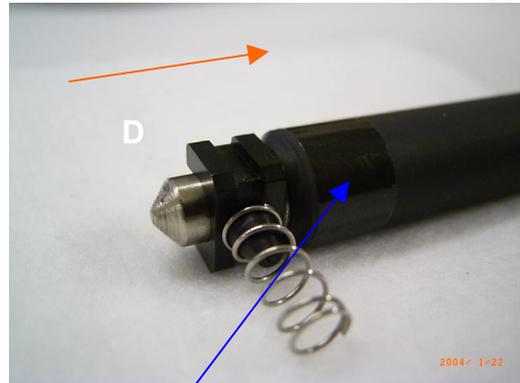
Tape-covered areas.
Do not remove this tape.

11. Hold the charge roller **by the tape-covered edges only**, and then attach parts B, C and D.

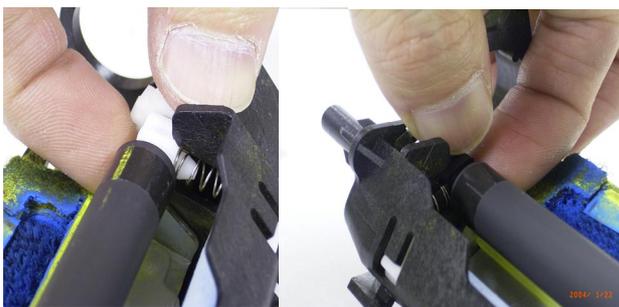
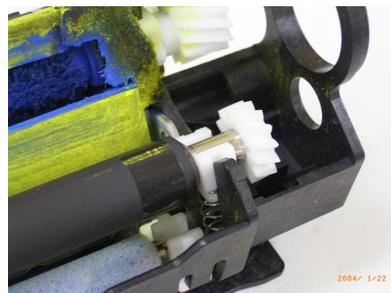
- Make sure parts B and D fit into the guide ribs on the unit frame.
- Make sure the spring is straight, not bent.
- Make sure the gears on both sides are attached to the shaft correctly
- Make sure the charge roller cleaner is secured inside the bushings on both ends.

12. Reattach the charge roller to the PCU frame (see **Important** below).

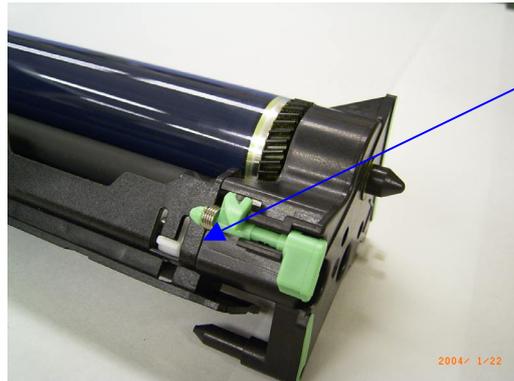
Make sure there is no gap between the cover and frame.

- Make sure there is **no gap** between the cover and frame.

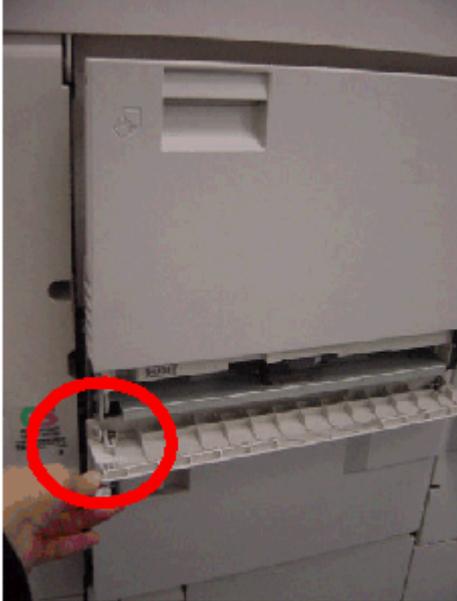
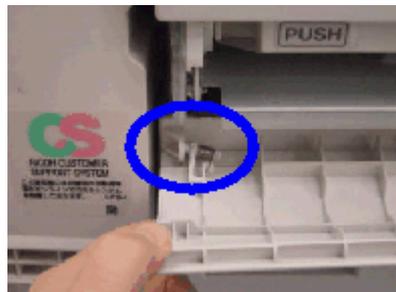
Attachment position

The bypass tray lower cover comes loose.

Attaching the New Stopper (Stopper:Cover:Manual Feed, P/N B1802941)

2. If the shaft is bent too far or in very bad condition, replace the bypass tray lower cover itself.

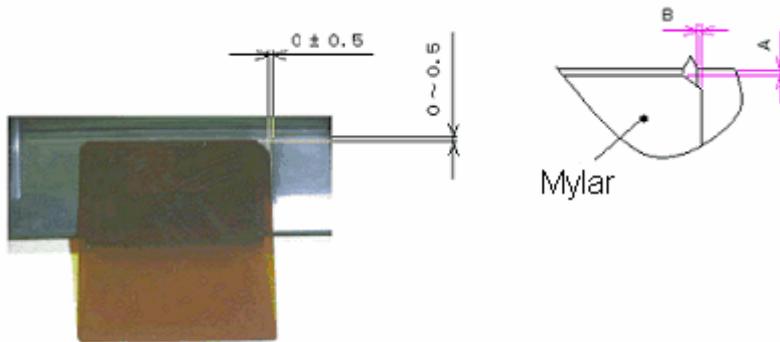
The junction gate Mylar at both ends of the duplex inverter unit bends. This happens most often when using paper that has a high stiffness and has a large curl. The paper hits the Mylar and causes it to bend.

Note: The jam occurs when the paper is guided to the inside of the bent Mylar. Clearing this type of jam with too much force causes further deformation of the Mylar and increases the jam occurrence.

1. Replace the junction gate Mylar (index #16) at both sides of the duplex inverter unit with **P/N B1809005**.
2. If any of the other junction gate Mylars are bent, replace all junction gate Mylars.

1. Clean the attachment area with alcohol.
2. Line up the top edge of the Mylar with the ridge of the guide plate, as shown in the photo (**0 to 0.5mm** from the ridge).
3. Line up the right edge of the Mylar with the groove, as shown in the photo (**-0.5mm to +0.5mm** from the groove).
4. Make sure the top edge of the Mylar is not sticking out from the ridge of the guide plate.
5. Make sure the entire attachment surface of the Mylar is attached firmly to the guide plate (no wrinkles, no bends).

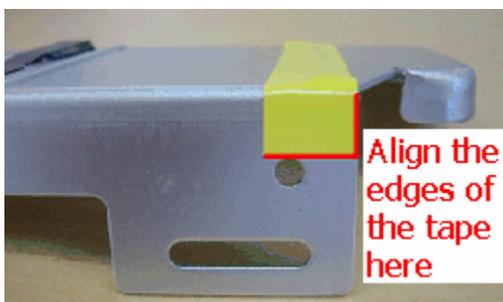
There are small burrs on the top edge of the side fence. In a small number of cases, this may cause injury if touched.

3. Attach one end of the tape to the bottom of the side fence. Then, attach the rest of the tape as shown.

- On the bottom of the side fence, make sure to align the two edges of the tape as shown in the photo below.
- Make sure to attach the tape firmly so that it does not wrinkle or peel off. **Make sure the tape completely covers the area with the burrs.**

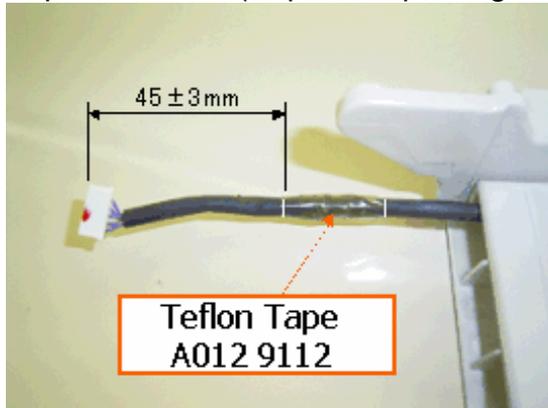
2. Size misdetection (harness damage):

Attachment position: $45 \pm 3\text{mm}$ from the leading edge of the connector

No. of wraps: 7-8 times (required tape length: $100 \pm 5\text{mm}$)

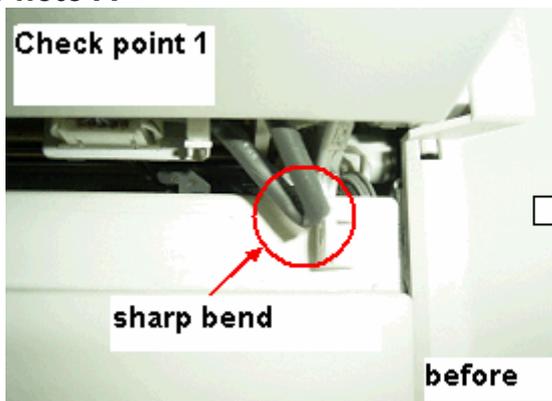
Photo A

- Make sure there are no sharp bends in the harness (like the one shown in **Photo A** below).
- Make sure that the harness passes through the cutout in the guide plate smoothly when the bypass tray is opened/closed (as in **Photo C** below).
- Make sure the cover is not sticking out at all when the cover is closed (as in **Photo D** below).
