| Model: Model V-C1 | Date: 2-Jun-05 | No.: RB132001a |

| Subject: Service Manual Revision | | Prepared by: H.Matsui | |
| From: 2nd Tech. Support Sec. Service Support Dept | | | |

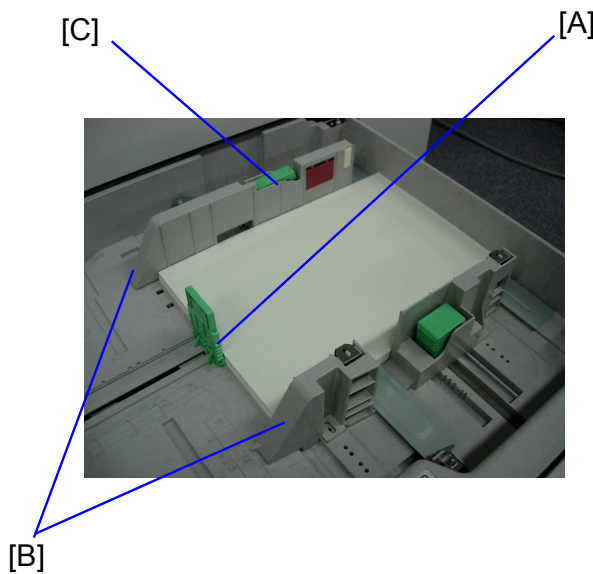
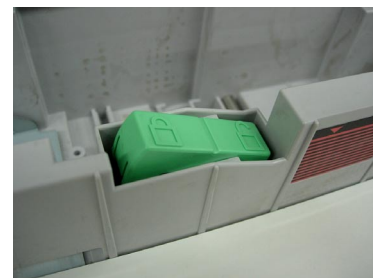
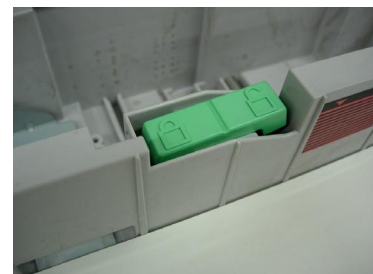
The size of the paper in the tray does not match the paper size that is displayed on the LCD. Sometimes, this causes a jam to occur.

**Note:** This can cause the machine to detect the wrong paper size when “Auto Paper Size Detection” is ON.

Side fence lock is unlocked.

Side fence lock is **locked**.

- Make sure to set the end fence [A] and side fences [B] correctly.
- Make sure to **lock** the side fence lock [C].

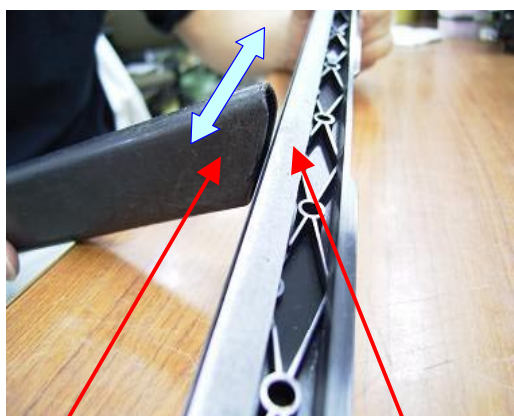
**NOTE:** Make sure you do not touch the charge roller cleaning roller with the vacuum cleaner nozzle [E].

If the vacuum nozzle touches the cleaning roller, this kind of damage will occur.

## 6. Clean the charge roller cleaning roller [D] with a vacuum cleaner if it is also dirty.

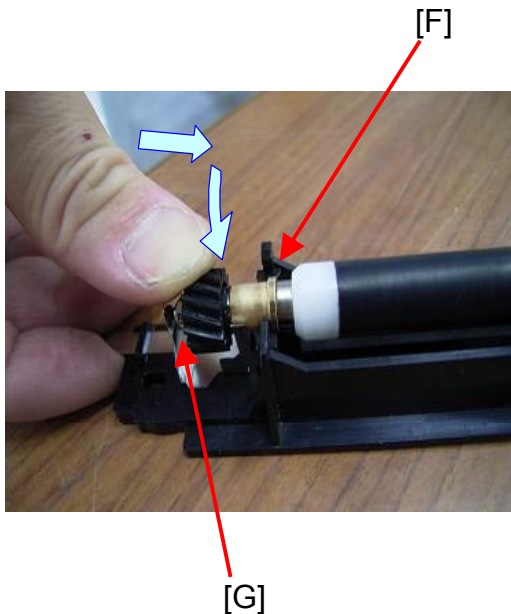
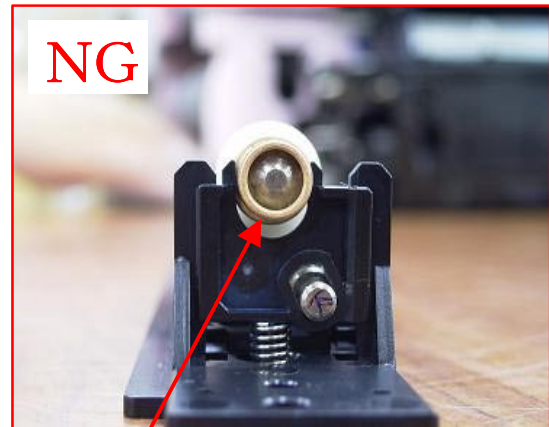
Bushing not inserted correctly inside the molding guide .

**NOTE:** Make sure that the bushing is inserted correctly inside the molding guide [F]. Also make sure that the charging terminal [G] touches the charge roller end correctly.

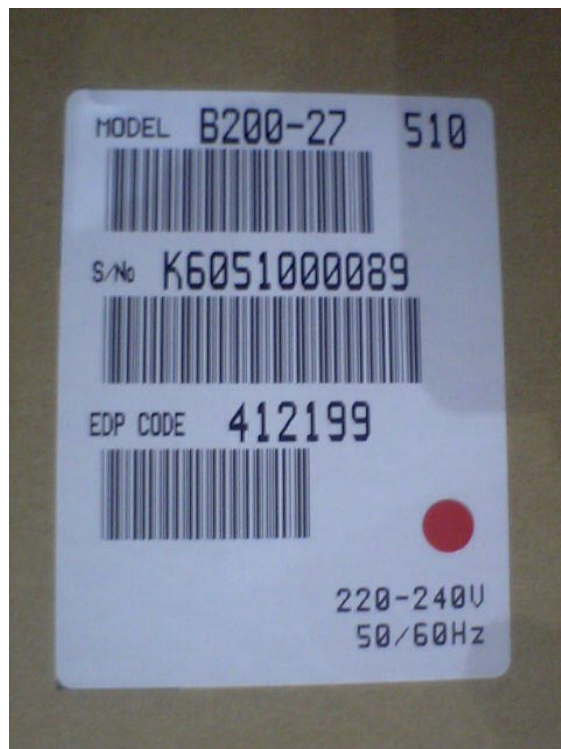
Example (B200-27)

Make sure the identification mark (see the picture) exists on the barcode label on the carton. The machine with this identification mark on the barcode label has already been retrofitted in the warehouse.

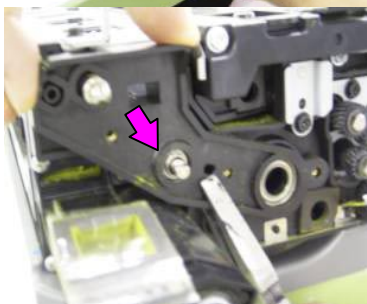
Rust can develop on the surface of the ball bearings inside the PCU faceplates, as the bearings are made of degreased chrome steel (not stainless steel).

3. Remove the "PCU Face Plate-Front".

Use a pair of needle-nosed pliers as shown if the removal procedure is difficult.

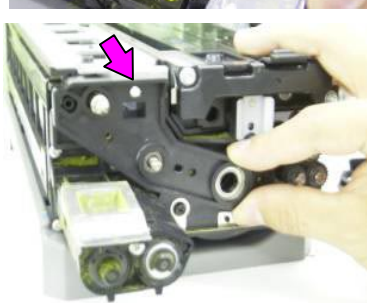
**Note:** The modified "PCU Face Plate-Front" has a white round paint mark (shown by the pink arrow).

5. Attach the modified "PCU Face Plate-Front" (3-screws).

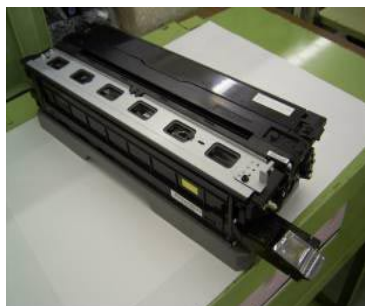
9. Attach the modified "PCU Face Plate-Rear" (4-screws).  
**Note:** The modified "PCU Face Plate-Rear" has a white round paint mark (shown by the pink arrow).

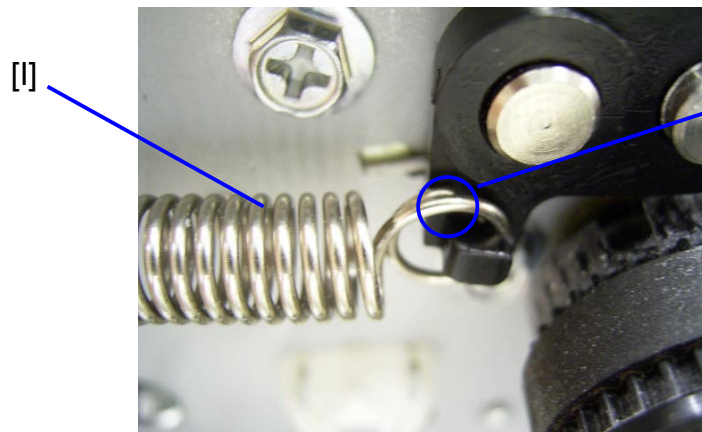
**NG position**  
The area where the spring loops meet [J] is facing up

- If the spring is in the NG position, change the spring to the **OK position**.

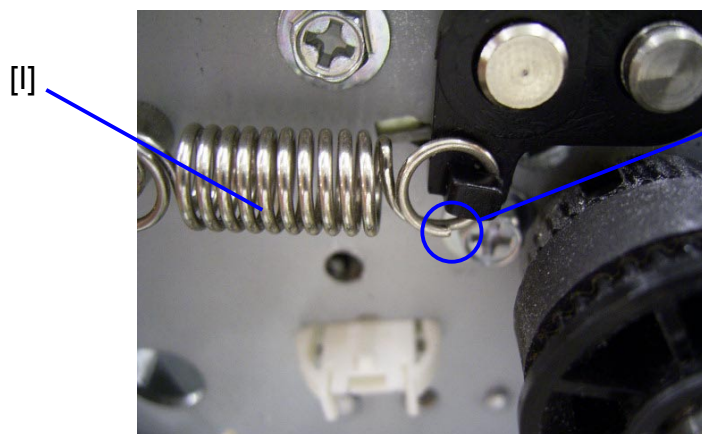
**OK position**  
The area where the spring loops meet [J] is **facing down**

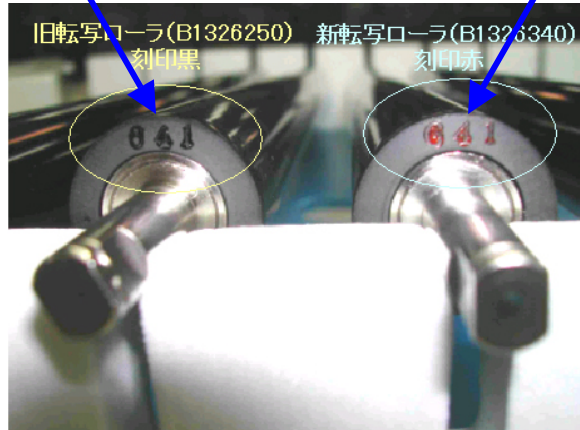
Old PTR (B1326250) has the lot number in black.

New PTR (B1326340) has the lot number in red.

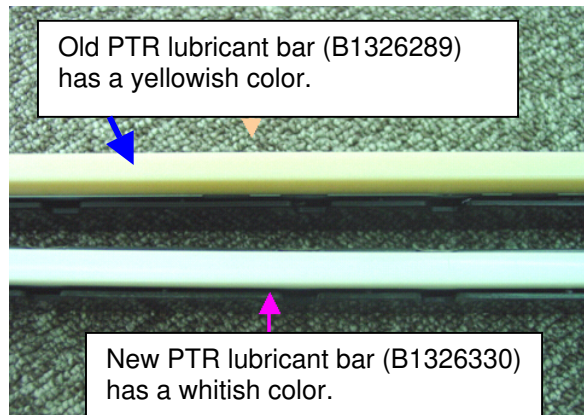
Old PTR lubricant bar (B1326289) has a yellowish color.

New PTR lubricant bar (B1326330) has a whitish color.

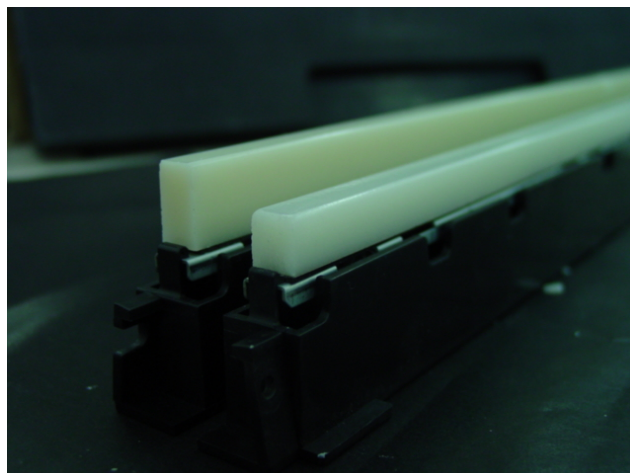
Old PTR lubricant bar (B1326289) is taller than new PTR lubricant bar (B1326330) when before use.

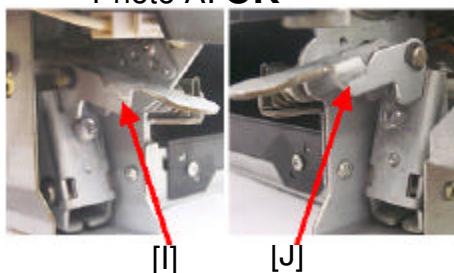
Photo A: **OK**

2. Make sure the pressure levers ([I], [J]) are in the **upper position** as shown in Photo A.

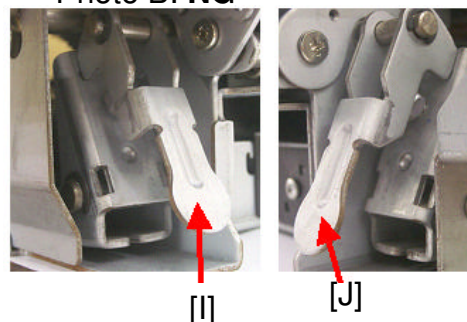
Photo B: **NG**

**Note:** If the levers are not in the upper position, pressure will not be applied between the fusing belt and pressure roller.

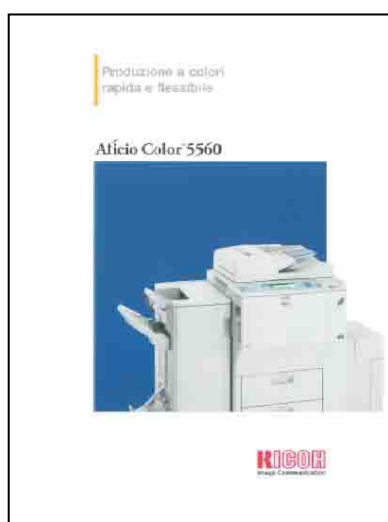
Original Image

Data scanned with Scan to Folder or Scan to Email is corrupted under the conditions listed below.

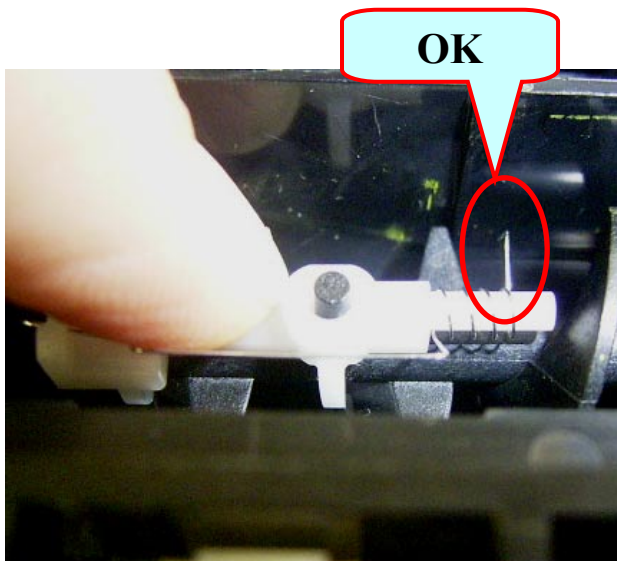
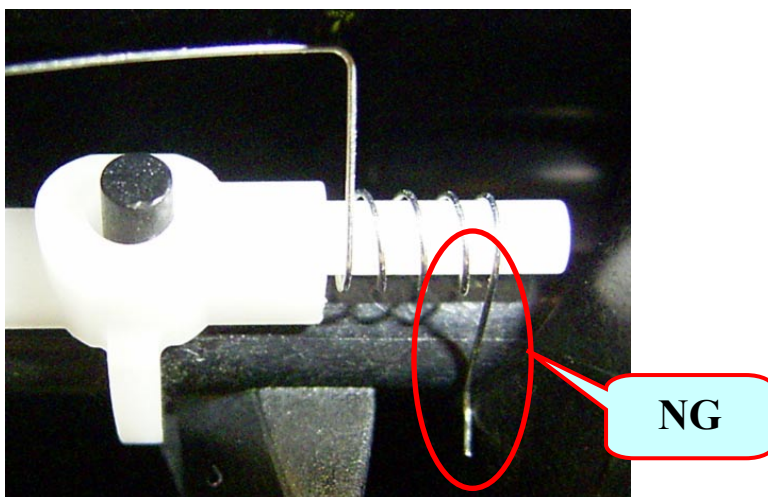
4. Check the position of the coiled end of the spring.

**Important:** If the spring was not attached correctly, remove it and attach it again.

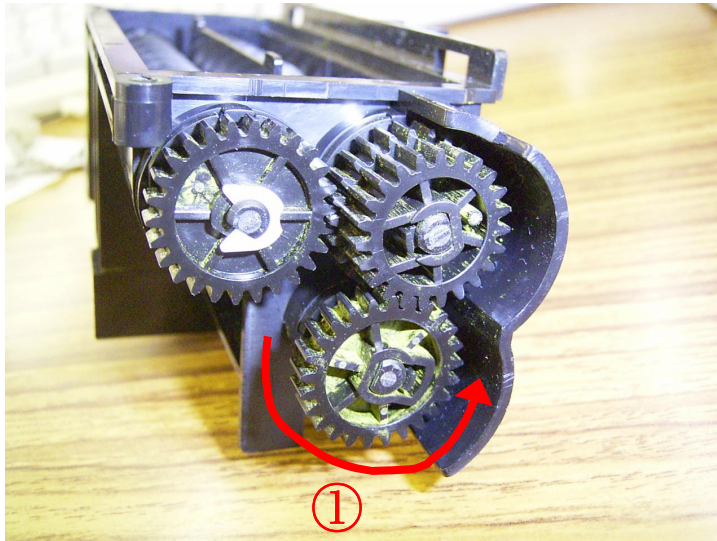
5. Rotate the gear in the direction of the arrow marked "1" until the spring touches the **detector part** of the Toner End Sensor.

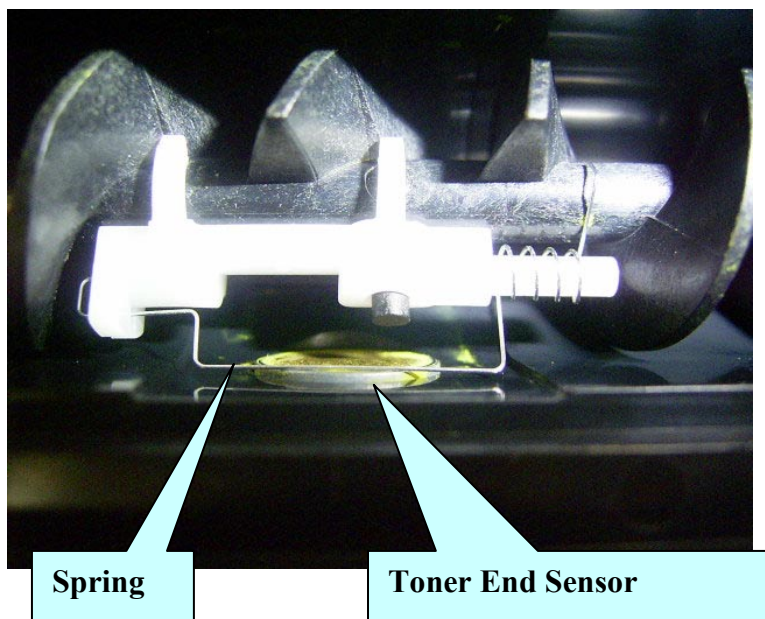
The spring is touching the detector part of the Toner End Sensor:

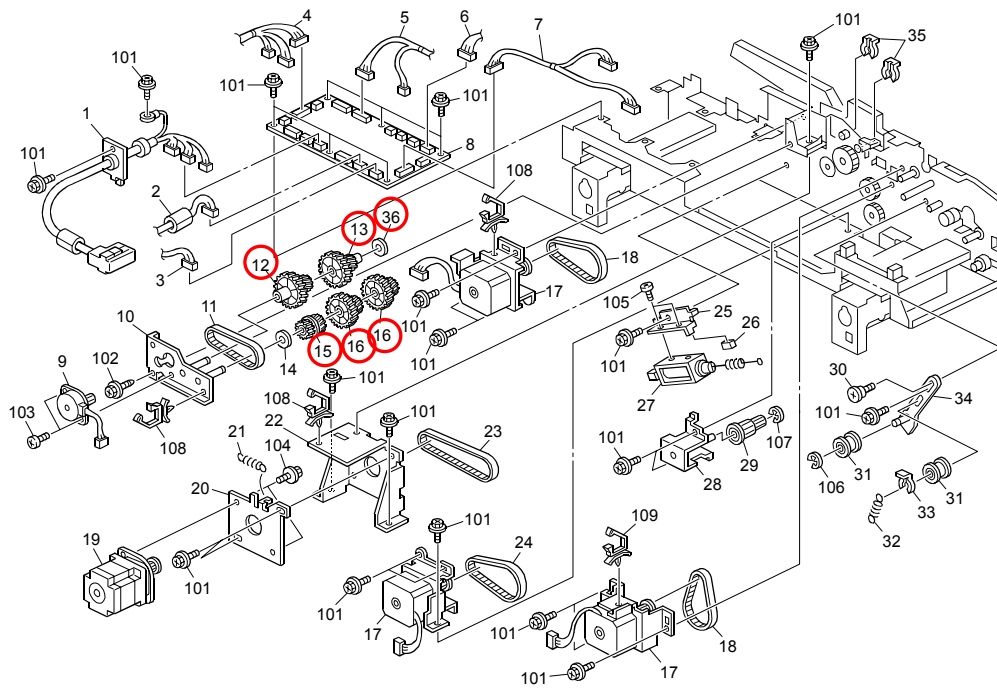
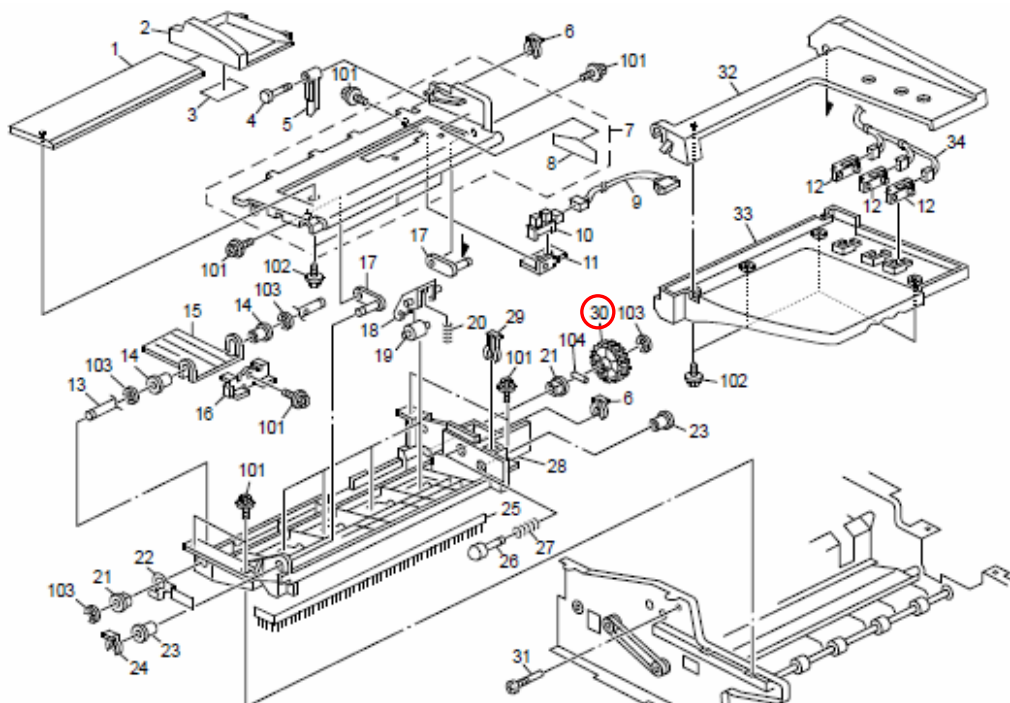
It is necessary to replace the above parts together as a set to avoid SC705.

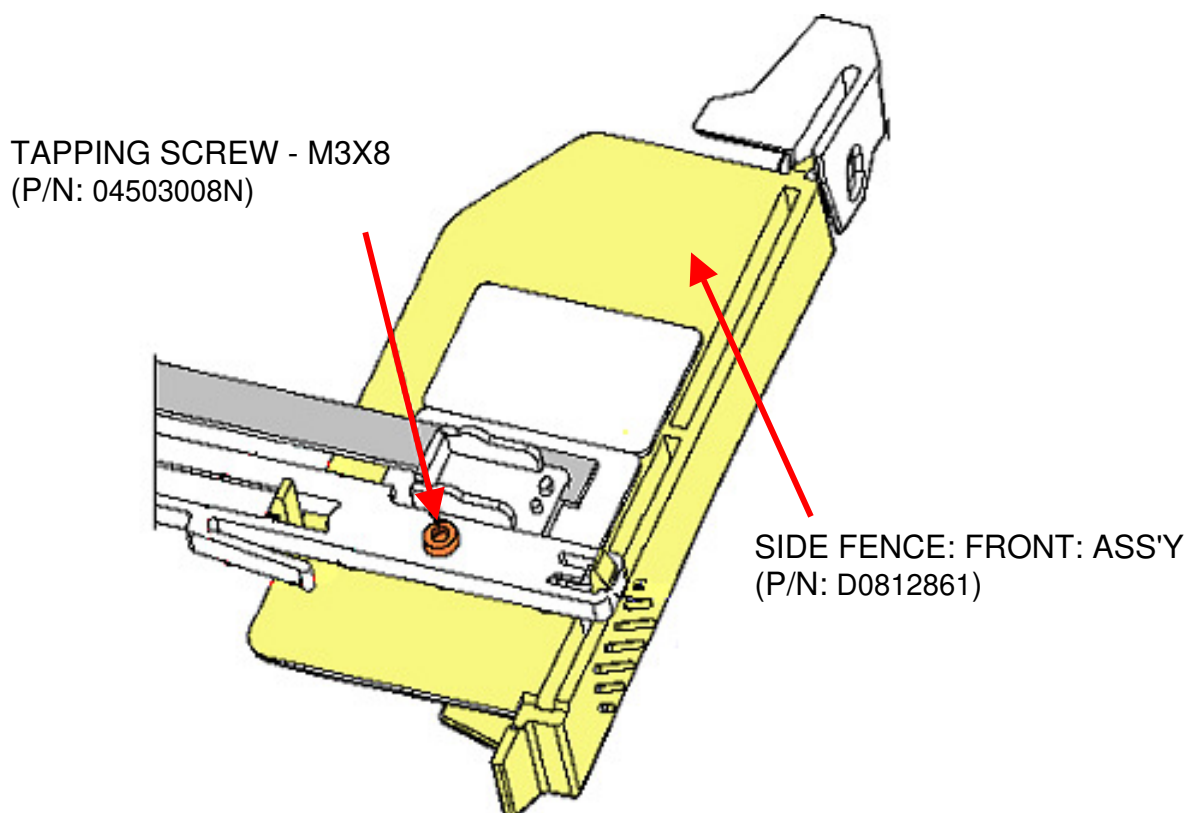
**Change:** A tapping screw (M3x8) was added to the side fence front assembly.

**Reason:** To fix the assembly in place, so that it does not detach from the hook when it is slid.

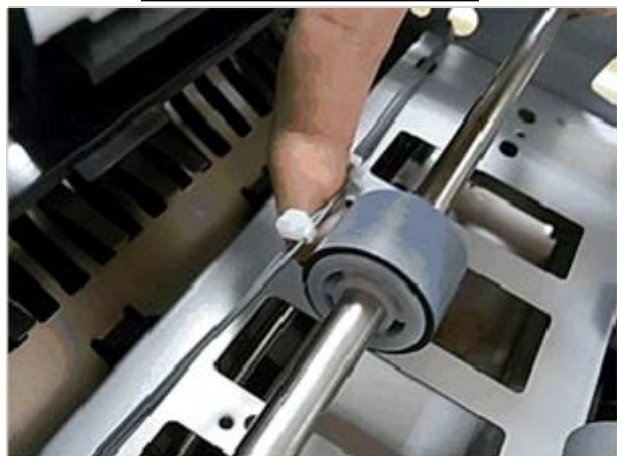
Before Parts Change

**Reason:** To prevent the harness from touching the roller.
