Model: Stinger – C1		Date: 31-Aug-99	No.: RA250001
Subject: Exit plate guide location		Prepared by: K. Miura	
From: Technical Service Dept., GTS Division			
Classification:	<input checked="" type="checkbox"/> Troubleshooting <input type="checkbox"/> Mechanical <input checked="" type="checkbox"/> Paper path <input type="checkbox"/> Other ()	<input type="checkbox"/> Part information <input type="checkbox"/> Electrical <input type="checkbox"/> Transmit/receive	<input type="checkbox"/> Action required <input type="checkbox"/> Service manual revision <input type="checkbox"/> Retrofit information

Model: Stinger-C1		Date: 30-Sep-99	No.: RA250002
Subject: ROM History (Stinger-Copy Version)		Prepared by: K. Miura	
From: Technical Service Dept., GTS Division			
Classification:	<input type="checkbox"/> Troubleshooting <input type="checkbox"/> Part information <input type="checkbox"/> Action required <input type="checkbox"/> Mechanical <input type="checkbox"/> Electrical <input type="checkbox"/> Service manual revision <input type="checkbox"/> Paper path <input type="checkbox"/> Transmit/receive <input checked="" type="checkbox"/> Retrofit information <input type="checkbox"/> Other ()

Model:

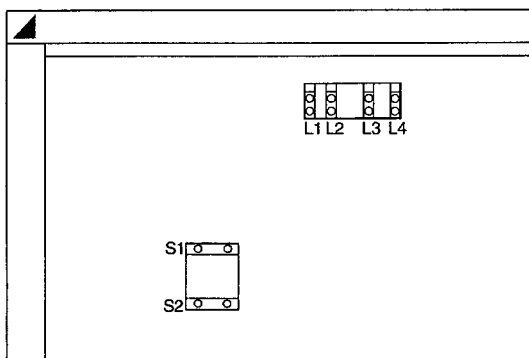
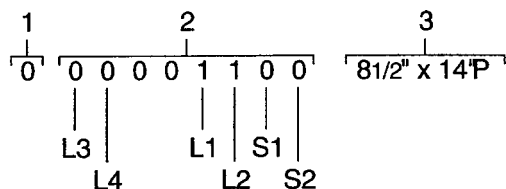
OLD

Please correct your service manual as follows:

Page: 4--55

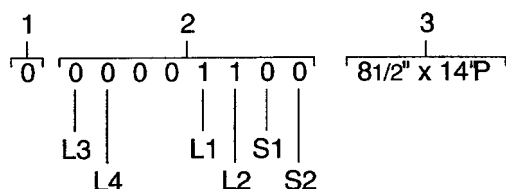
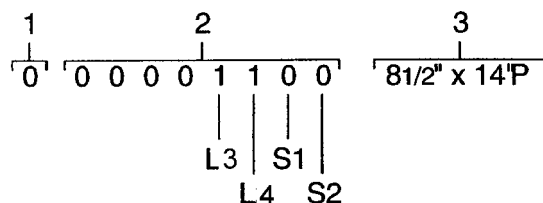
NEW

A4/A3 version machines

LT/DLT version machines

NOTE: The length sensors L1 and L2 are used only for A4/A3 version machines.

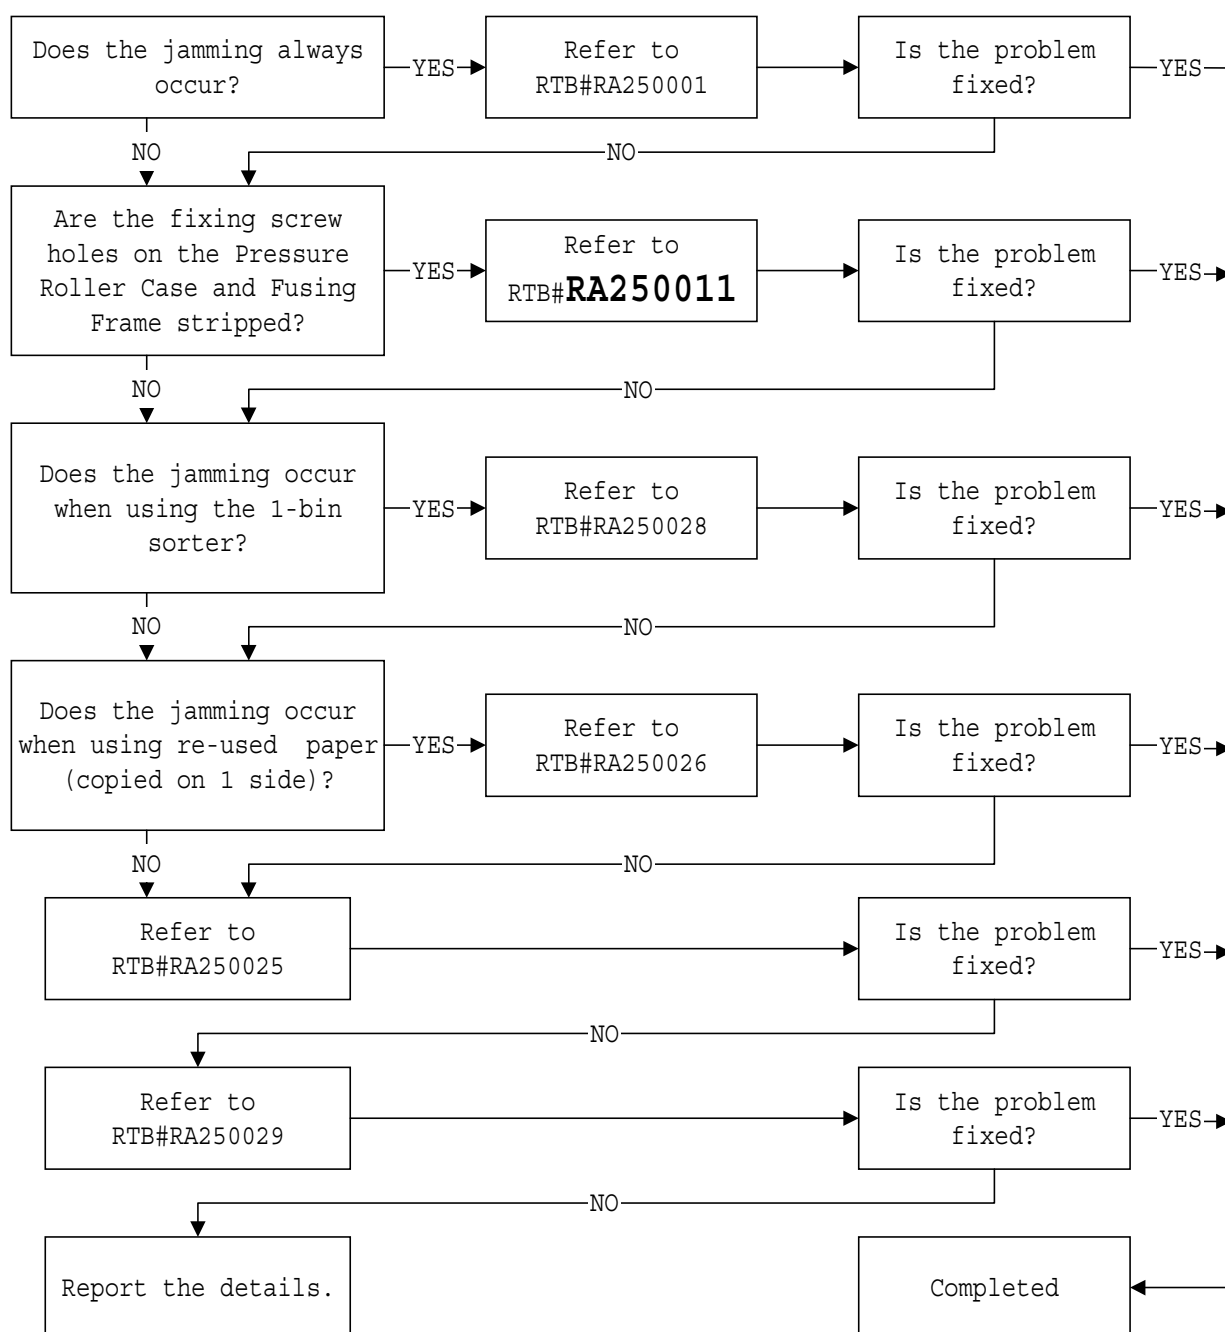
Subject: Paper jam analysis flow chart		Prepared by: K. Miura	
From: Technical Services Dept., GTS Division			
Classification:	<input checked="" type="checkbox"/> Troubleshooting	<input type="checkbox"/> Part information	<input type="checkbox"/> Action required
	<input type="checkbox"/> Mechanical	<input type="checkbox"/> Electrical	<input type="checkbox"/> Service manual revision
	<input type="checkbox"/> Paper path	<input type="checkbox"/> Transmit/receive	<input type="checkbox"/> Retrofit information
	<input type="checkbox"/> Other ()

To analyze the cause of jams, use the flow chart below:
