RIGON **Technical Bulletin** No. RTB-001 SUBJECT: Service manual correction DATE:Nov. 15, '96 PAGE: 1 of 4 PREPARED BY: T. Itai FROM: 2nd Field Information Dept. QAC CHECKED BY: S. Fujii **CLASSIFICATION:** MODEL: AD1 Revision of service manual Information only ☐ Troubleshooting Retrofit Information Other

The following parts of the service manual have been corrected.

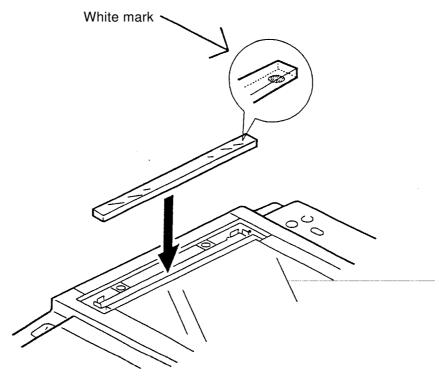
Fig. 3

2. The surface of the exposure glass has been treated by the mater replant process.

Note: This exposure glass has a white mark. This mark must be at the bottom rear side at installation.

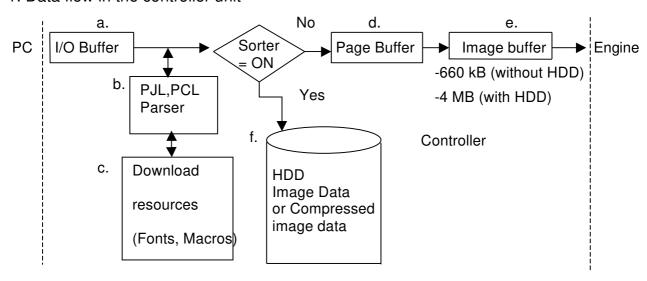
1. Data flow in the controller unit

If the user sends a print job which will use lots of memory, it might cause a memory overflow. Memory overflow might happen at points b, c, and d above. When memory overflow happens and the user presses the continue key, the printer prints only part of the page. This problem can be solved by adding SIMM memory (8 MB or more).

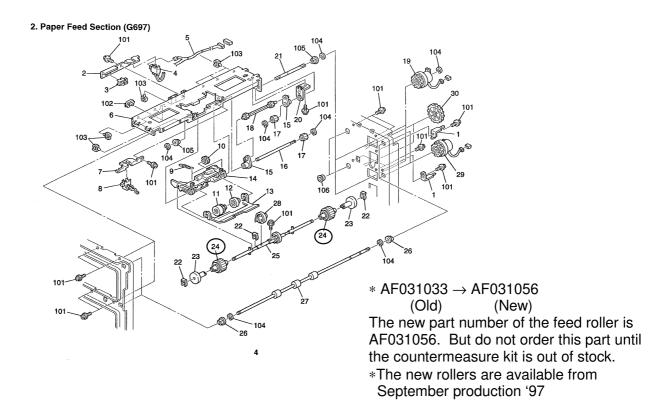
CAUSE: Paper skewing or no feed from PS330 (Paper Tray)

* Use these new rollers for machines which have the paper jam problem.
