Model: Russian-C		Date: 15-Dec-99	No.: RA265001
Subject: Quick dial problem		Prepared by: K. Miura	
From: Technical Services Dept., GTS Division			
Classification:	<input checked="" type="checkbox"/> Troubleshooting	<input type="checkbox"/> Part information	<input type="checkbox"/> Action required
	<input type="checkbox"/> Mechanical	<input type="checkbox"/> Electrical	<input type="checkbox"/> Service manual revision
	<input type="checkbox"/> Paper path	<input type="checkbox"/> Transmit/receive	<input type="checkbox"/> Retrofit information
	<input type="checkbox"/> Other (      )

Model: Russian-C1		Date: 15-Feb-00	No.: RA265002
Subject: Service Manual Correction		Prepared by: S. Tomoe	
From: Technical Services Dept., GTS Division			
Classification:	<input type="checkbox"/> Troubleshooting <input type="checkbox"/> Part information <input type="checkbox"/> Action required <input type="checkbox"/> Mechanical <input type="checkbox"/> Electrical <input type="checkbox"/> Service manual revision <input type="checkbox"/> Paper path <input type="checkbox"/> Transmit/receive <input type="checkbox"/> Retrofit information <input checked="" type="checkbox"/> Other (      )

Model: Russian-C1

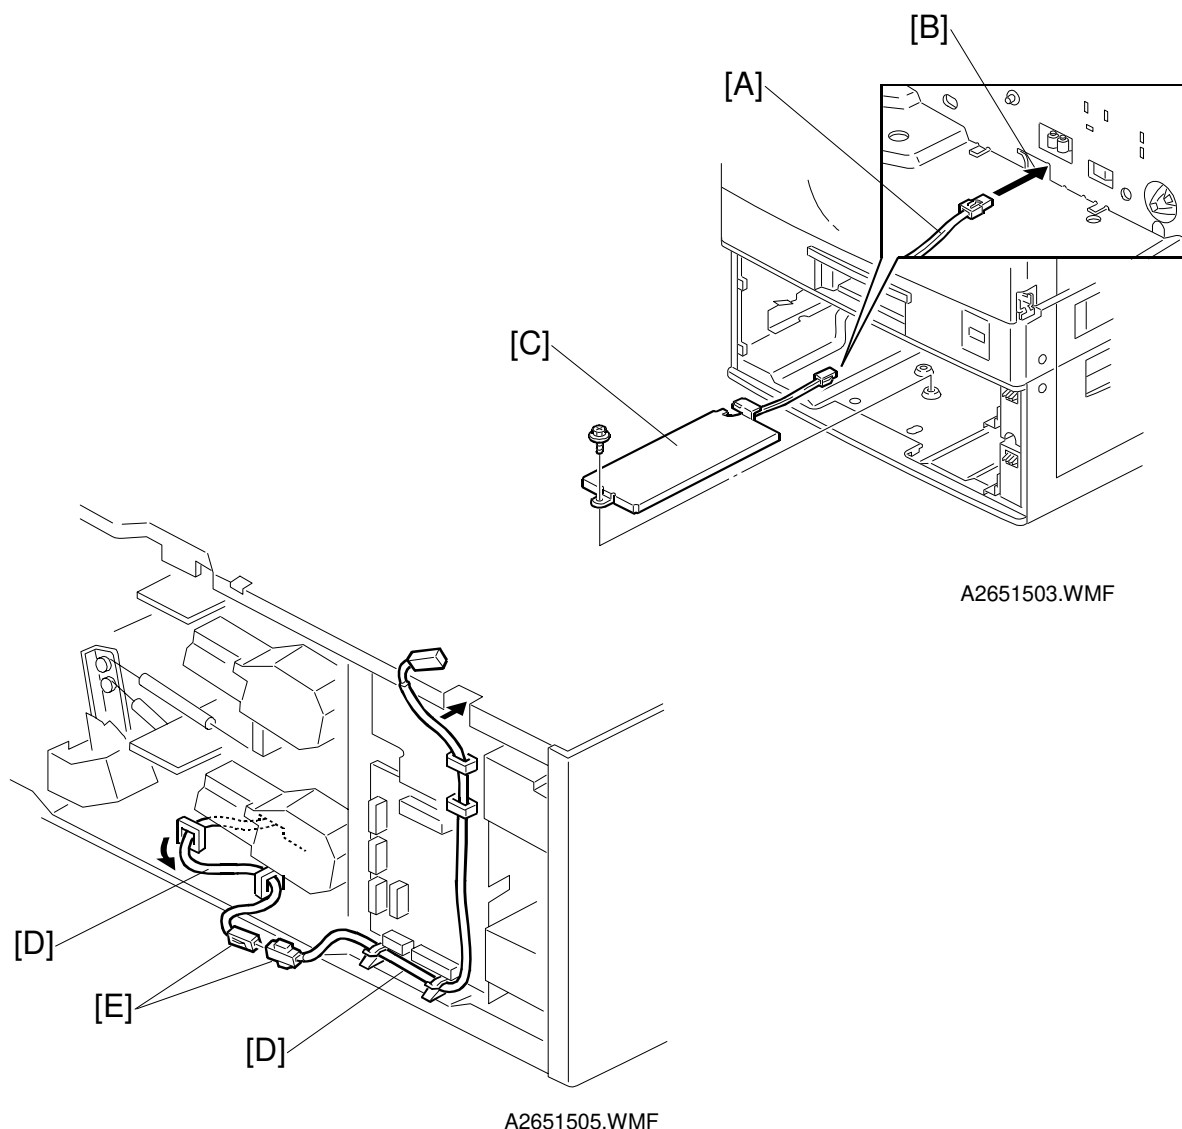
3. The call-outs and installation steps for the optional tray heater should be corrected as follows (P 3-46).

5. Slide out the two paper trays from the optional paper tray unit.
6. Pass the connector [A] through the opening [B].
7. Install the tray heater assembly [C] (1 screw).
8. Clamp the cables [D], as shown.
9. Join the connectors [E].
10. Reinstall the cable guide.

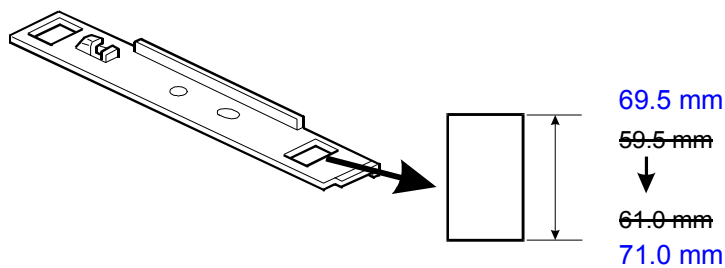
Figure 2

Skewed image on the original cannot be corrected even if the ADF position is changed (refer to figure 1).

To expand the shift range, the bottom of the hinge has been shortened by 1 mm and the opening in the scanner rear upper cover has been expanded by 1.5 mm. See figure 2.

A: 58.5 mm → 57.5 mm

If the skewing on the original cannot be corrected, replace the scanner rear upper cover and/or the right hinge of the ADF.

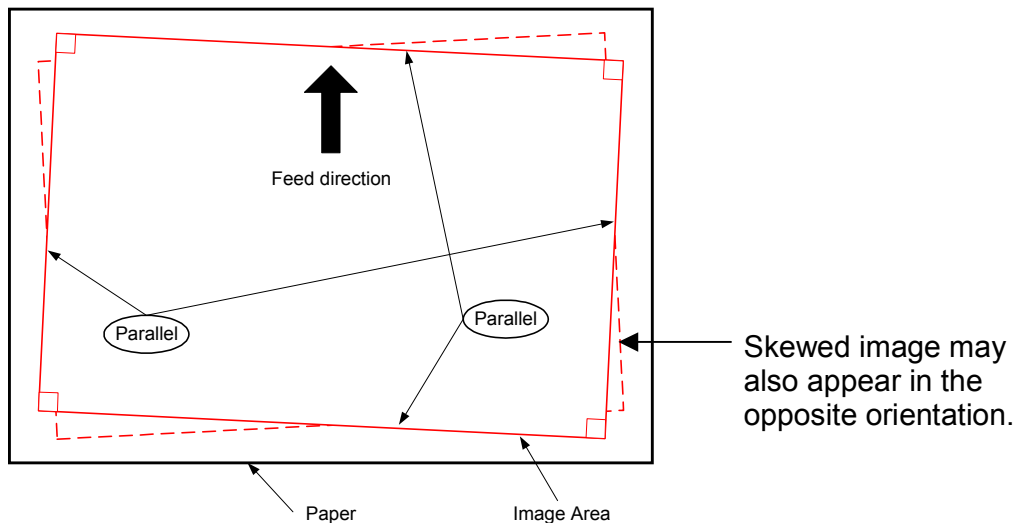
## 1.1 SKEWED IMAGES

- The image's leading and trailing edges are parallel to one another.
- The image's left and right edges are also parallel.
- However, **all four sides** are slanted with respect to the paper's edge.

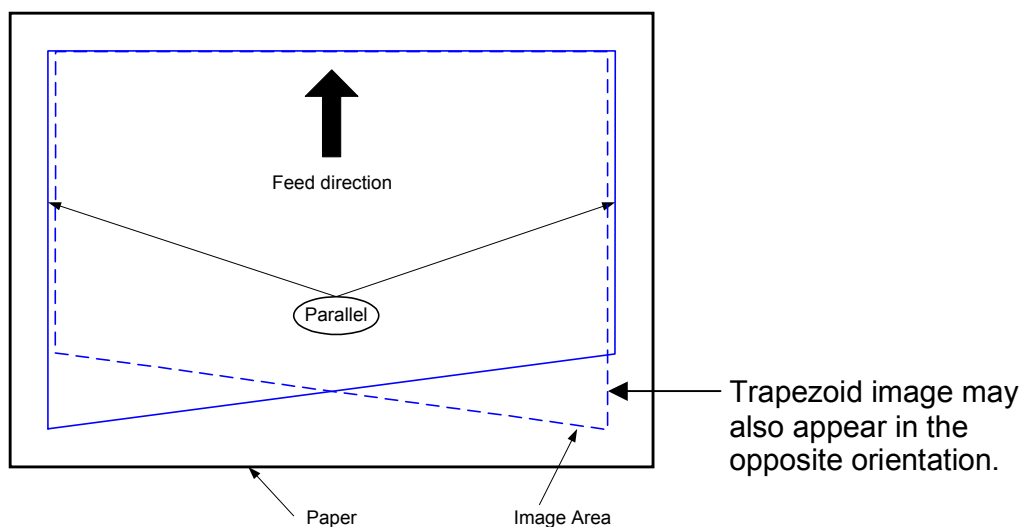
## 1.2 TRAPEZOID IMAGES

- Only the image's **trailing edge** is slanted with respect to the paper.
- The remaining 3 sides are parallel to the paper's edges.

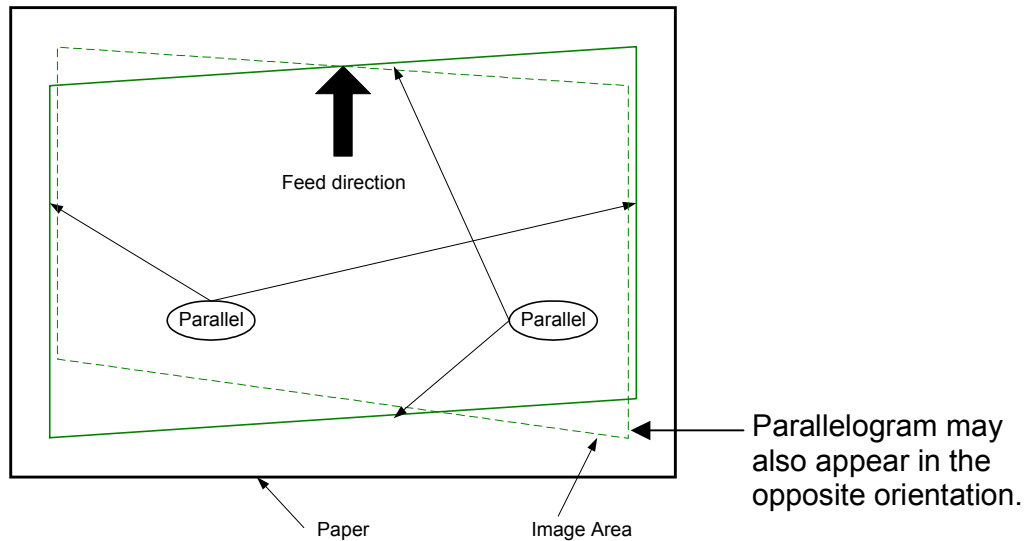
## 1.3 PARALLELOGRAM IMAGES

- Like skewed images, the leading/trailing edges and left/right edges are parallel to each other, however here, the **leading and trailing edges** are both slanted with respect to the paper's edge.
