Model: NAD 30S/30/40		Date: 31-May-98	No: MA230001a												
Subject: China/Taiwan Version Information		Prepared by: S. Tomoe													
From: Technical Service Department.															
Classification:

The China and Taiwan version are going to be produced from June 1998. This RTB clarifies the differences between other Ricoh versions and China/Taiwan versions.

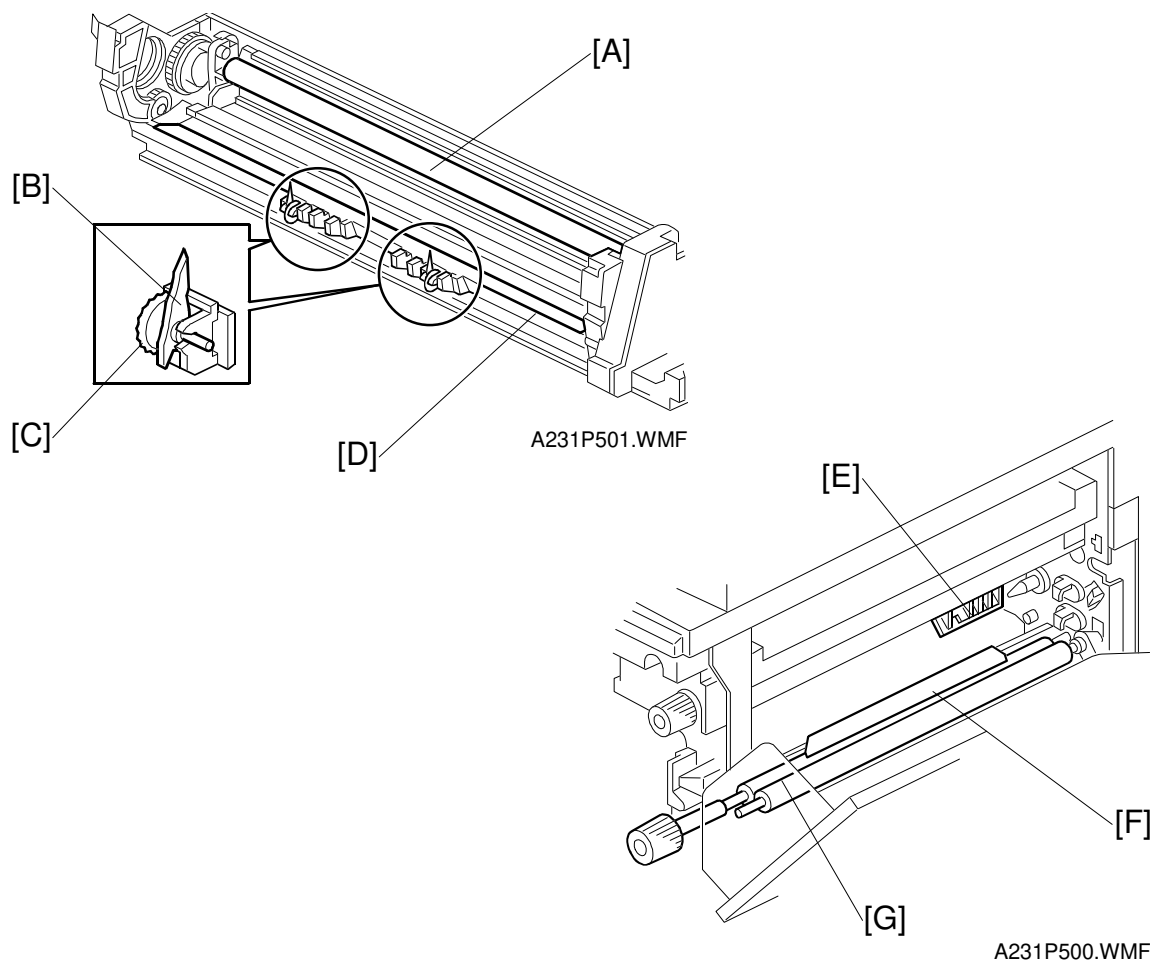
PM	EM	Action	Problem	Fig.	
Around the Drum						
Charge Roller	Replace	Clean	Clean with alcohol. After cleaning, dry the roller with a dry cloth.	Dirty background on front and rear of paper	A	
Pick-off Pawls	Replace	Clean	Clean with a dry cloth.		Toner falls onto the paper.	B
Spurs	Clean	Clean	Clean with a dry cloth.			C
PCU Entrance Seal	Clean	Clean	Clean with a dry cloth			F
ID Sensor	Clean	Clean	Clean with a dry cloth. After cleaning, do SP3001-2.		E	
Cleaning Unit						
Cleaning Entrance Seal	Clean	Clean	Clean with dry cloth	Toner falls onto the paper.	D	
Paper Feed						
Relay Rollers	Clean	Clean	Clean with water or alcohol.	Paper non feed or paper double feed	G	
Registration Roller	Clean	Clean	Clean with water or alcohol.			
Bottom Plate Pad	Clean	Clean	Clean with water or alcohol.			
Fusing Unit						
Hot roller	Replace	Clean	Clean with alcohol (or a suitable solvent).	Offset image

1. Pull out the PCU, then clean the following parts.
  - ID sensor [E]
  - PCU Entrance Seal [F]
  - Registration Roller [G]
2. Remove the drum, then clean the following parts.
  - Charge Roller [A]
  - Pick-off Pawls [B]
  - Spurs [C]
  - Cleaning Entrance Seal [D]

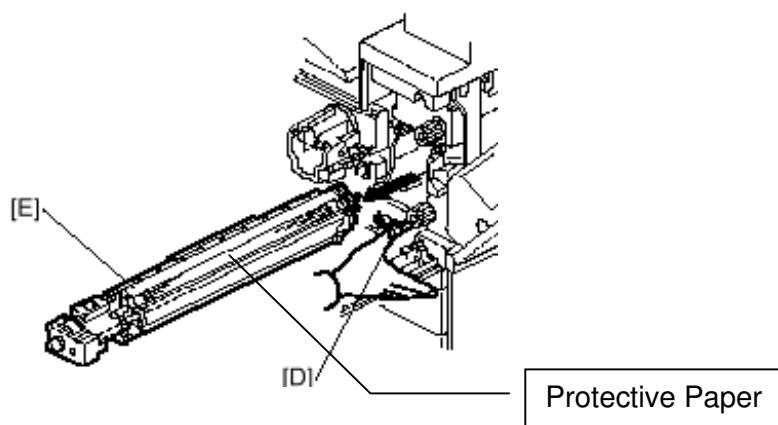
For the same purpose at RPL, they cover the development roller with the protective paper. This is because they work with the development unit with a bare roller (which may hit the drum hard) and they produce a large number machines, which requires a more tolerant method for the factory workers.

Therefore, when installing the RPL-made machines, remove the protective paper.

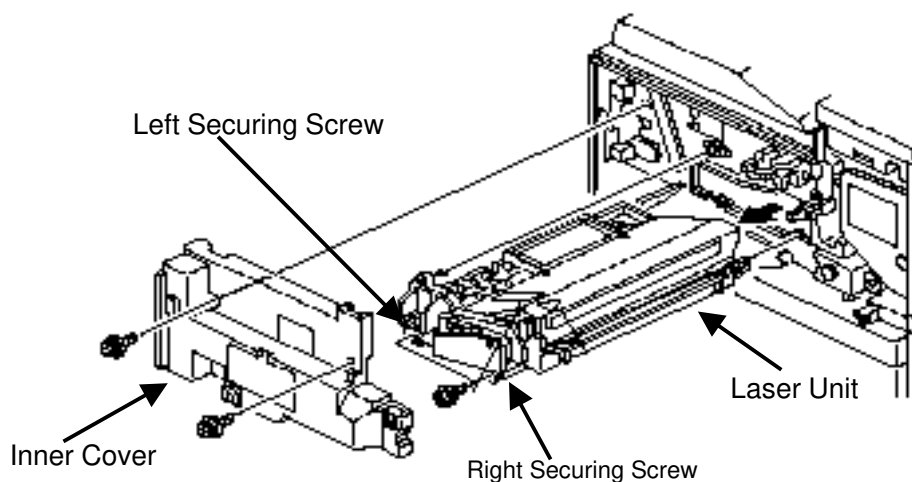
2. Make sure the three laser diode unit securing screws are not loose. If the screws are loose, tighten the screws and check to see if the SC322/SC326 has been solved. If the SC Code still appears, follow the steps below to twist the laser unit.

1. Open the front cover and remove the inner cover. (See the illustration)

3. Loosen the two securing screws for the laser unit (see the illustration below).
4. Tighten the right securing screw while jacking up the right side of the laser unit with a screwdriver.

5. Tighten the left securing screw and put the inner cover back on.
6. If SC322/SC326 is still indicated after the above action, replace the laser unit with a brand new one.

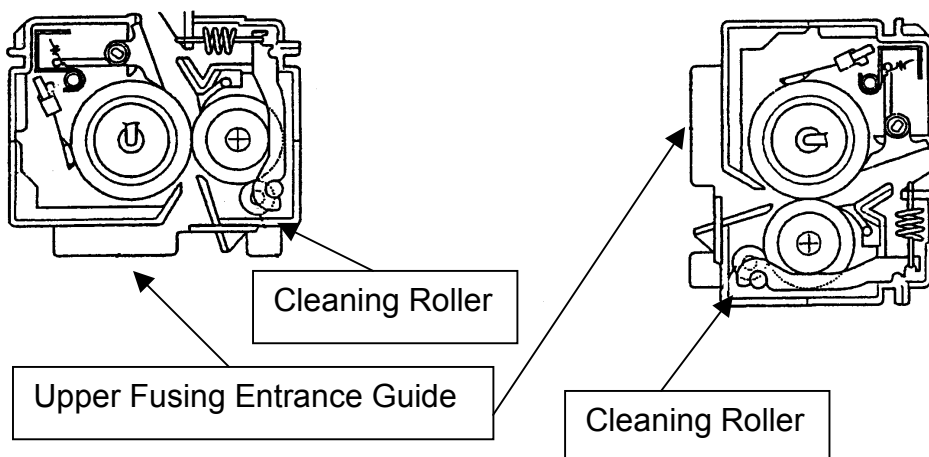
Even if the upper entrance guide is bent, the cleaning roller will still properly clean the pressure roller. However, if the upper entrance guide is removed/installed with the fusing unit positioned so that the upper entrance guide is on top, the cleaning roller may fall off and the hot roller and pressure roller may be scratched.

When installing/removing the upper fusing entrance guide, please make sure the fusing unit is positioned as shown below.

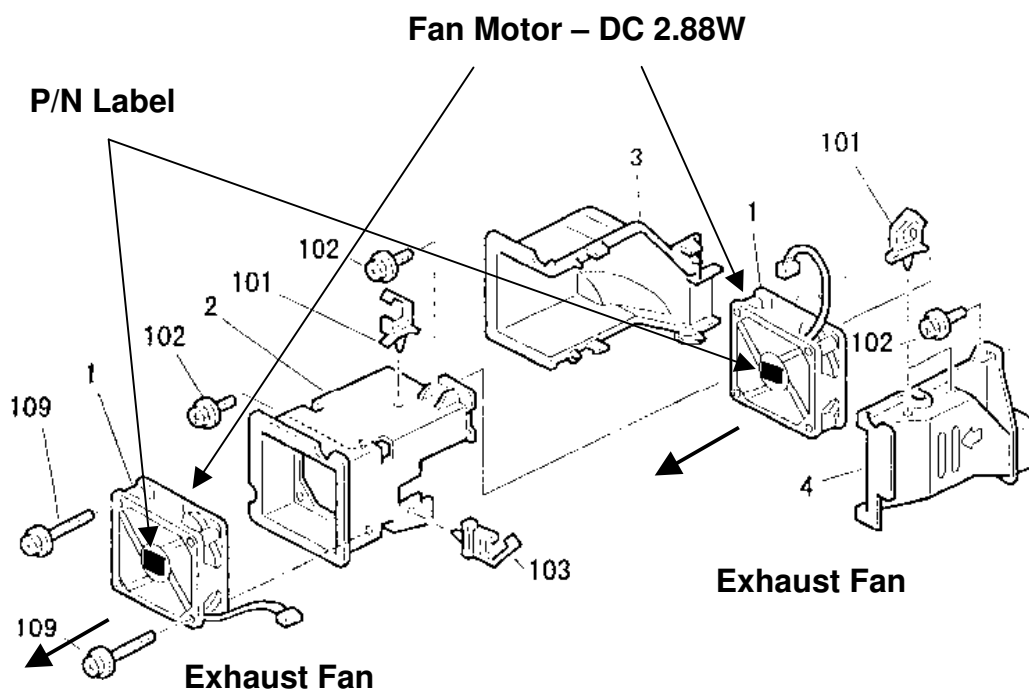
When you install the fan motor, be sure to check that the fan is installed with part number label facing out (exhaust direction) as shown in the illustration. If the fan is installed in the opposite direction (intake direction), a machine malfunction or overheating may occur.

Please exercise caution when installing/removing the fan motor AX64-0080.

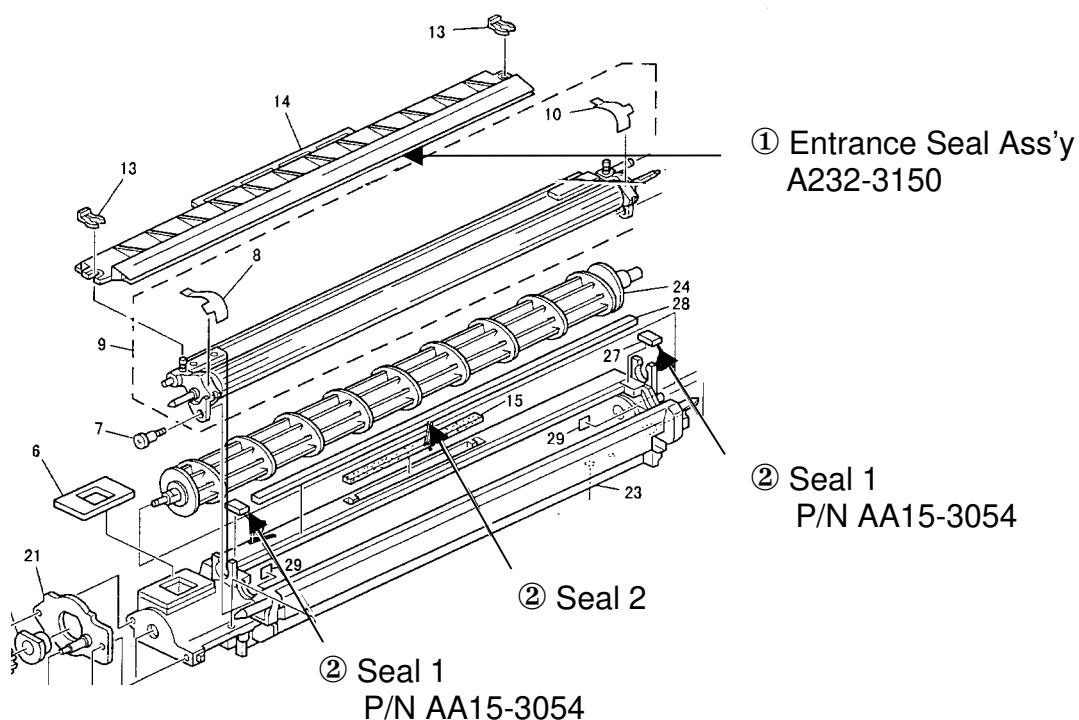
1. The width of the entrance seal ass'y has been changed as shown in the illustration.
2. The width of the side sponge seals has been changed as shown in the illustration.

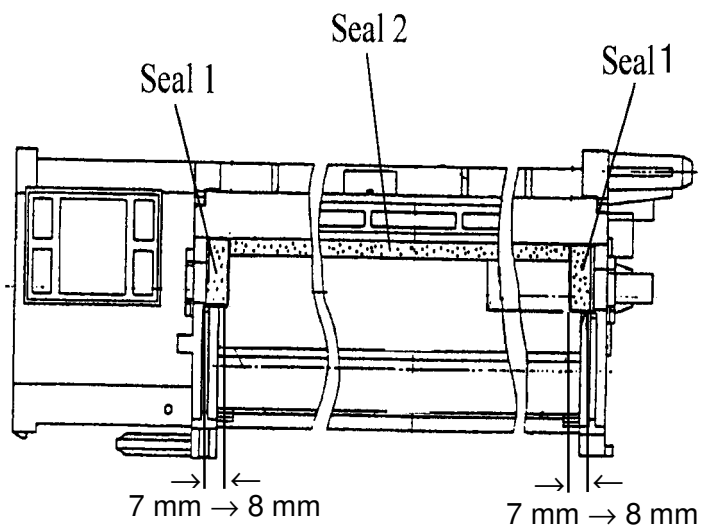
Developer leakage from the development unit.

② : The width of seal 1 has been changed from 7 mm to 8 mm.

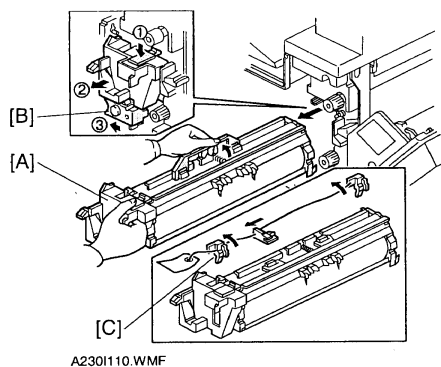
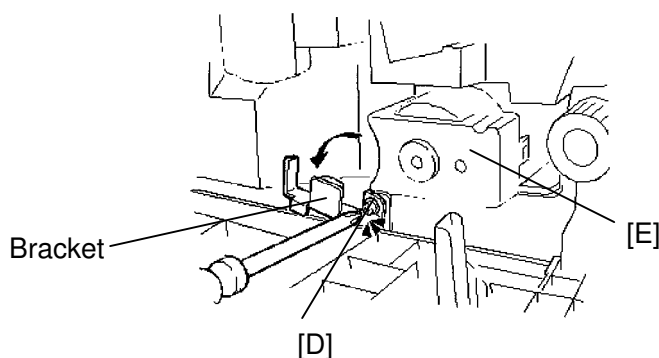
Development Unit Replacement Procedure. (Service manual page 3-7)

A bracket for securing the unit has been added.

6. Open the front cover.

7. Push down the lever (1). Then pull the PCU [A] out a small distance (2), and move the development unit [B] to the left (3) so that the development unit is away from the drum, then slide out the PCU completely.

9. While loosening screw [D], turn the bracket counterclockwise, Then remove the development unit [E].

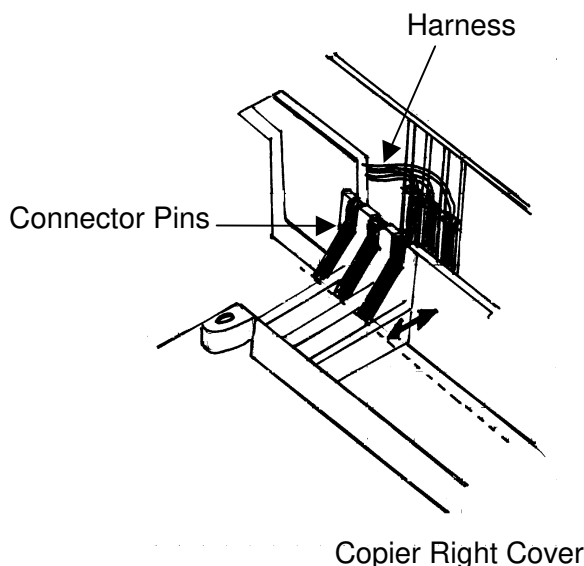
To prevent the connector pins from being bent, the material of this pin has been changed from phosphorus bronze to SUS. The part number of the relay harness (A2323995) has not been changed.

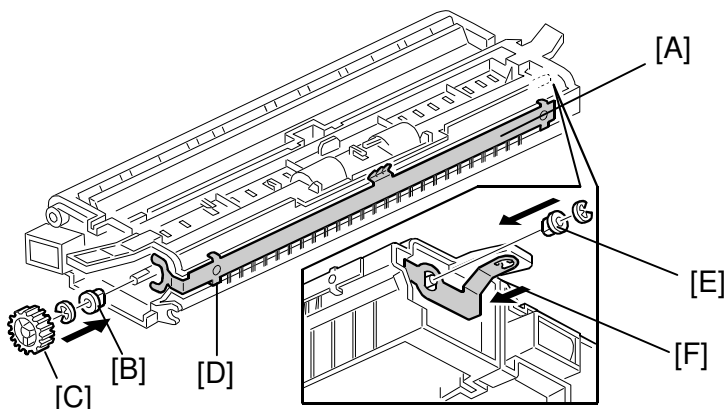
## Exit Unit Installation Procedure

Paper jam in the exit unit or bridge unit under low-humidity conditions. The paper is stopped in the exit or bridge unit.

A malfunction caused by static electricity build-up around the sensor in the exit unit or bridge unit

1. Replace the anti-static brush assembly with the new one [A] (A2844460) after removing the bushing [B] (1 E-ring) and gear [C].  
**Note:** Although the groove of the frame can be located in both the front and back, the standard is for the groove to be located in the back [D]. The grounding plate pawls for the rear groove should be set first, followed by those for the front groove.
2. Install the bushing [B].
3. Remove the bushing [E] (1 E-ring).
4. Attach the edge of this grounding plate [F] (A2844462) to the back of the attachment projection on the exit unit frame.

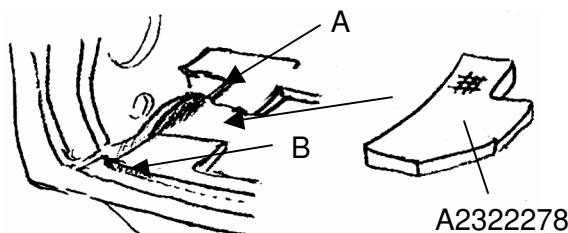
If the seals are not attached properly, it is possible for small gaps to be created. Since this would allow toner to leak out, please make sure to attach the seals in the proper position and orientation.

Area "A"	Area "B"
Target:	No gap	No gap
Acceptable gap:	0 to 0.5 mm	0 to 0.3 mm

1. Remove the seal and use alcohol to clean the surface to which the seal will be attached.
2. Attach seals to both the front and rear of the drum (A2322277, A2322278), as shown in the illustration below. Please note that the surface to which the seal will be attached is curved. It is therefore necessary to reconfirm that the entire seal is firmly attached.

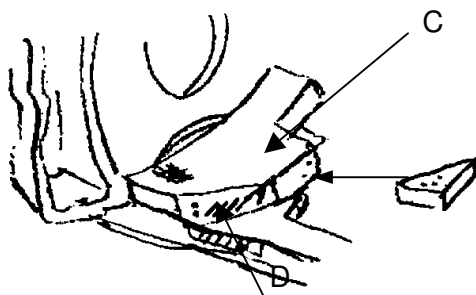
Area "C"	Area "D"
Target:	No gap	No gap
Acceptable gap:	0 to 0.5 mm	0 to 0.5 mm

3. Attach the entrance seal (A2322350) in between the seal attached in step 2 above and the frame.

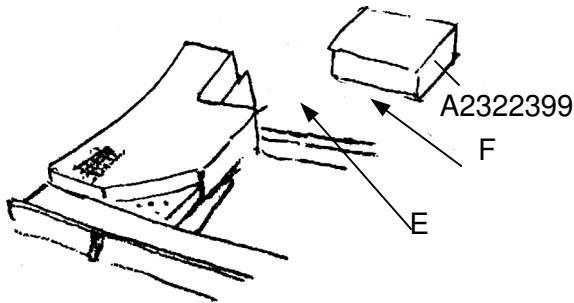
Area "E"	Area "F"
Target	No gap	No gap
Acceptable gap	0 to 0.5 mm	0 to 0.5 mm

4. Line up the blade seal (A2322399) flush against both surfaces of the frame and attach it as shown in the illustration.

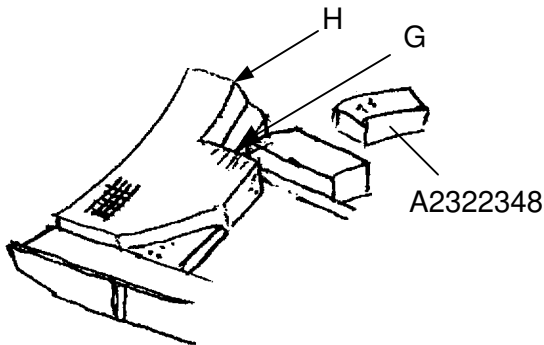
Area "G"	Area "H"
Target	No gap	No gap
Acceptable gap	0 to 0.5 mm	0 to 0.5 mm

5. Attach the seal (A2322348) to the frame on top of the seal attached in step 4 above.

Please make sure to first line the seal up flush against the two surfaces of the frame (as in step 4).

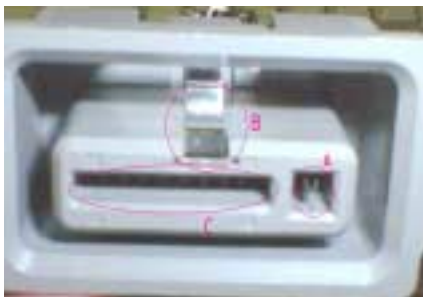
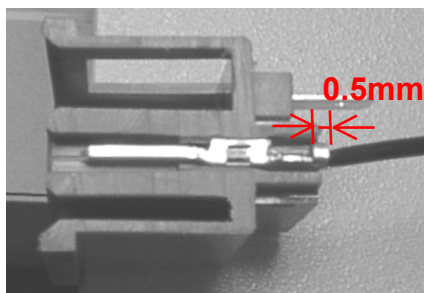
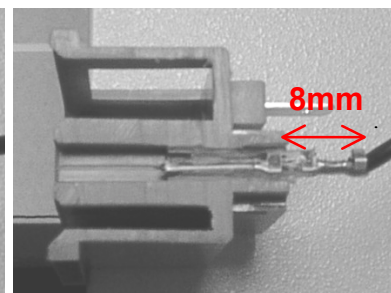
## Mainframe wiring

Through vibration tests, it was confirmed that the pin does not separate from the ADF or finisher connectors. However, although the probability is extremely low, it is possible that the pin could separate from the connector, fall onto the lamp stabilizer and cause a short circuit. We have confirmed that even if this were to happen, there would be no damage to any components or lamp stabilizer circuits. The exposure lamp would remain on and/or SC101 would occur.

A: Grounding pin	B: Shield line	C: Signal Line
ADF	Connected to outer frame of mainframe	Connected to outer frame of mainframe	GND line present
Finisher	Connected to outer frame of mainframe	Not connected to outer frame of mainframe	GND line present

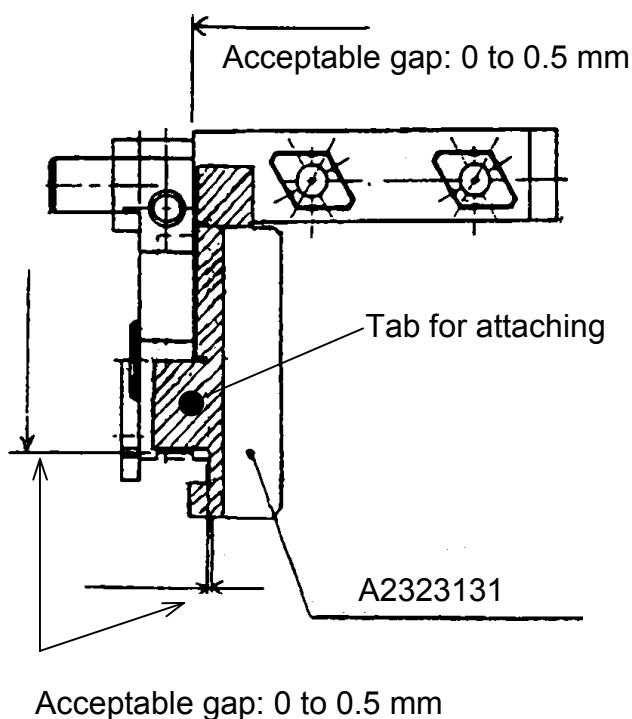
If the seals are not attached properly, it is possible for small gaps to be created. Since this would allow toner to leak out, please make sure to attach the seals in the proper position and orientation.

1. Remove the seal and clean with alcohol the surface to which the seal will be attached.
2. Attach seals to both the front and rear of the Development Roller Ass'y (A2323131, A2323132), as shown in the illustration below.

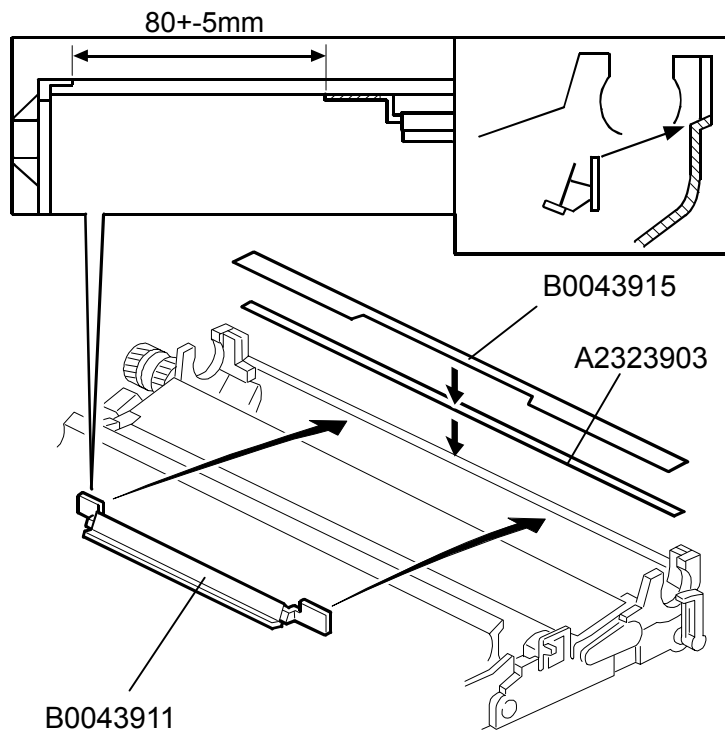
**Fig. 1:**

This RTB contains the replacement procedure for the modified parts in MB MA230073, which announced modifications applied to minimize dirtiness on the rear side of copies.

1. Remove the Transfer Unit, then the Transfer Belt and Cleaning Blade.
2. Peel off the old Entrance Mylar, then clean the surface of the attachment area underneath.
3. Clean out the inside of the unit thoroughly.
4. Attach the Remove Paper Dust Mylar (B0043911) as shown in Fig. 1.
5. Attach the Tape – Entrance Mylar (A2323903) and Entrance Mylar (B0043915) as shown in Fig. 1.
