Modification Bulletin

Model: SP3 Date			e: 15-Feb-98	No: 1		
Modified Article: Bushing for Development			Prepared by: E.Fukuyama			
From: QAC Field Information Dept.						
Reason for	□ Parts catalog correction	☐ Vend	lor ch	ange 🔲 To n	neet standards	
Modification:	☐ To facilitate assembly	☐ To im	nprove	ve reliability ⁽)		
	☐ Part standardization	Other

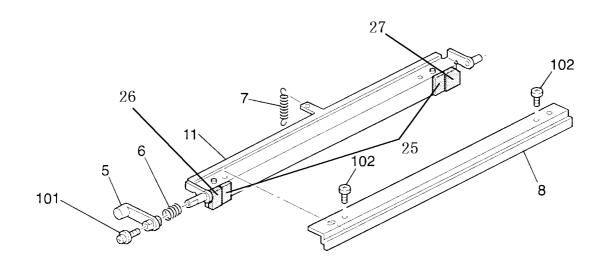
Old part Number	New part Number	Description	Qty	Int	Page	Index	Note
	AA151809	Rear Seal	2		51	25	New Index
	AA151807	Shield:Blade:Front	1		51	26	New Index
	AA151782	Shield:Blade:Rear	1		51	27	New Index

Please add them to your parts catalog.

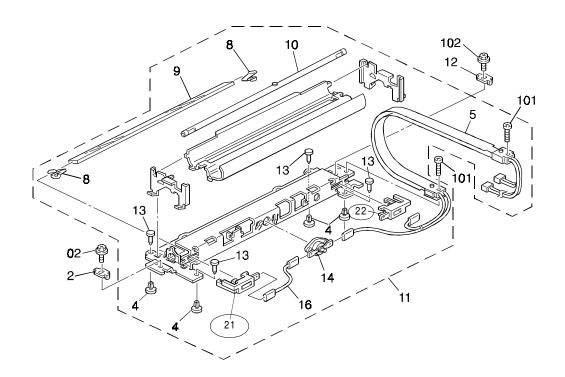
Old part number	New part number	Description	Qty	Int	Page	Index	Note
		Front Terminal	1		35	21	
	A1341773	Rear Terminal	1		35	22

The following parts have been added. Please correct your parts catalog.

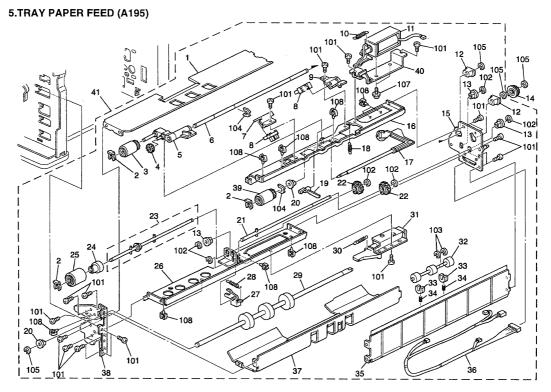
Old part number	New part number	Description	Q'ty	Int	Page	Index	Note
	A13427250	Paper Feed Unit – Lower	1		19	41

The following parts have been added. Please correct your parts catalog.

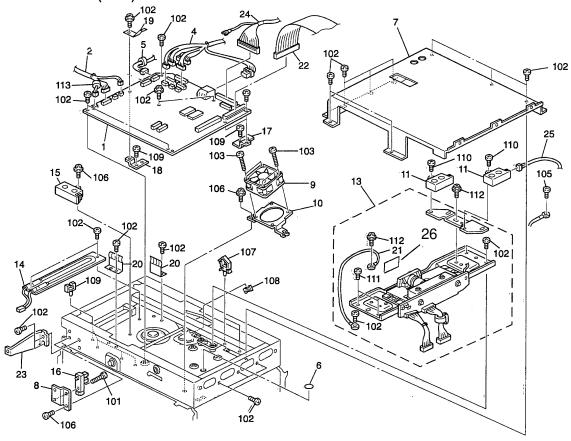
14.OPTICS SECTION 2 (A195)

Old part number	New part number	Description	Q'ty	Int	Page	Index	Note
-	AA011041	Light Filter-G530/G533	1	•	37	26

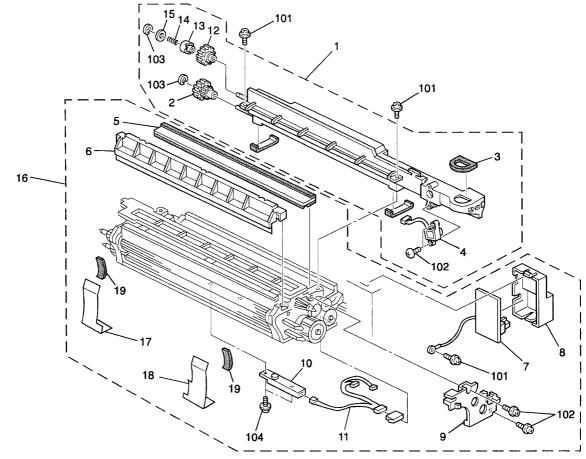
19.DEVELOPMENT UNIT 1 (A195)

Incorrect	Correct	Description	Q'ty	Int	Page	Index	Note
part number	part number						
A1343051	A2173050	Development unit	1		47	16
