Model: Mojito		Date: 14-Apr-00	No.: RA293001
Subject: Software Update for Mail Box CS360		Prepared by: A. Sasaki	
From: Technical Service Dept., GTS Division			
Classification:	<input type="checkbox"/> Troubleshooting <input type="checkbox"/> Part information <input checked="" type="checkbox"/> Action required <input type="checkbox"/> Mechanical <input type="checkbox"/> Electrical <input type="checkbox"/> Service manual revision <input type="checkbox"/> Paper path <input type="checkbox"/> Transmit/receive <input type="checkbox"/> Retrofit information <input type="checkbox"/> Other ()

Model: Mojito		Date: 19-May-00	No.: RA293002
Subject: LG kit (8 1/2"x14"paper size tray Installation procedure and parts catalog		Prepared by: F. Noguchi	
From: Technical Service Dept., GTS Division			
Classification:	<input type="checkbox"/> Troubleshooting <input type="checkbox"/> Mechanical <input type="checkbox"/> Paper path <input type="checkbox"/> Other ()	<input type="checkbox"/> Part information <input type="checkbox"/> Electrical <input type="checkbox"/> Transmit/receive	<input type="checkbox"/> Action required <input checked="" type="checkbox"/> Service manual revision <input type="checkbox"

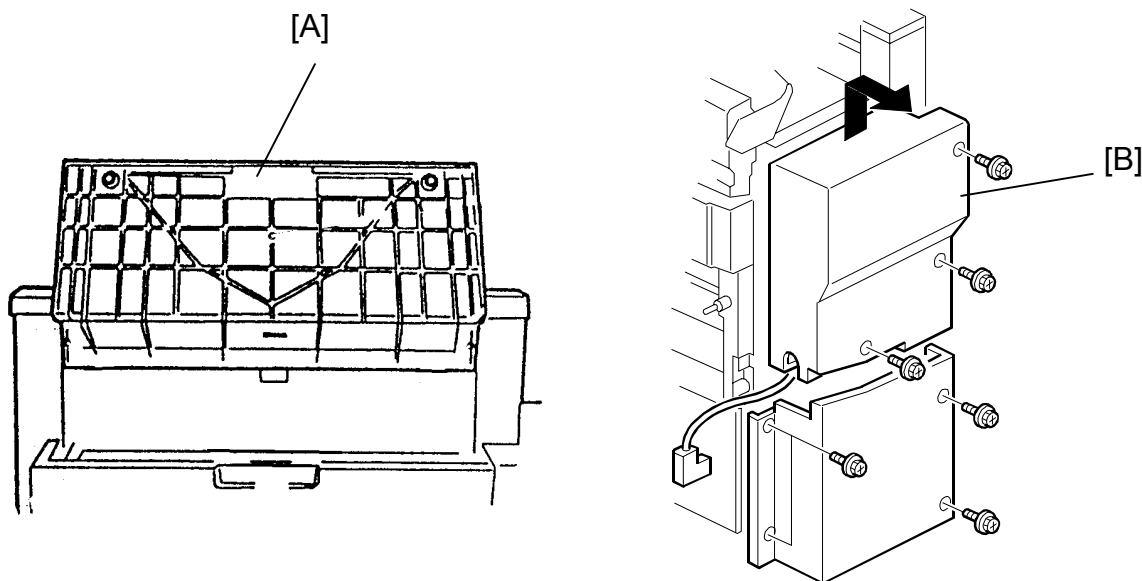
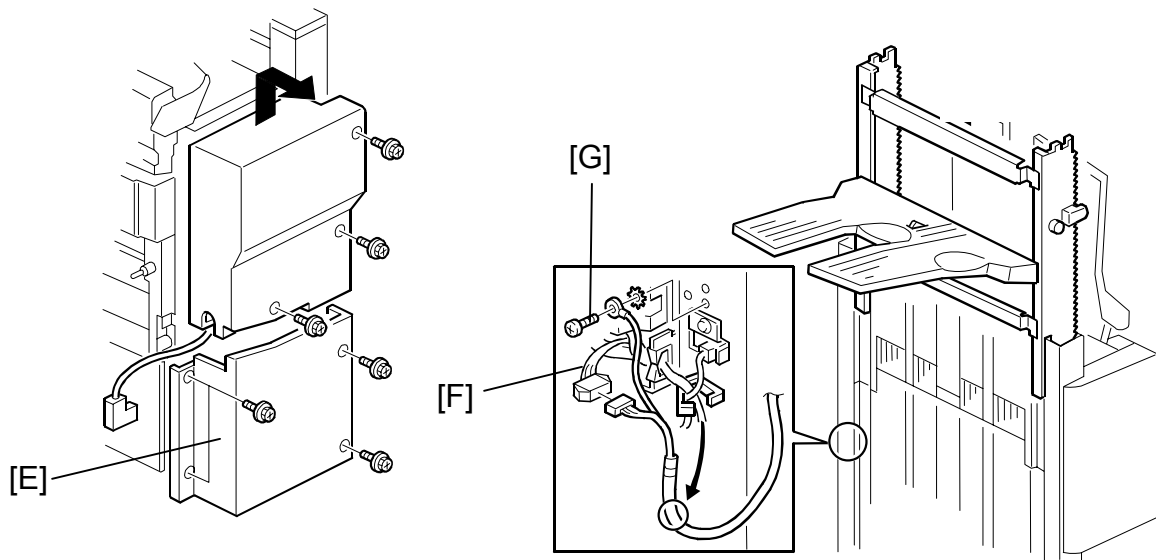
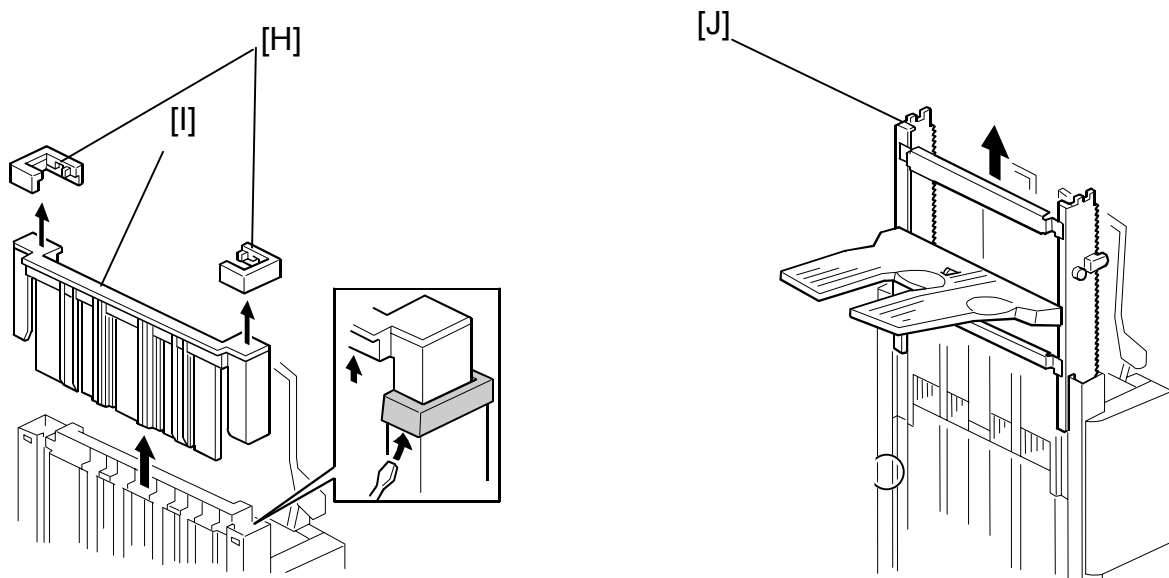
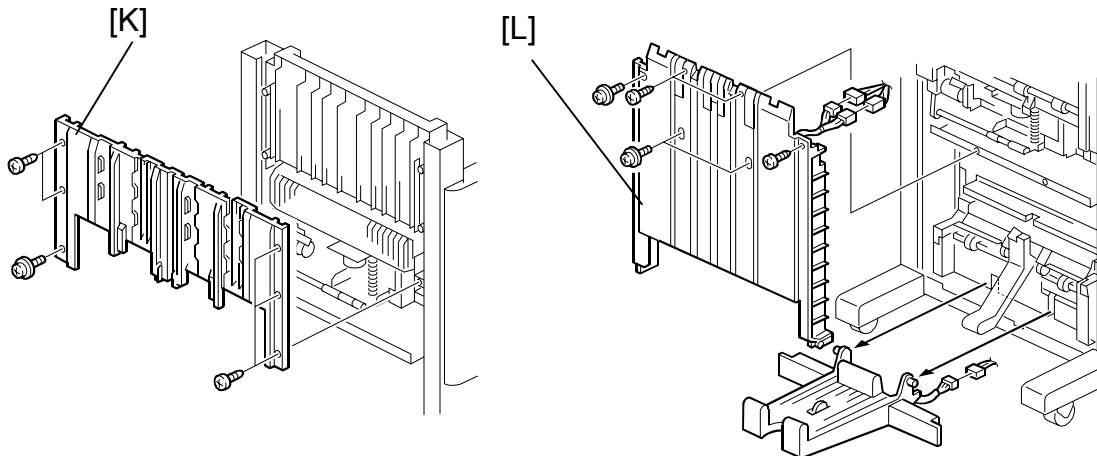
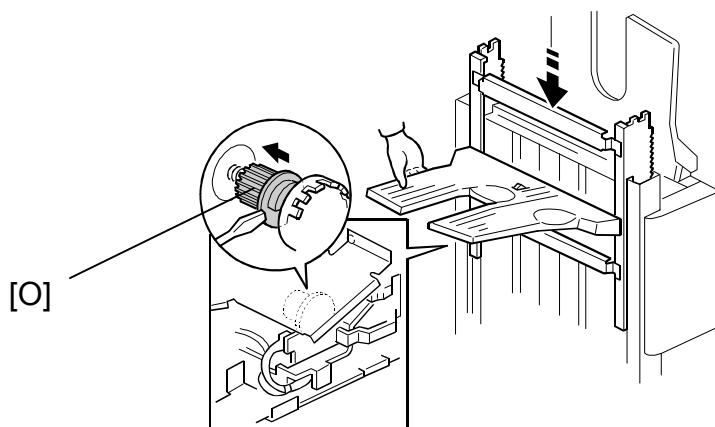
The cable of the guide plate motor is caught between the guide plate unit and frame. In the worst case, the cable covering peels off and the +24V line is shorted to ground. These two factors combine to cause the finisher board to be damaged.

5. If the cable is caught at area [D], go on to the next step. If not, the finisher is OK.

1. Hold up the proof tray and open the top cover [A].
2. Unhook the upper rear cover [B] and remove it (3 screws).

6. Remove the lower rear cover [E] (4 screws).

7. Disconnect the connector [F] and remove the grounding wire [G] (1 screw).

8. Unhook the two stoppers [H] and remove them.

9. Remove the slide guide [I] by pulling it up.

10. Remove the shift tray unit [J] by pulling it up.

10. Remove the upper shift guide [K] (6 screws (5 x M4, 1 x M3)).
11. Remove the lower shift guide [L] (2 connectors, 6 screws [3 x M4, 3 x M3]).

12. Loosen the rear side screws [M] of the exit unit.
13. Free the cable [N].
14. Check the surface of the cable.
15. If the cable wires are visible, wrap them with vinyl tape.

16. Reassemble the machine.

Note: When reinstalling the shift tray unit, release the clutch gear [O] of the tray lift motor by carefully inserting a screwdriver.

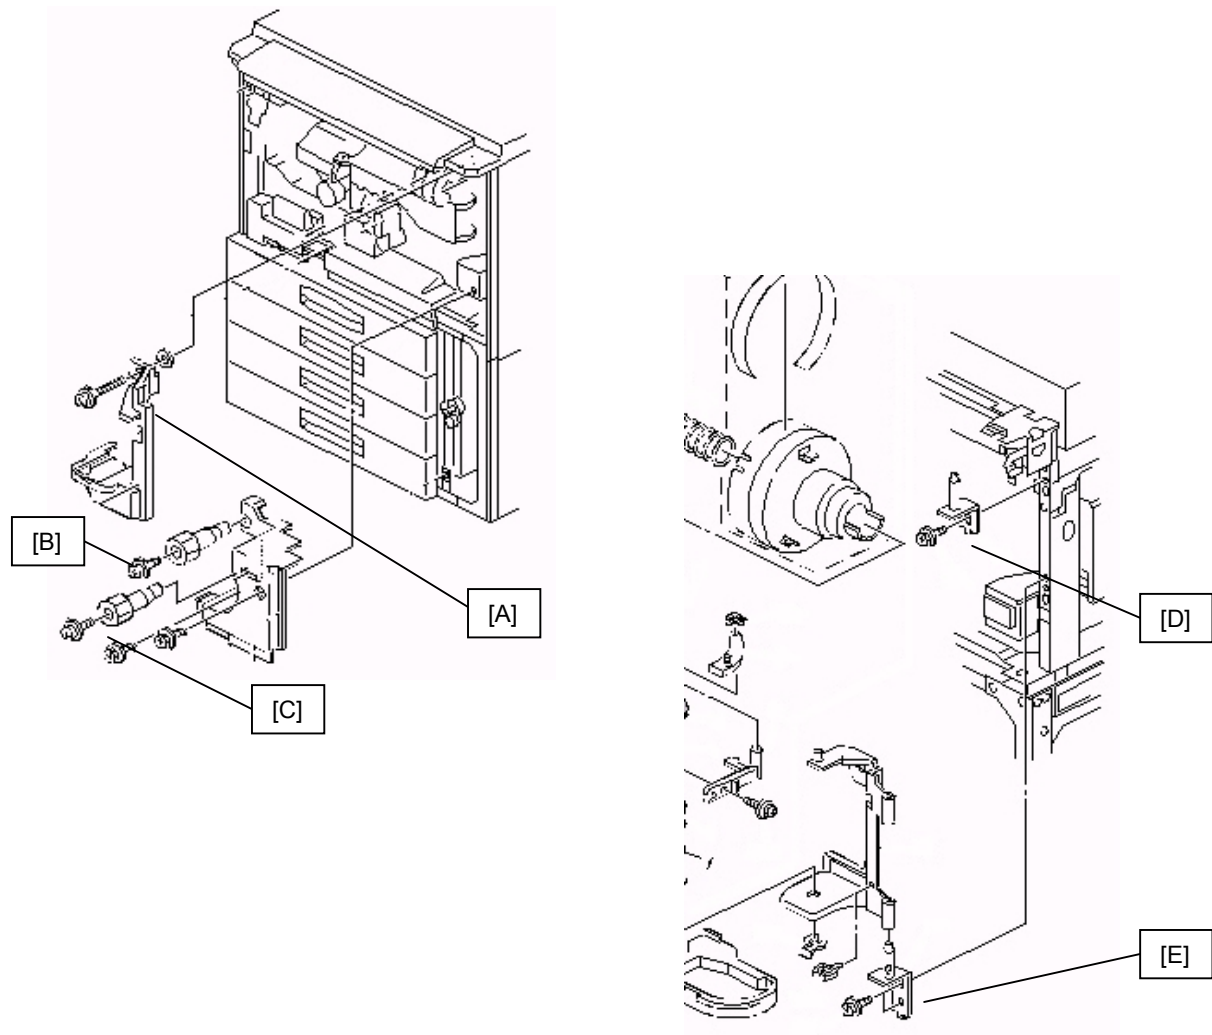
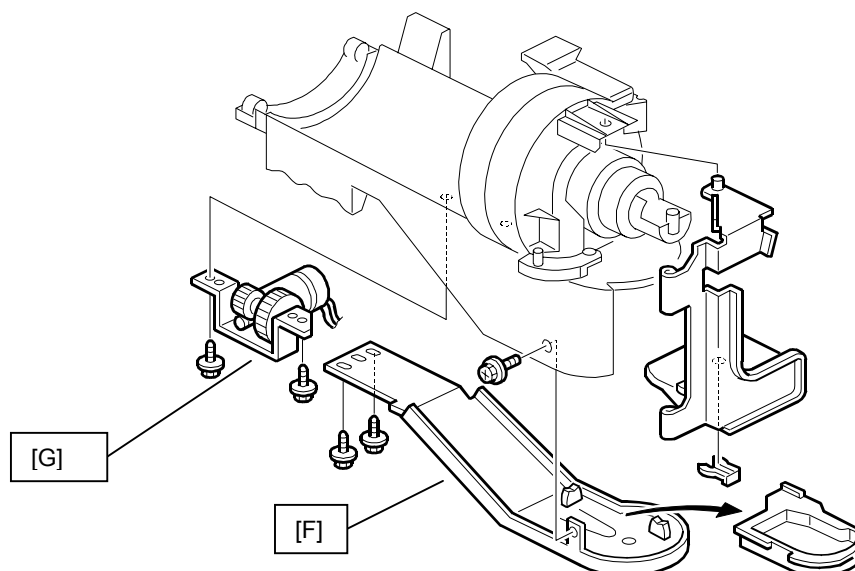
The Motor Joint Gear of the toner bottle holder is worn down, causing noise and uneven rotation.

The amount of grease applied to the gear during production was not enough to prevent premature wearing.

Note: Please make sure that grease is applied at the next PM visit or inspection.

1. Remove the toner bottle.
2. Remove the right inner cover [A] (1 screw, 1 nut).
3. Remove the registration roller knob [B] (1 screw).
4. Remove the right lower inner cover [C] (2 screws).
5. Disconnect the DC motor connector.
6. Remove the contact point stay [D] (1 screw).
7. Remove the lower hinge [E] (2 screws).
8. Remove the toner bottle holder assembly.

9. Remove the turn bracket [F] (3 screws).
10. Remove the toner bottle bracket [G] (2 screws).

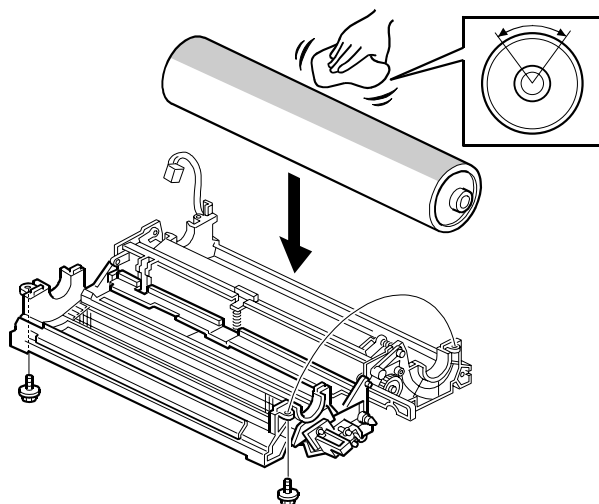
Note: If the setting powder is not applied, the drum's cleaning blade may turn outward, causing a drum cleaning failure.

- Be sure to apply enough powder to give the area a moderate dusting (so that the area turns white).
- If setting powder is not available, please apply waste toner in the same manner described above (waste toner is charged and will be attracted to the drum surface). Please note that although dirty background will have a greater tendency to occur, be sure to apply the waste toner if there is no setting powder available.

2. Install the new drum in the OPC unit so that the powdered area (in bold below) faces the cleaning blade.

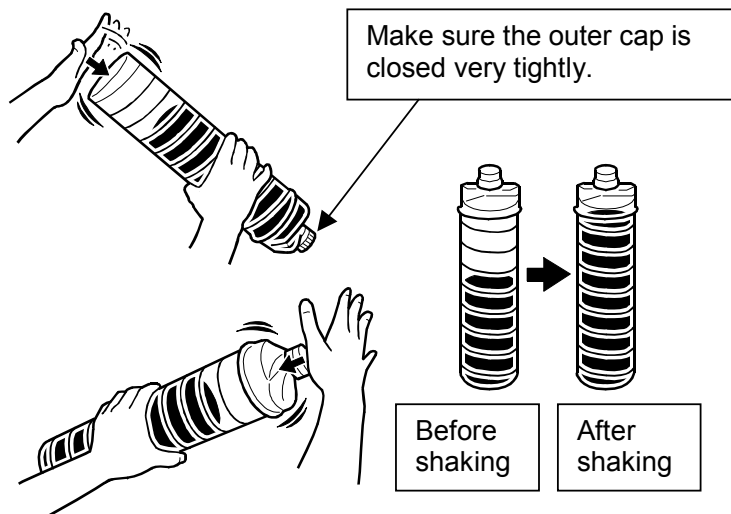
The machine does not clear the toner end condition after a new bottle is installed. As a result, the machine continues to do toner recovery and supplies too much toner.

Before shaking: Near the 6th marking from the bottom (60% full)

After shaking: Near the 9th marking (90% full)
