| Model: Bellini-C1 | | Date: 28-Aug-03 | No.: RA294000b |
| Subject: Troubleshooting | | Prepared by: M. Matsuda | |

This bulletin is a troubleshooting guide for Bellini-C1.

Troubleshooting Guide for Bellini-C1

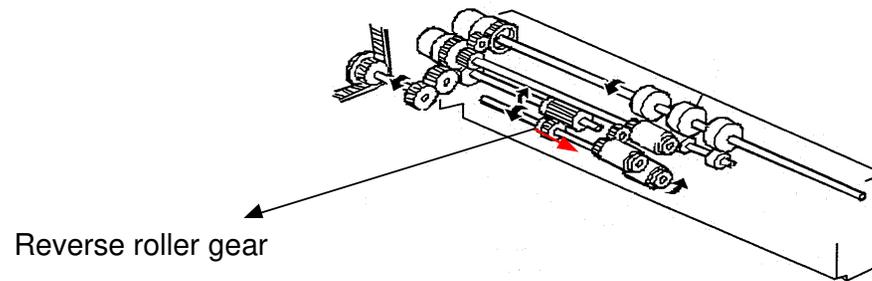
Note: This is only effective for block multi-feeds, i.e. not for multi-feeds of just a few sheets.

Increase the separation pressure, preventing blockages from forming in the feed and separation nips:
Move the reverse roller gear toward the separation roller, until it contacts the D-cut section as shown below.

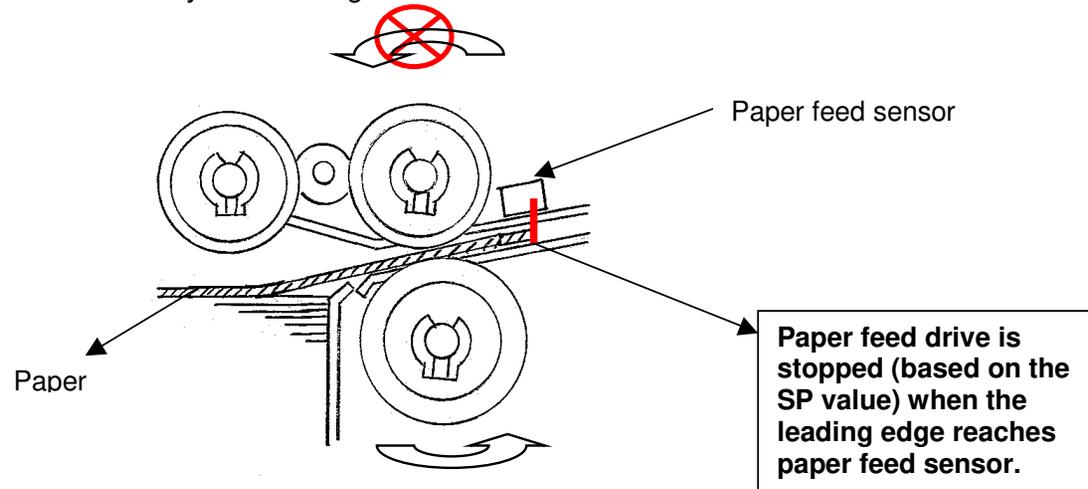
If the setting is not 0, the machine stops the paper when the leading edge reaches the paper feed sensor, increasing separation efficiency and making it difficult for block multi-feeds to occur.

1. Increase the value of SP1907-001 to 006 by 1x10msec, then check the result.
2. If it does not succeed, increase by 10msec again. Change in 10 ms steps until you eliminate this problem..

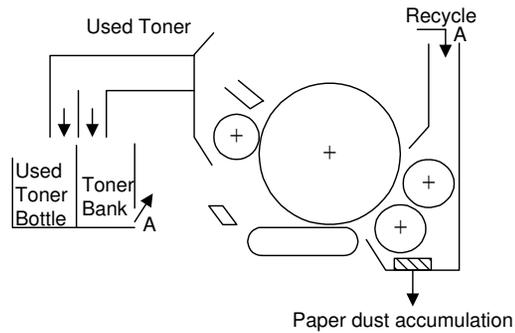
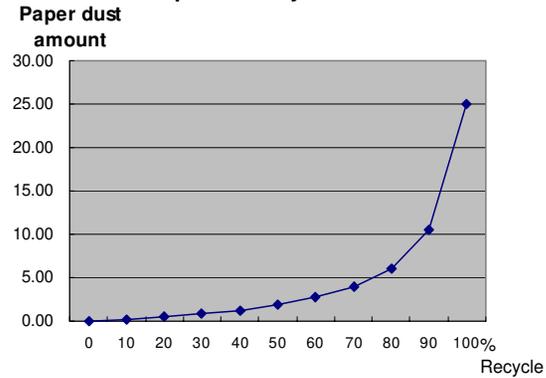
**Black Spots
(Black Fiber Spots)**

Paper dust accumulated on the doctor blade causes toner scattering results in the spots mark, dirty background and black band. Please refer to the attache Black Spots troubleshootin.

- A combination of the following will minimize the appearance of the fiber spots:
1. Dispose of the developer in the development unit and clean the unit.
 2. Decrease the percent of toner being recycled by changing the angle of the toner recycle pipe (see illustration below). If the pipe is on 100% recycling, we recommend changing over to 60% recycling at first. Although there will be an immediate reduction in fiber spots with solutions 1 and 2, wait until the next PM visit before making a final determination on the effectiveness. This is because it takes time for the paper fibers to be removed from the toner path.
 3. Use paper that does not shred its fibers easily.

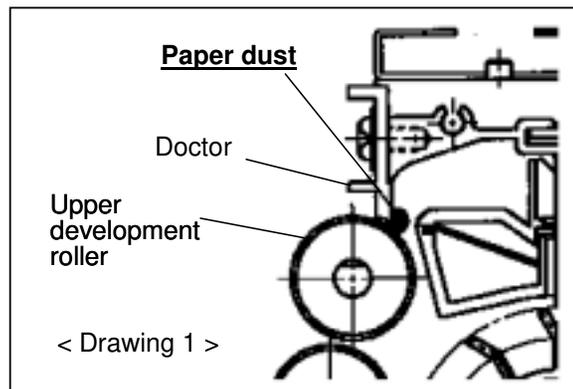
Paper dust gathers at the front and rear sides of the doctor blade gap in the development unit, causing the gap to become narrower which decreases the airflow from the lower development casing.

CAUTION: Do not remove the doctor blade or loosen any screws on the development unit, as this will make it impossible to readjust the doctor gap in the field and lead to image quality problems. ***If the blade has already been removed or screws loosened, contact the key person for this model at the Ricoh regional headquarters in your field.***

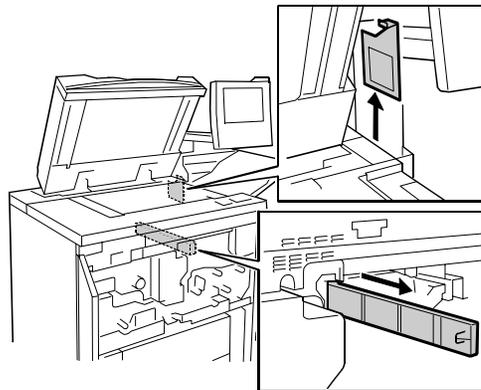
The above cleaning/replacements are also effective in maintaining proper machine internal temperature, which is key in minimizing scattering since slight rises in temperature can cause scattering to occur more easily.

Note: The toner filter should be replaced every 300k (Bellini-C1) or 350k (Bellini-C2).

2. If toner scattering still occurs, clean the toner transport path.

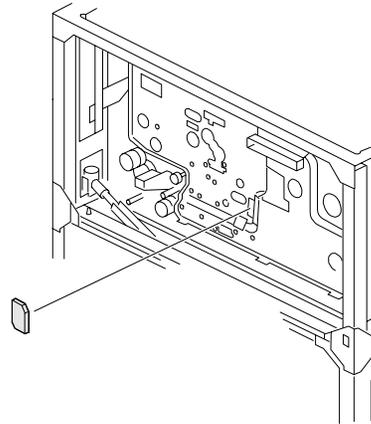
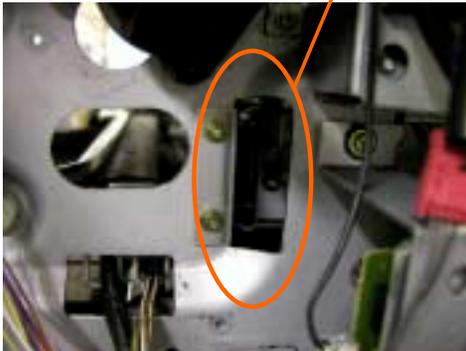
Rear side view

Cover this opening with the seal

c) Attach the new seal (B0703619) as shown below to the opening in the rear side plate. This will prevent toner scattering in the fusing and duplex areas.

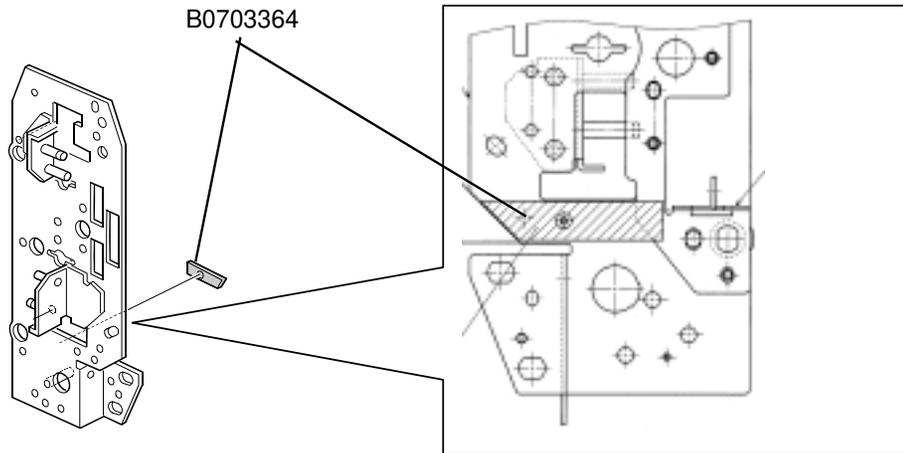
- Attachment position: Refer to Parts Catalog, pg. 78

Toner may scatter to the outer portion of the toner bank unit when the toner bottle chuck opens the bottle. The split toner covers the detection area of the toner over flow sensor, causing it to mis-detect the waste toner bottle full condition.

- P/N: B0703364 (Shield: Bracket Chuck)

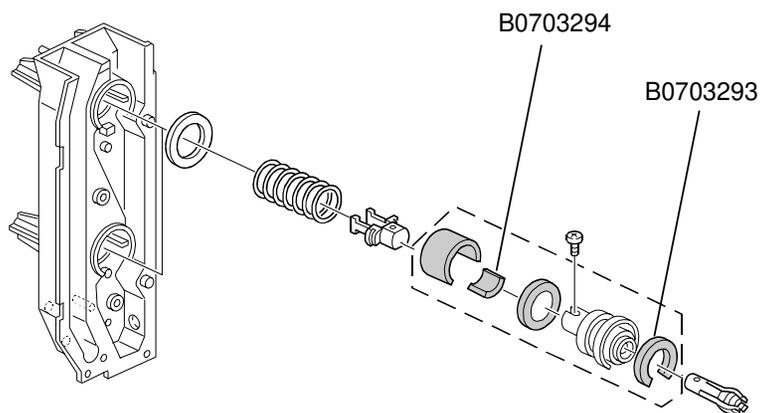
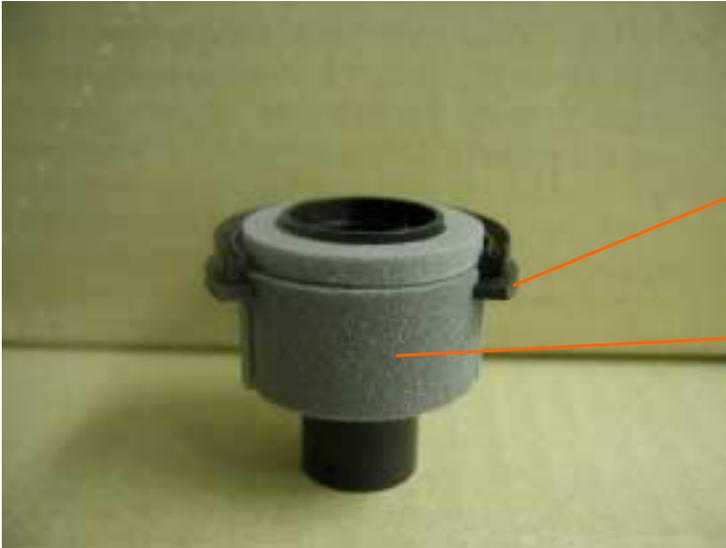
- Attachment position:

When toner is supplied to the toner bank unit, it may leak out from the bottle and gradually accumulate in the chuck area, eventually preventing the bottle-holding mechanism on the chuck from releasing the bottle.

Two kinds of the shields have been added to ensure toner does not leak out from the toner bottle.

- P/N: B0703293 (Shield Slider), B0703294 (Shield Slider Short)

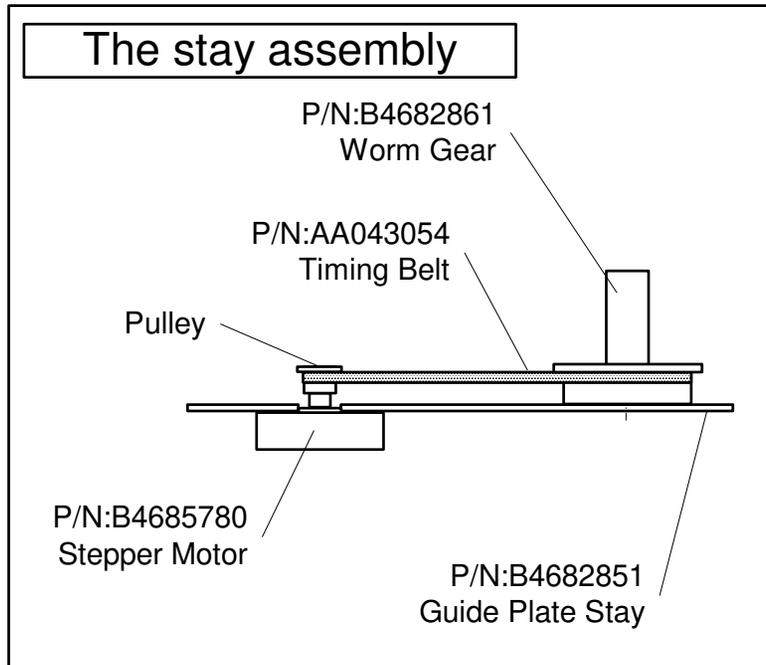
Fig. 1

Insufficient tension in the shift-transfer timing belt causes excess torque in the belt's motor when the paper passes, resulting in a motor lock and paper jam in the finisher exit section.

1. Remove all of the following shift-transfer section components (P/C: pg. 13).

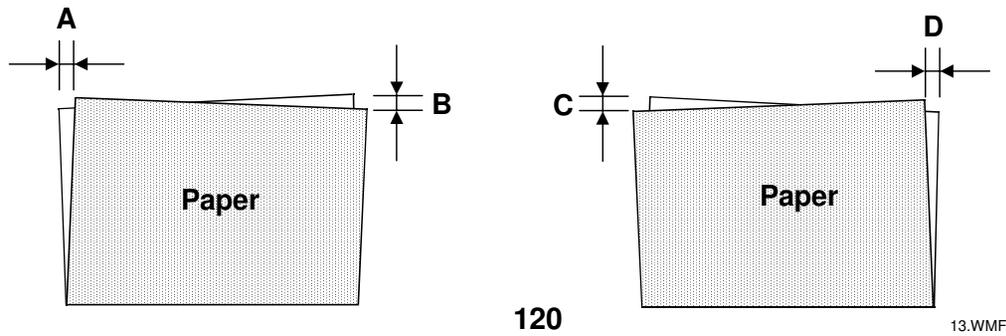
All distances shown below (A, B, C, D): **2mm or less**.

12. Print out 3 Booklet sets (2-3 sheets each) and check for folding skew.

13. If A, B, C or D is over 2mm, do the following.

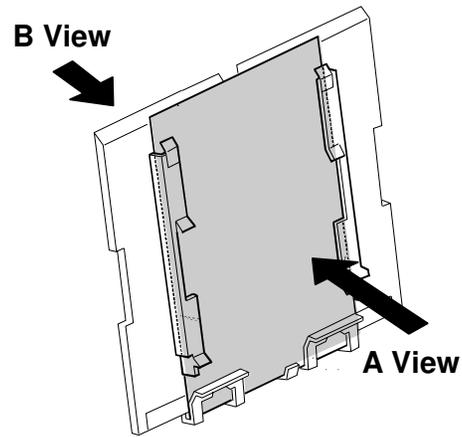
Note: Although the fences may be parallel and 0 – 0.5mm from the paper edges, they may not be 90 degrees with respect to the folding mechanism. Steps 16 can correct this.

16. Repeat Steps 12 and 13 above, and if A, B, C or D is still above 2mm, go on to Step 17. If A, B, C, and D are all 2 mm or less, go on to step 19.

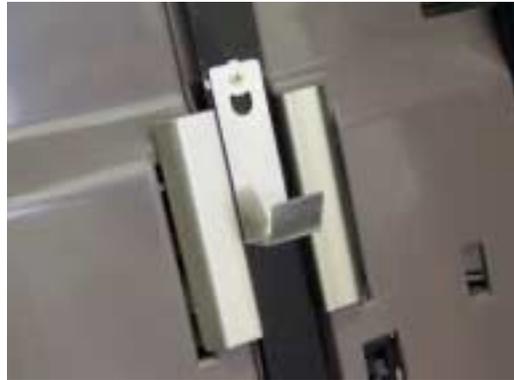
02073004.WMF

19. Bring the belt hook to the position shown in the photograph below then adjust the hook until it is parallel to the belt itself.

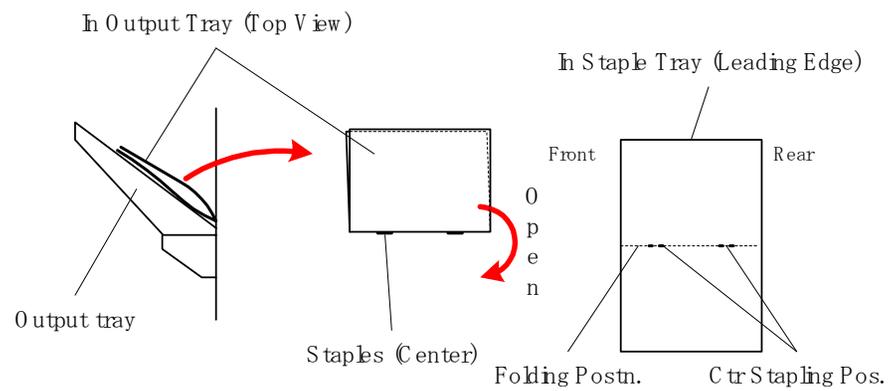
Fig. 1: The Stack in the Output and Staple Trays

| Symptom | Cause | Check/Adjustment |
|--|--|---|
| <p>6. Poor Stacking Within a Booklet Stack Sheets in the booklet stack shift, primarily in the horizontal (short-edge) direction.</p> | <p>The jogger fence gap is too wide, which prevents proper aligning of the stack's side edges.</p> | <ul style="list-style-type: none"> ● Check the current width of the jogger fence gap (“Jogger Fence Gap Check” below), and if necessary adjust the gap using SP6120 (in the “-” direction). → See “Adjusting the Jogger Fence Gap” below. |

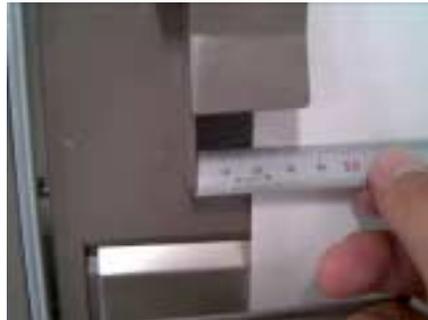
Photo 2

4. Measure the distance between the paper contact area on the front jogger fence and the front edge of the paper stack (Photo 2).
 - This distance should be **19mm** for all paper sizes.
 - This same 19mm should be used as the reference target in cases where the jogger fence gap is adjusted with SP6120 (procedure below).

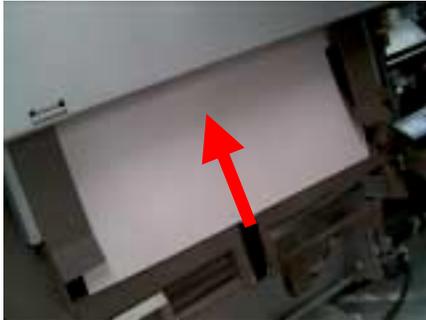
Photo 3

1. Place one A3 sheet (thick paper) in the tray, and then manually move the belt pawl so that the paper position is raised approximately 100mm (Photo 3).

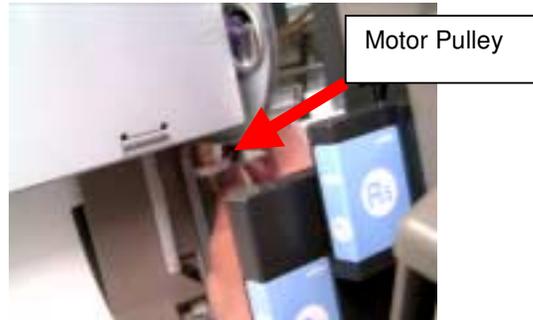
2. Place the paper flush against the rear jogger fence, then slowly close the front fence to the edge of the paper manually by rotating the jogger motor pulley (black knob in Photo 4 above).

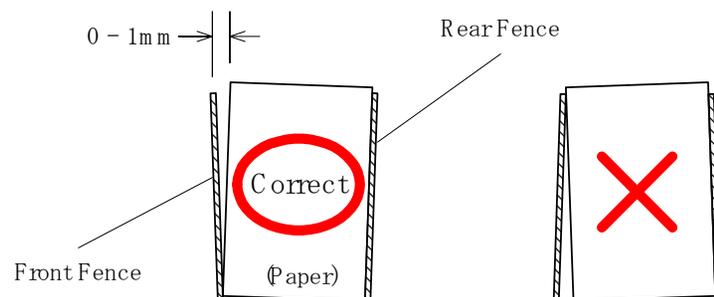
Fig. 2: Upper Area Paper-Fence Gap

3. Make sure the lower area of the front jogger fence and paper stack are touching, then measure the distance between the paper contact area on the upper area of the front jogger fence and the front edge of the upper area of the paper stack.
 - It is essential to make the measurement on the upper area, as shown in Figure 2 below.
 - The allowable distance is **0-1mm**.
