| Model: Bellini | | | Dat | e: 15-Dec-99 | No.: RA294001 |
| Subject: Toner Hopper Gear Replcement at Installation | | | Prepared by: H.K. | | |
| From: Technical Services Dept., GTS Division | | | | | |

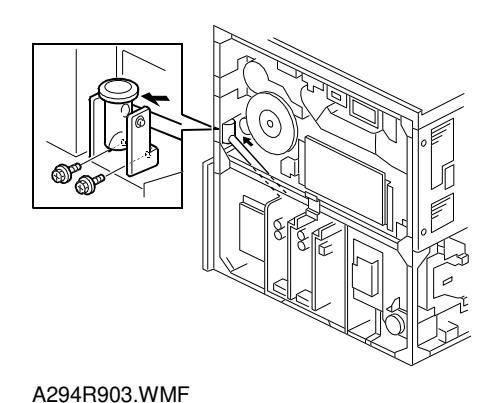
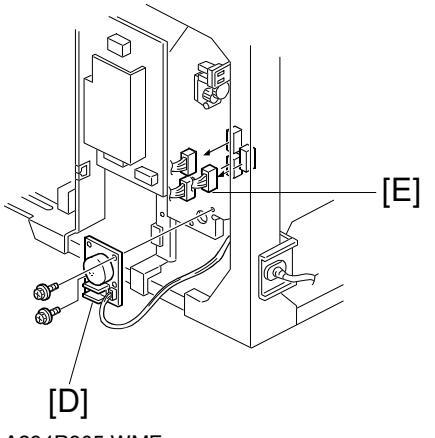
We have found that toner in the toner transport tube may be blocked due to vibrations during machine transportation. Please note the following remarks and do the procedure when the machine is transported.

- 3 Remove the noise filter [C] (2 screws and 4 connectors; upper: ④, ② white lower: ③, ① yellow) and toner bank motor [D] (2 screws, 1 connector).
- 4 Disconnect the three connectors [E] from the toner bank unit.

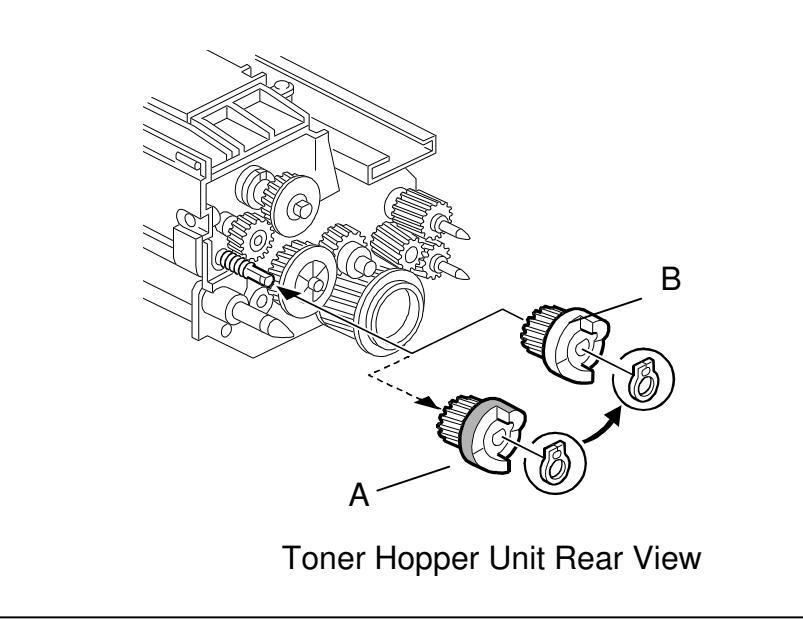
While SP2-207-2 (Toner Bank Toner Supply) is performed at installation, the rotation of the toner hopper gear (AB013748: Joint Gear -15Z) may cause an oversupply of toner from the hopper to the development unit. This in turn causes relatively high image density in copies/printouts made just following installation. To correct this, machines in mass-production have been modified as follows:

Replace the red idler gear with the white gear after carrying out SP2-207-2 (Toner Bank Toner Supply) by referring to the procedure for the Toner Hopper Drive Gear Replacement (Joint Gear - 15Z) packed in the accessory plastic bag. The red idler gear is not necessary after machine installation.

*Remove the Joint Gear 15Z that has been marked red [A]. Replace it with the white gear [B] and a spare C-ring packed in the accessory plastic bag.

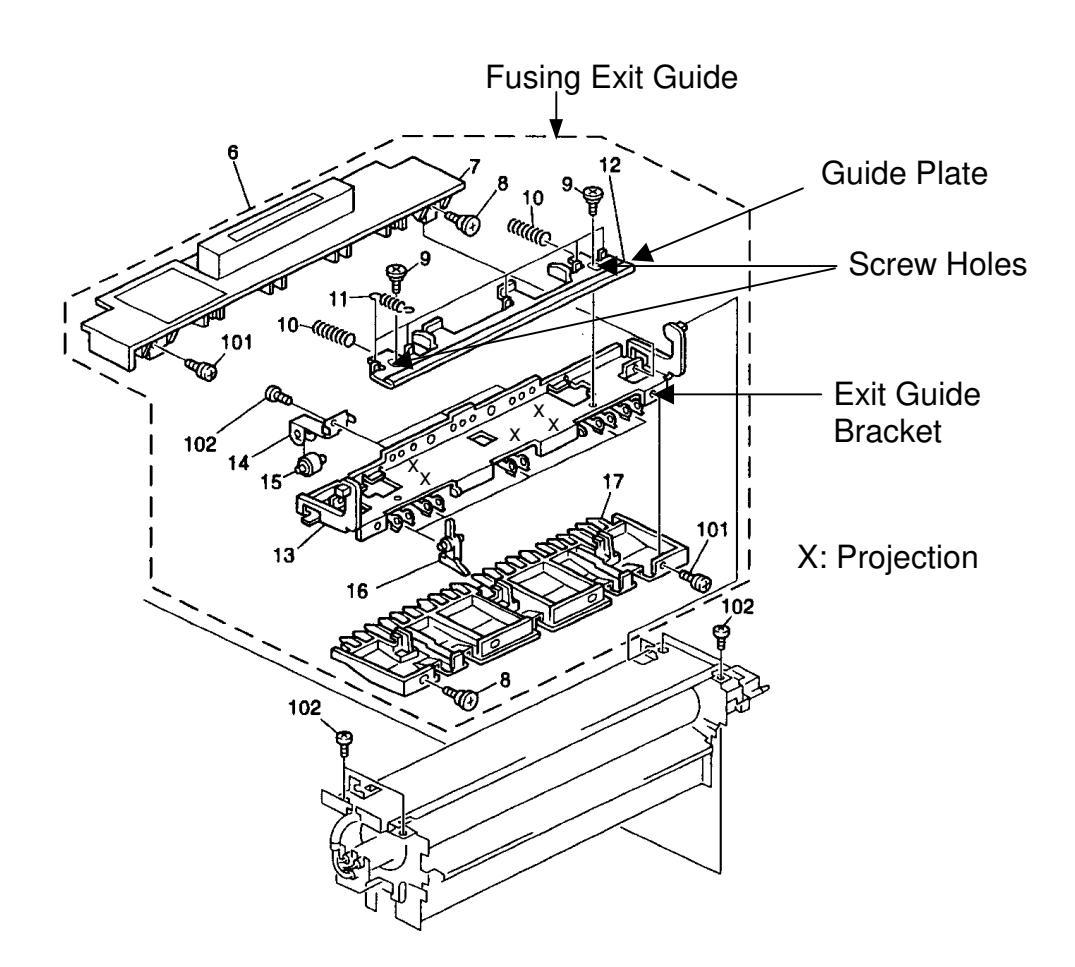
Cause:

In order to minimize the sliding mechanical load, apply grease to the Stripper Release Slider in the following places:

- The 2 shoulder screw holes on the Guide Plate
- The 5 projections on the surface of the Exit Guide Bracket

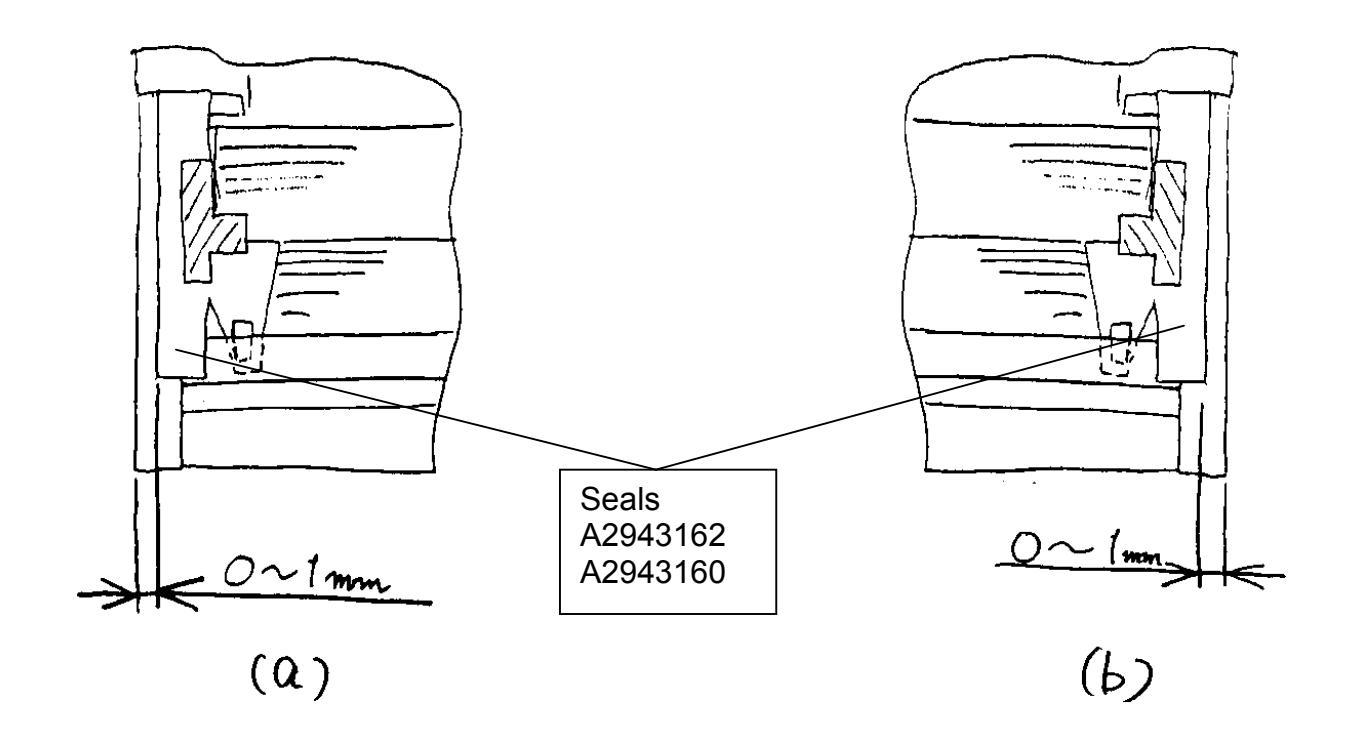
Figure 1

Note: If these two reference values (height, inside margin) are not followed when attaching A2943160 and A2943162, developer can ride on the seals. This will lead to developer leakage.

Align the side edge of each seal with the edge of the side plate as shown, using the outer edge of the plate as the reference point.

The attachment position (outside of the plate edge) for the seals on the side plates has been changed from $0 \sim 1$ to $0.5 \sim 1.5$ mm.

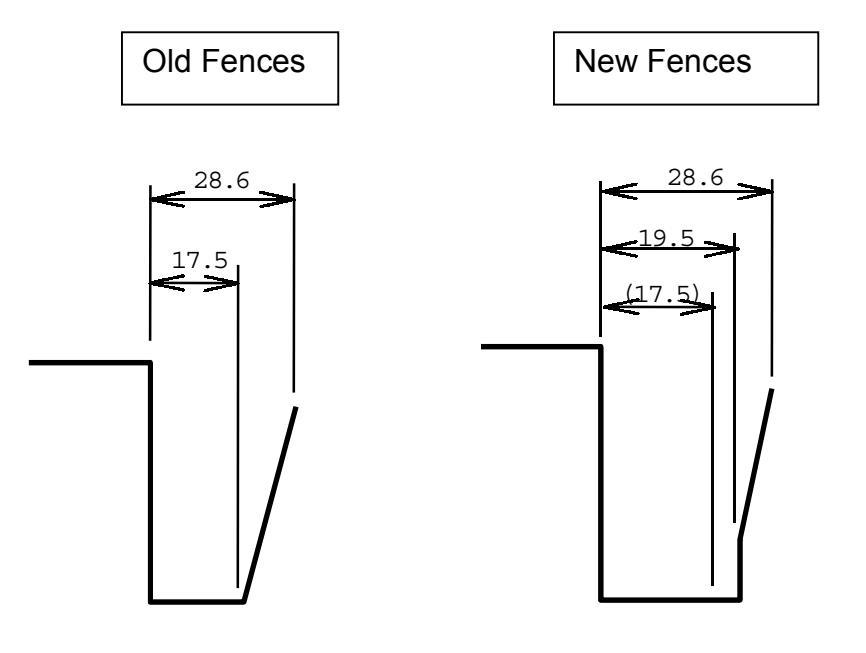
The widths of the positioning fences (front, middle and rear) have been increased as shown below.

Note 1: When replacing either of the old fences in the field, install all three new parts as a set.

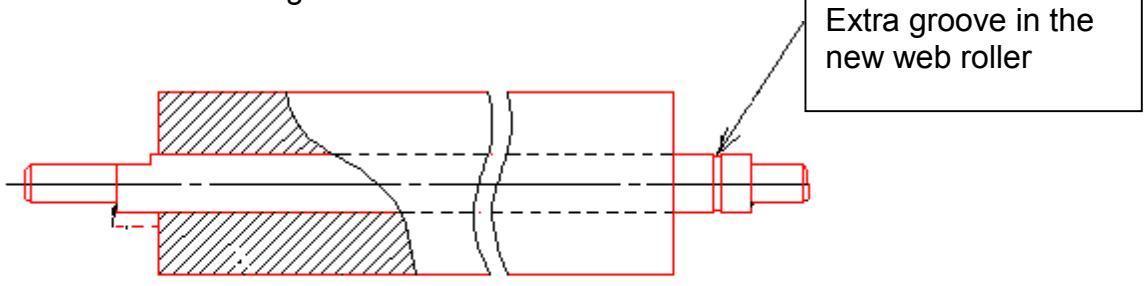
We have found that the diameter of some web cleaning rollers (AE040029) was slightly narrower in the central area, but the degree of variation was within specification (± 0.3 mm). Due to this decreased diameter, the fusing cleaning ability at the central area tends to decrease. This can cause some toner to remain on the hot roller, resulting in black lines, black dots in the background and/or offset images.

To distinguish the new roller from the old one, the shaft of the new roller has temporarily been marked black on the front face (refer to the illustration in the following procedure). Later, instead of using the black mark, an extra groove will be added to the rear shaft of the new web cleaning roller.

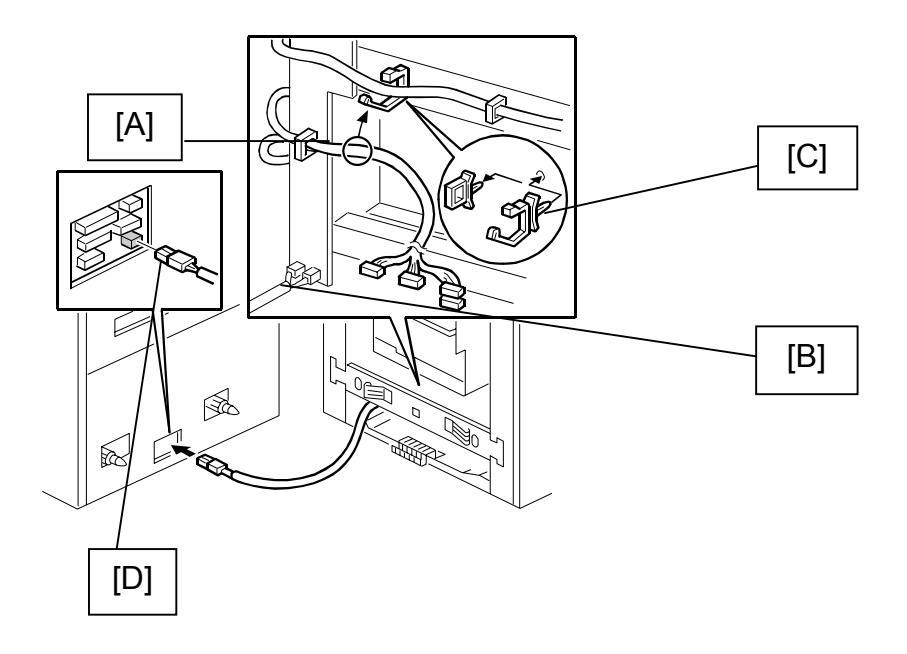
Note: In accordance with safety standards, the connecting cable [A] must not be touching the interface cable [B] when the optional LCT tray heaters are installed. Therefore, be sure to perform steps 7-10 so that the cables remain separated.

- 7. Replace the wire saddle with the new one ([C] P/N: 11050292), which is included in the optional tray heater kit.
- 8. Lead the connecting cable [A] as shown.
- 9. Connect the connector [D] of the interface cable to the mainframe interface.
- 10. Re-install all parts.

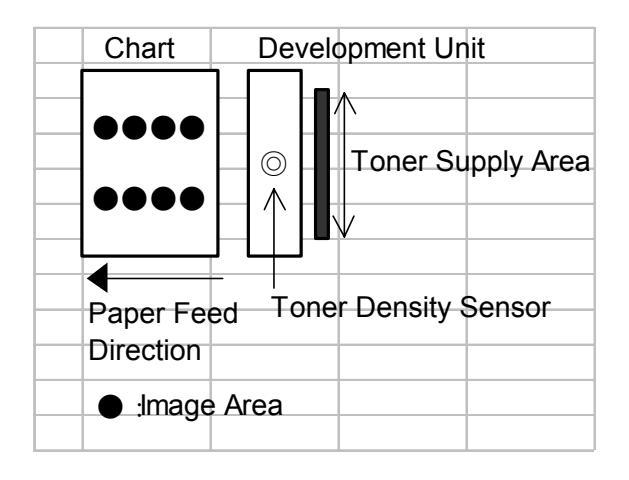
The toner density sensor, which controls the amount of toner supplied, is located in the middle of the development unit. However, there is no image in the center of the chart. The images are concentrated in the two areas between the center and left/right edges.

During continuous copying, the toner density is regulated by the output of the toner density sensor so that the target level is maintained. The amount of toner supplied to the development unit is then determined by the sensor's output and the chart's image ratio.

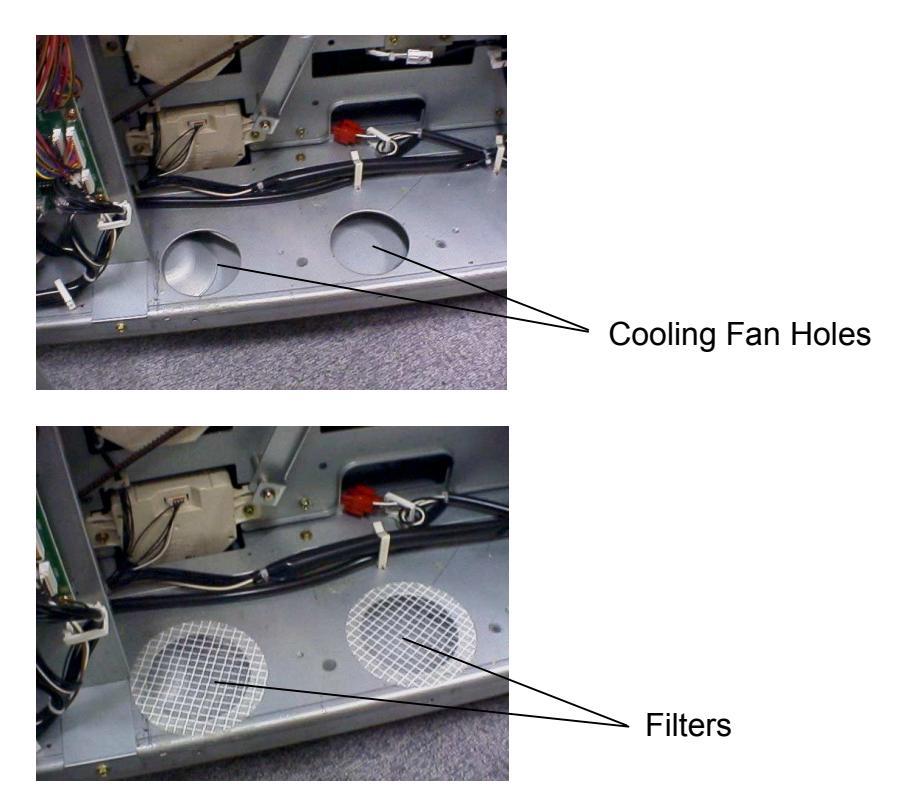
PSU broken: The high voltage line is shorted to the low voltage line by anti-static brush fibers drawn into the PSU by the cooling fan.

- 1. Turn off the main switch.
- 2. Pull the power plug out and wait for 5 minutes until the charge remaining in the PSU is discharged.
- 3. Remove the machine lower/rear cover (6 screws).
- 4. Remove the PSU (4 screws and connectors).
- 5. Install the filters as shown in the illustration.

Note: Clean out the dust and oil on the frame before installing the filters.

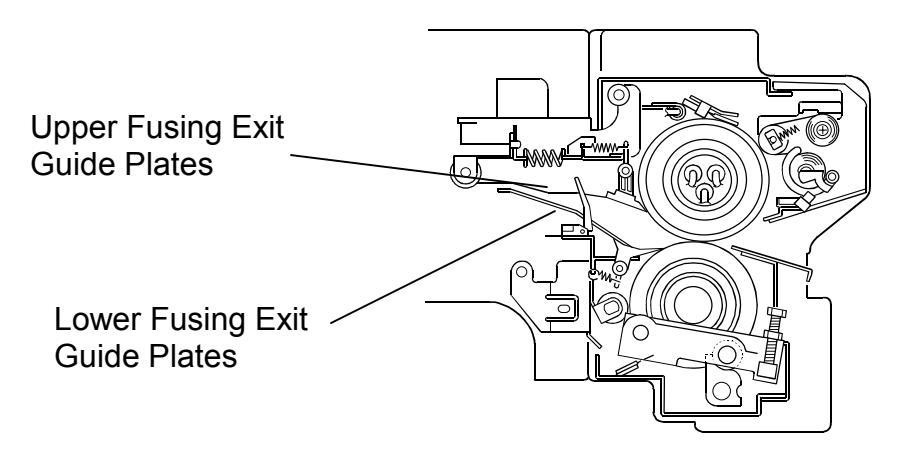
Note: If toner is not cleaned off this part, paper jam may occur.

3. Upper and Lower Fusing Exit Guide Plates

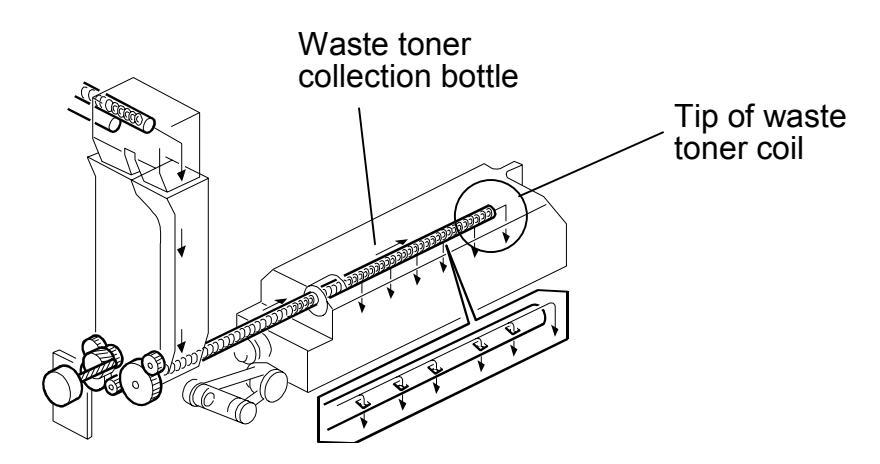
The waste toner full condition cannot be reset even after the waste toner collection bottle is replaced with a new one.

The tip of the waste toner coil located in the toner bottle is blocked with hardened toner. The hardened toner is not broken up even when the coil rotates after a new waste toner collection bottle has been installed.

CAUTION: Make sure that your face is not close to the coil when doing this, as some pieces of the hardened toner can chip off in random directions.

We strongly recommend replacing the waste toner collection bottle at PM or EM visits, before the bottle becomes full.

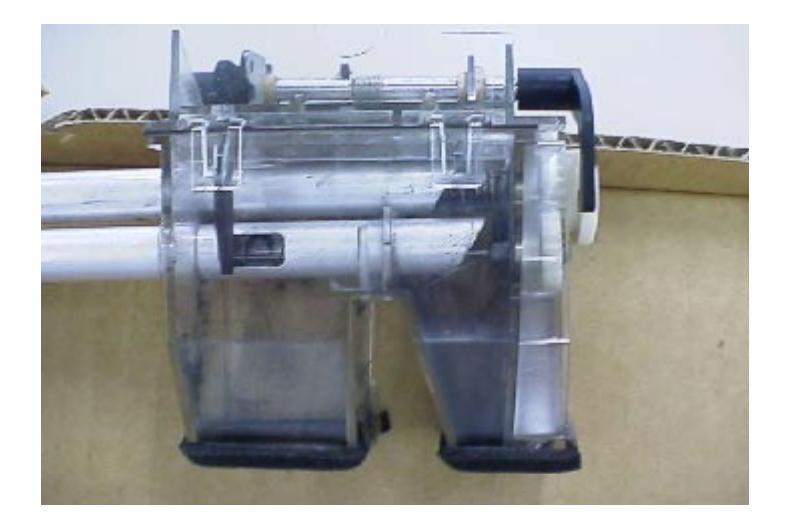
With 0% toner recycling, toner yield drops approximately 16% and the waste toner bottle becomes full at approximately 200k copies. At 60% recycling, toner yield drops approximately 5 to 6% and the waste toner bottle becomes full at approximately 400k copies.

It is also possible to select 0% toner recycling. To do this, set the pipe so that the square opening is facing the non-operation side as shown below. Since the tapping function is not necessary here, do not remove the tapping arm screw.

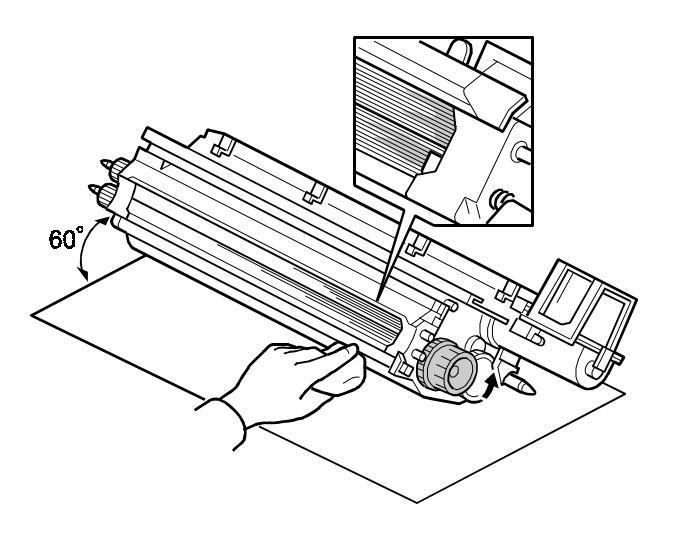
1. The development sleeves are contaminated with toner.

When toner is stuck on the development sleeve surface, the BG potential will be decreased by the same amount as the charge on the toner that is stuck on the sleeves. The development sleeve tends to be contaminated with toner when the toner concentration is increased or when lots of non/low image copies are made. Reference:

1. Clean the development sleeve.

The development sleeves should be cleaned every PM.

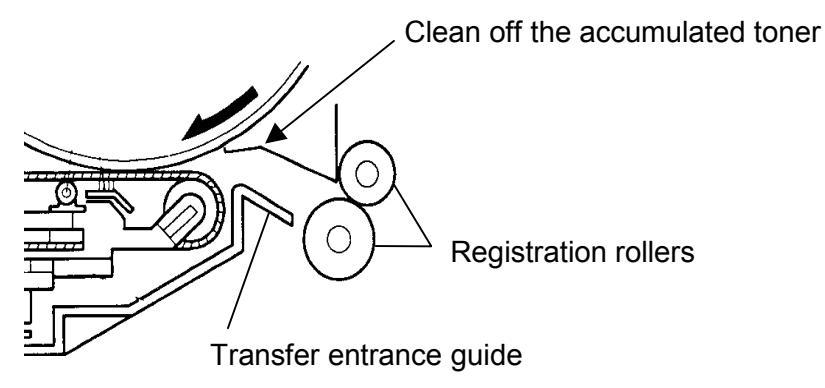
A. . Toner scattering.

Action: Clean off the toner that has accumulated on the drum stay located above the registration rollers/transfer entrance guide.

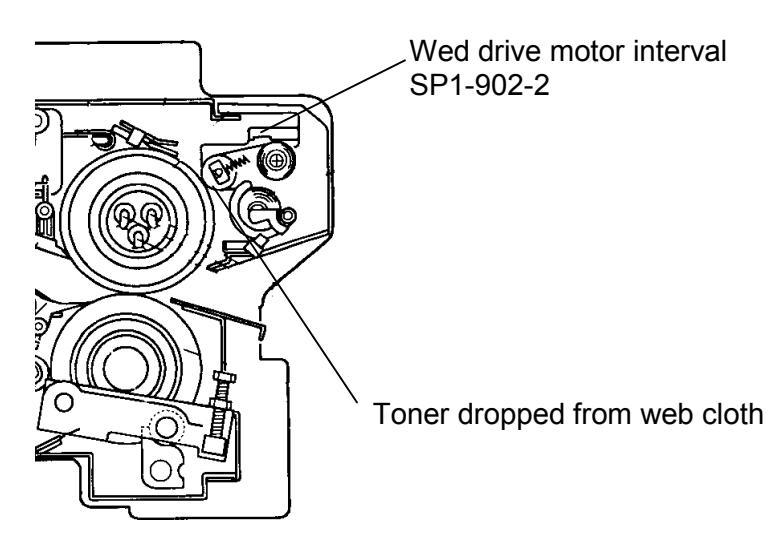
B. Toner drops from web cloth.

Action: Reduce the setting of the web motor drive interval (SP 1-902-2). However note that if the interval is reduced from 40 s to 20 s, the web cloth yield will reduce to the half of the target.

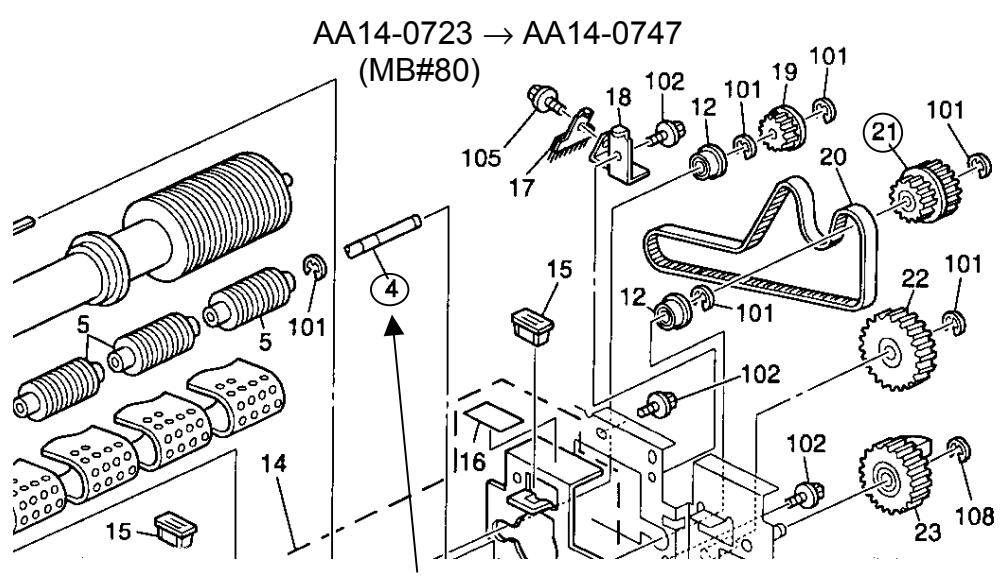
Cooling Roller Shaft

The cooling roller shaft is worn, which causes the roller drive gear to slip.

The symptom tends to occur at around 3000K copies (10PM cycle). Therefore we recommend that the older AA14-0723 shaft be replaced with A294-9451 (AA14-0747: This is the part number for the new cooling roller shaft of the massproduction units.) when the pressure roller is replaced at PM.

Replace the cooling roller shaft with the new shaft PN: A294-9451, which uses a stronger, wear-resistant material. Please refer to MB MA294080 for serial number cut-ins for this modification.

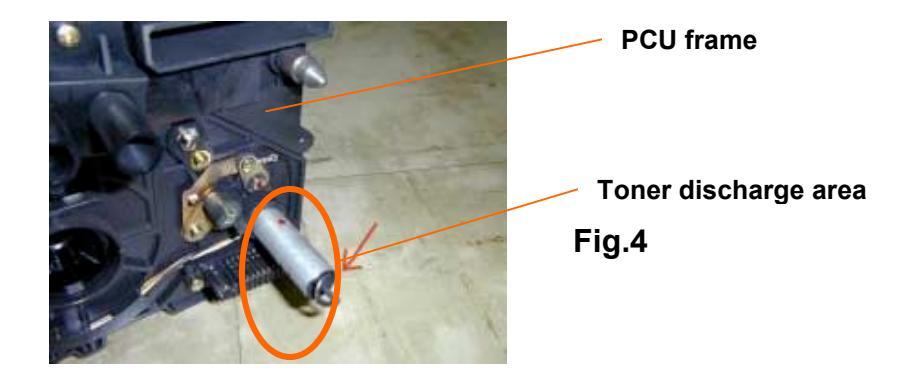
- Check for any deformation of the toner transport screw on PSU.
- Check for any toner blockages/clumping.

If either or both above items is YES, replace the PSU and throroughly clean the entire toner transport path.

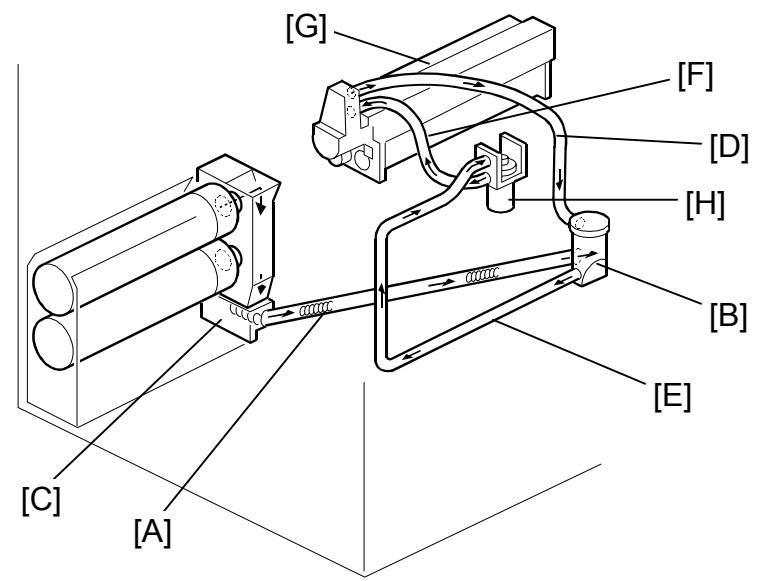
| Parts | Remarks | Possible Failure | Note |
|--|---|---|---|
| Toner Transport Coil [A] (A2943477) | Do not remove the toner transport tube [A] while the toner supply cylinder [B] is in. | The toner transport coil [A] may be damaged. | Remove the toner supply cylinder [B] first. |

1. When the upgrade kit is installed or when the toner transport path is maintained.

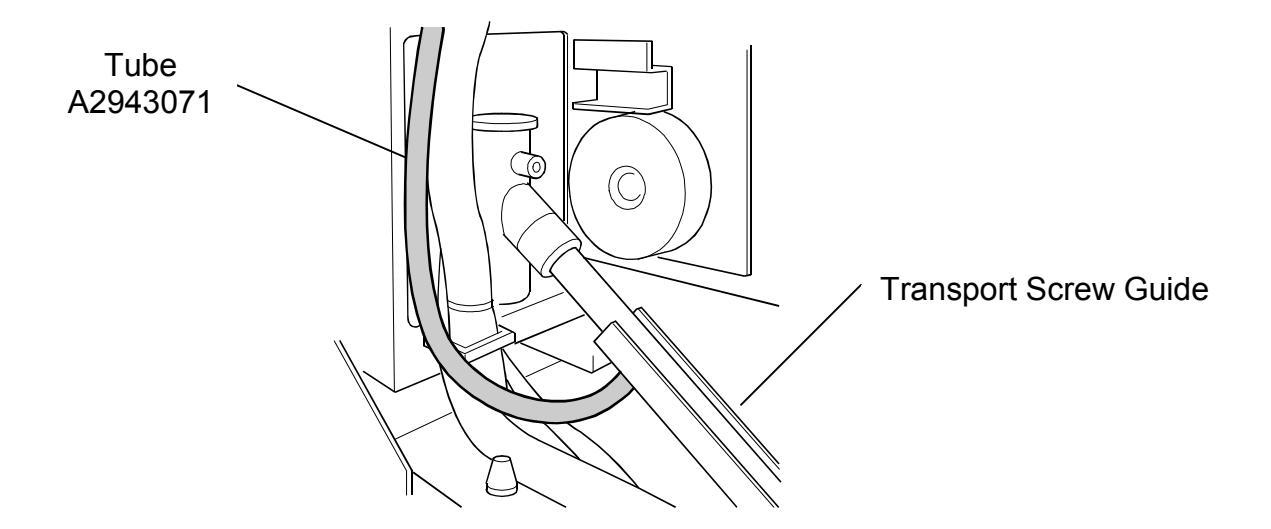
- Between the Toner Hopper and the transport joint
- 1) Remove Tube 6x9x740 (A2943070) that currently runs between the Toner Hopper and the upper joint of the transport joint.
- 2) Clean the inside of Tube A2943071 (removed in the previous procedure).
- 3) Re-install Tube A2943071 so that it runs between the Toner Hopper and the **lower joint** of the transport joint.

Note: Lead the Tube under the Transport Coil Guide as shown below.

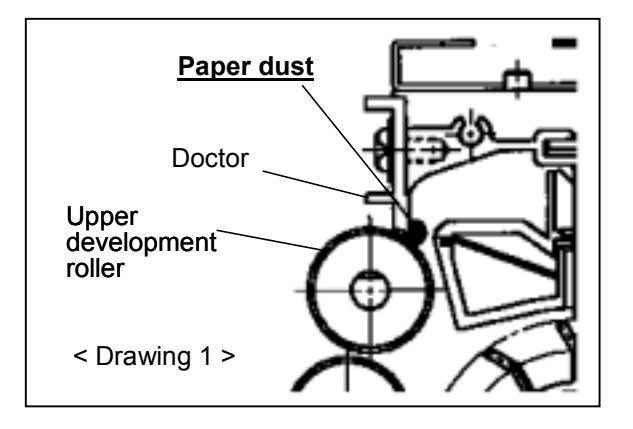
Paper dust gathers at the front and rear sides of the doctor blade gap in the development unit, causing the gap to become narrower which decreases the airflow from the lower development casing.

SOLUTION

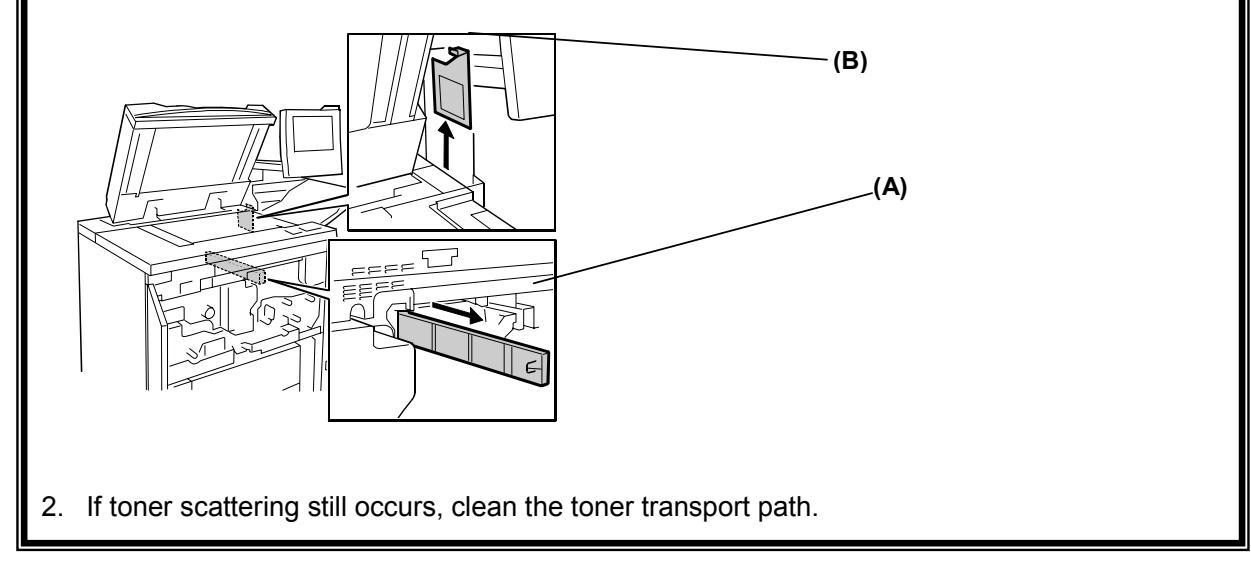
The above cleaning/replacements are also effective in maintaining proper machine internal temperature, which is key in minimizing scattering since slight rises in temperature can cause scattering to occur more easily.

- **IMPORTANT:** Check the following items before performing the solution below.
- 1. Check the toner filter [A] and drum filter [B], and clean or replace them as necessary.
- **Note:** The toner filter should be replaced every 300k (Bellini-C1) or 350k (Bellini-C2).

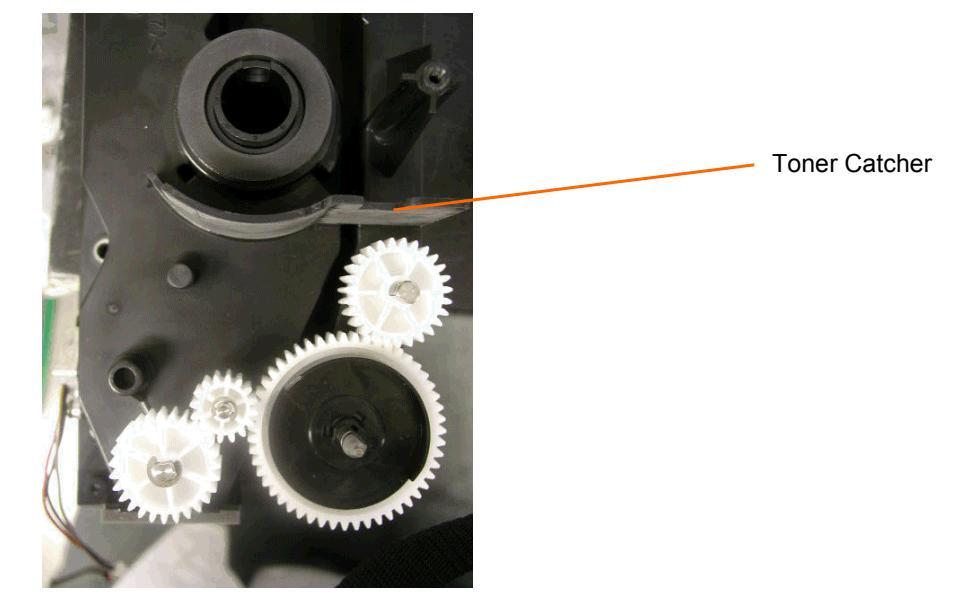
Toner may scatter to the outer portion of the toner bank unit when the toner bottle chuck opens the bottle. The split toner covers the detection area of the toner overflow sensor, causing it to mis-detect the waste toner bottle full condition.

1. A toner catcher has been added to the toner bank case as shown below.

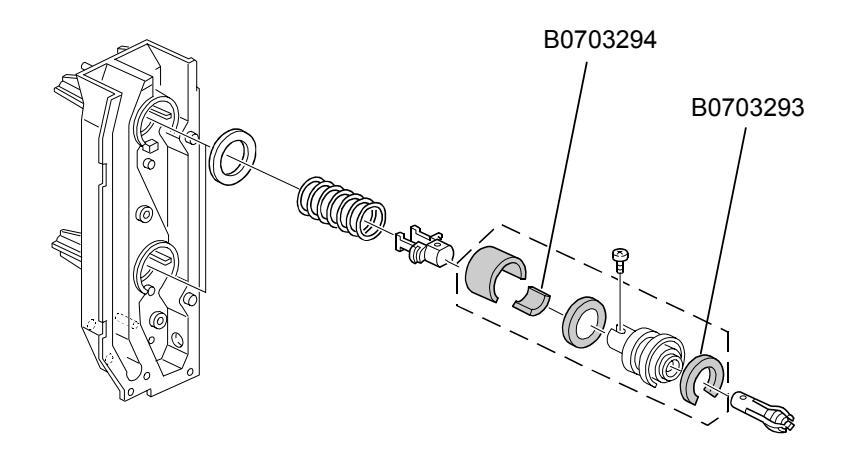
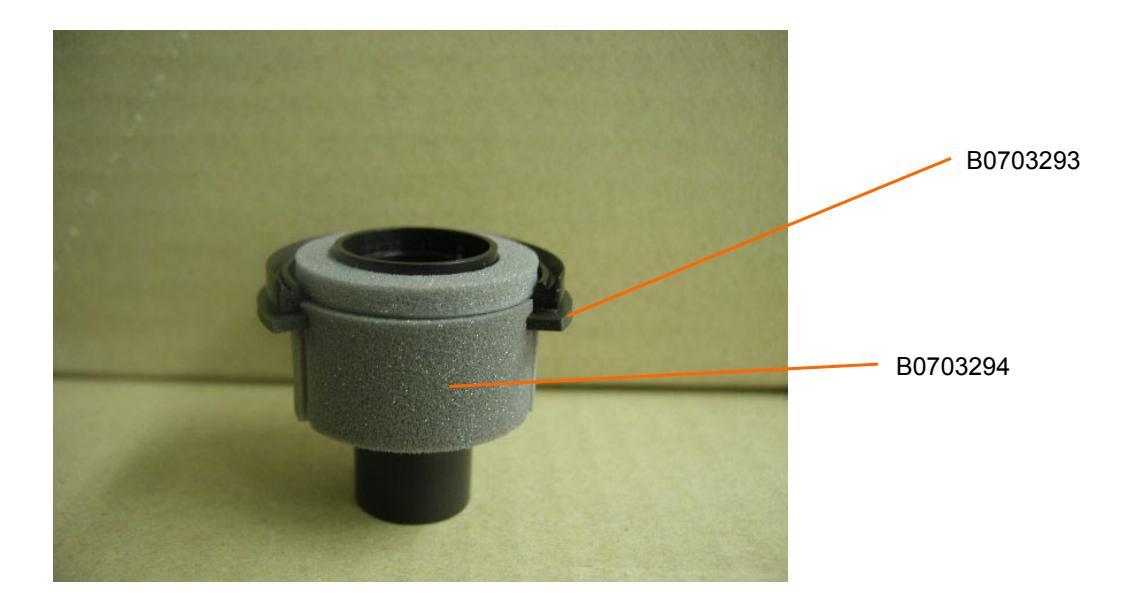
When toner is supplied to the toner bank unit, it may leak out from the bottle and gradually accumulate in the chuck area, eventually preventing the bottle-holding mechanism on the chuck from releasing the bottle.

Two kinds of the shields have been added to ensure toner does not leak out from the toner bottle.

- P/N: B0703293 (Shield Slider), B0703294 (Shield Slider Short)
- Attachment position:

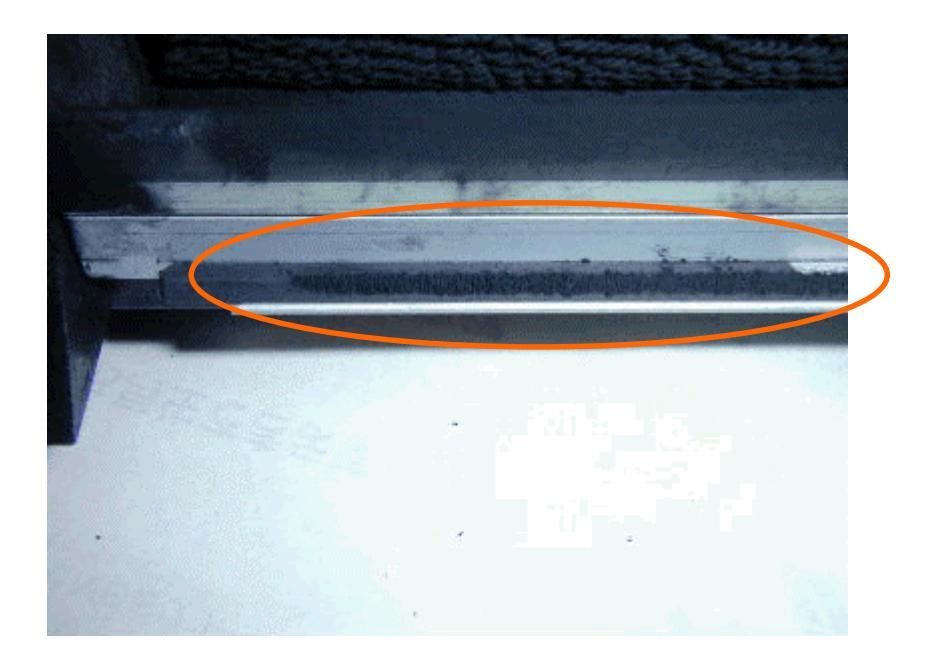
Carrier builds up on the drum unit carrier catcher as shown below, and then falls onto the transfer belt causing dirty paper stack edges (Bellini-C1c/d).

When this error occurs, the charge on the drum surface increases, which can cause too much carrier to stick to the catcher.

A. Check whether or not the quenching lamp remains on (normal) during machine operation, and replace the lamp if it flickers or remains off.

- **B.** Check to see that the Bellini-C1c/d development unit is installed and replace if necessary.
- C. Check the value of SP3902-1.
 - If the value is 0, the last auto process control was unsuccessful, therefore please check the drum potential sensor for dirtying, defects or poor connection and replace if necessary.
 - If the value is 1, auto process control was successful (SP3902-2 will be within 800+/-20v), which indicates a quenching lamp failure. Therefore please check the lamp operation as described in Check Point A above.
