Model: Azalea	Date: 28	-Feb-97	No: 002	1/5		
Subject: ROM Modification for Scanner / Printer Function			Prepared by: N. Kaiya			
From: QAC 1st Field Information Dept.			Checke	d by: T. Inoue	nove	
Classification:	 □ Troubleshooting □ Mechanical □ Paper path □ Other () 	 Part information Electrical Transmit/re 	ation ceive	 Action required Service manual revi Retrofit information 	sion

Model: Azalea			Dat	e: 15-Mar-97	No: 3
Subject: Paper Creasing in Duplex Mode				Prepared by: N. Kaiya	
From: QAC 1st Field Information Dept.				Checked by: T. Inoue	
Classification:	☑ Troubleshooting	Part information Action required		n required	
	🗌 Mechanical	Electrical		🛛 Servi	ce manual revision
	Paper path	Transmit/receive		ceive 🗌 Retro	fit information
	☐ Other())

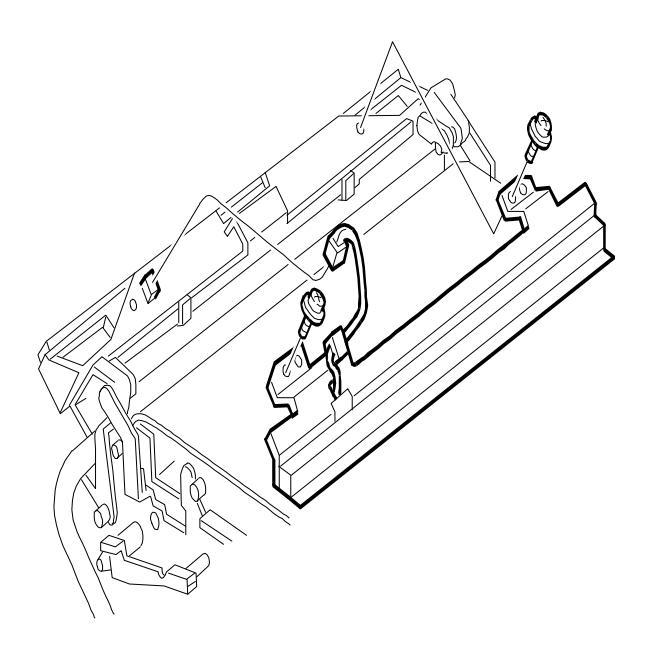
The LED array for the printer option has been installed in the copieduring production. It is no longer necessary to replace the LED array when installing the printer option n the Azalea.

Part Number : A1666161 → A6246161
