Model: Cattleya		Date: 15-Jun-99	No.: RA257001
Subject: Silicone Oil for the Fusing Unit		Prepared by: H. Matsui	
From: Technical Service Dept., GTS Division			
Classification:	<input type="checkbox"/> Troubleshooting <input type="checkbox"/> Mechanical <input type="checkbox"/> Paper path <input type="checkbox"/> Other (      )	<input type="checkbox"/> Part information <input type="checkbox"/> Electrical <input type="checkbox"/> Transmit/receive	<input type="checkbox"/> Action required <input checked="" type="checkbox"/> Service manual revision <input type="checkbox"/> Retrofit information

Model: Cattleya		Date: 31-Aug-99	No.: RA257004
Subject: Drum damage at installation		Prepared by: H. Matsui	
From: Technical Service Dept., GTS Division			
Classification:	<input type="checkbox"/> Troubleshooting <input checked="" type="checkbox"/> Mechanical <input type="checkbox"/> Paper path <input type="checkbox"/> Other (      )	<input type="checkbox"/> Part information <input type="checkbox"/> Electrical <input type="checkbox"/> Transmit/receive	<input type="checkbox"/> Action required <input type="checkbox"/> Service manual revision <input type="checkbox"/> Retrofit information

Model: Ca

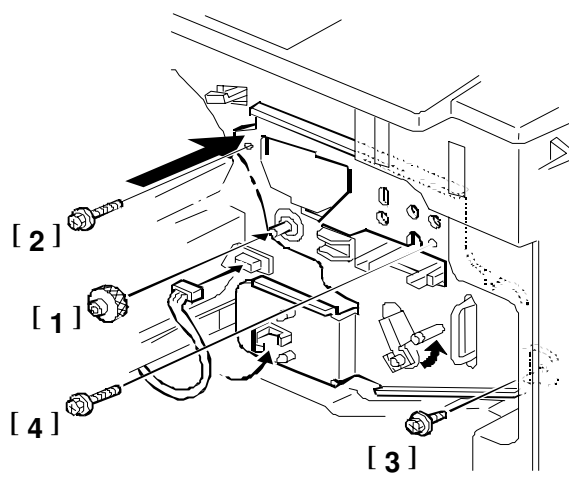
When the knob of the transfer faceplate is loose, SC457 is displayed.

Due to a mistake when setting the transfer faceplate, the drum knob loosens and the setting position of the image transfer belt cleaning unit shifts.

1. Remove the transfer faceplate.
2. Reinstall the transfer faceplate and tighten the knob [1].
3. Pushing the upper left part of the faceplate against the revolver/drum drawer, tighten the three screws in the following order: [2], [3], [4].
4. Re-tighten the knob.

**Note:** Re-tighten this knob with the transfer belt tension lever as is (until the drum rotates along with the knob).

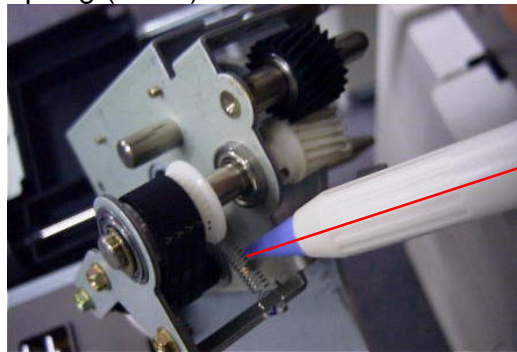
Tension Spring

It has been found that the tension spring for the timing belt does not have enough strength to prevent this random jitter.

5. Remove the tension spring (silver) and install a new one (black).

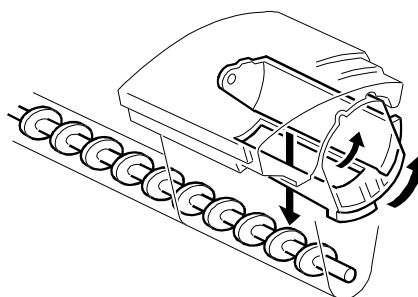
If the toner cartridge (which is not empty) is removed from the toner cartridge replacement position, the cartridge lever may not turn smoothly when reinstalling the toner cartridge. If the cartridge lever is not completely turned to its lock position, toner may scatter from the toner hopper.

Press the lock pin and turn the shutter completely.  
Clean the sponge seal around the opening of the cartridge as well.

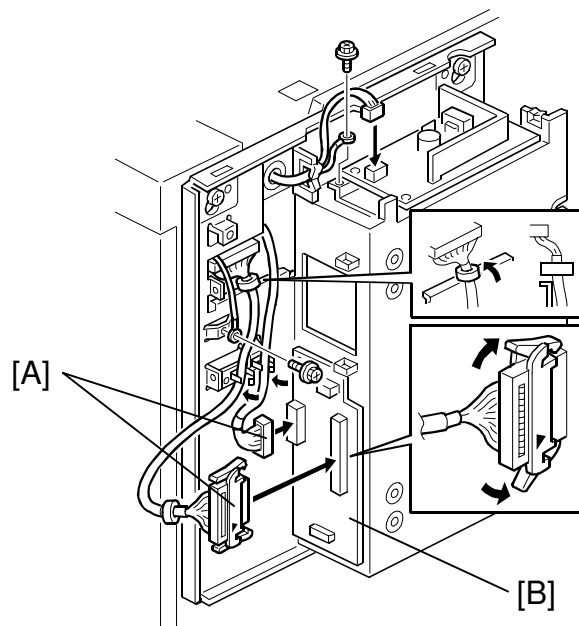
## - BUSSW Board Replacement Procedure -

Normally, the input pins (#12 to 17) of IC18 on the BUSSW board are not used for the function of the IC18. However, due to an error in the software programmed in IC18, these pins were allocated as output pins. The resulting increase in power consumption causes the IC to heat up and malfunction.

1. Turn off the main switch and unplug the power cord.
2. Disconnect the cable(s) from the controller.
3. Remove the exterior cover of the I/F unit (4 screws).
4. Remove all the shield covers.
5. Remove the controller from the I/F unit.
6. Disconnect the connectors [A]
7. Replace the BUSSW board [B] (4 screws, 1 grounding screw).

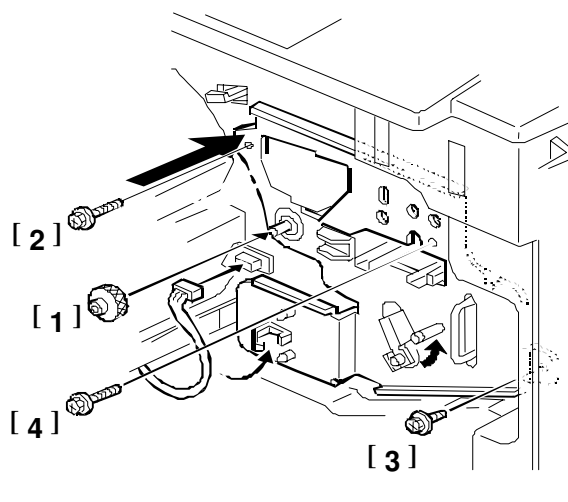
Under these conditions, a toner band may form around the development sleeve due to heat caused by the heavier load on the developer. This is likely to occur in development units which have a relatively wide doctor gap (but still within specification) among the four development units (YMCK).

1. Install the transfer faceplate and tighten the knob [1].
2. Pushing the upper left part of the faceplate against the revolver/drum drawer, tighten the three screws in the following order: [2], [3], [4].
3. Re-tighten the knob.

**Note:** Re-tighten this knob with the transfer belt tension lever as is (until the drum rotates along with the knob).

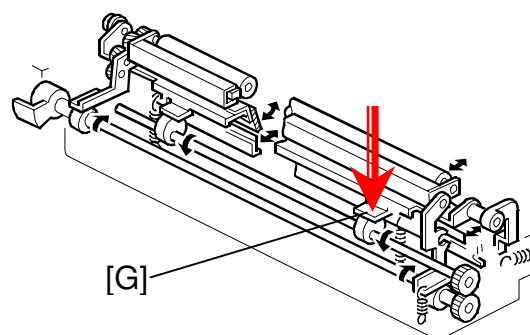
The screw [C] securing the entrance seal release lever [D] came loose and the entrance seal [E] contacted the image transfer belt [F] during the copy process. This caused the vertical lines in blank areas and the smeared images below the lower edges of solid image areas.

2. After loosening the screw [C] of the entrance seal release lever [D], re-secure the lever so that the gap between the edges of the entrance seal [E] and the cleaning blade [F] is **1.5 – 2.5 mm**. This can be done by turning the lever [D].

3. Check the gap. If it is incorrect, finely adjust by turning the lever while pressing down the front tab [G] of the cleaning blade bracket, and firmly tighten the screw while maintaining pressure on the tab.

4. After securing the screw, turn the gear [A] clockwise 1 revolution and confirm that the gap is within the adjustment range.

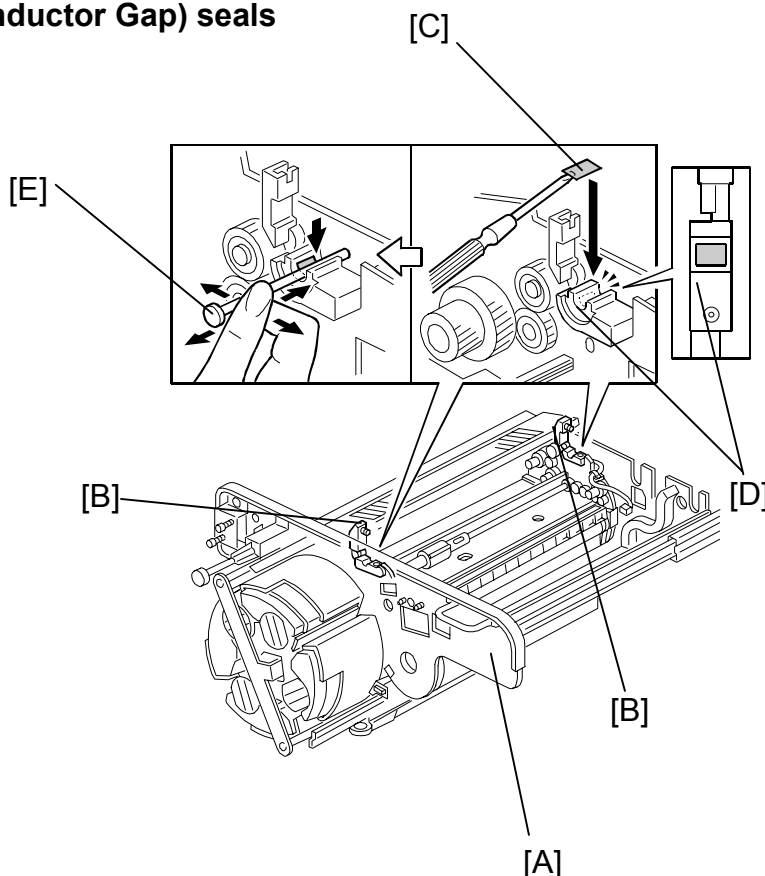
### (1) Attaching the PG (Photoconductor Gap) seals

1. **Be sure to attach the seals in the center of the Development Unit Supporter as shown.**
2. **Do not attach more than one seal to each supporter. If two or more seals are attached, the PG will be too narrow. This will cause compressed toner bands on the development roller and OPC drum, leading to drum damage.**
3. **Using one of the front door hinge pins [E], smooth out the seal so that there are no air bubbles.**
4. ***P/No.A2573224: " PG Seal " contains 1 PG seal.***

1. Pull out the revolver/drum drawer [A] and open the development unit lock [B] at both ends of the revolver
2. Remove the old development unit.
3. Clean the surface of the development unit supporter [D] with a blower brush. Use alcohol if necessary.
4. Using a small screwdriver, attach **one** PG seal (P/N A2573224), to each of the **two** Development Unit Supporters [D]. As shown in the illustration, the supporters are located at both ends of the revolver unit.

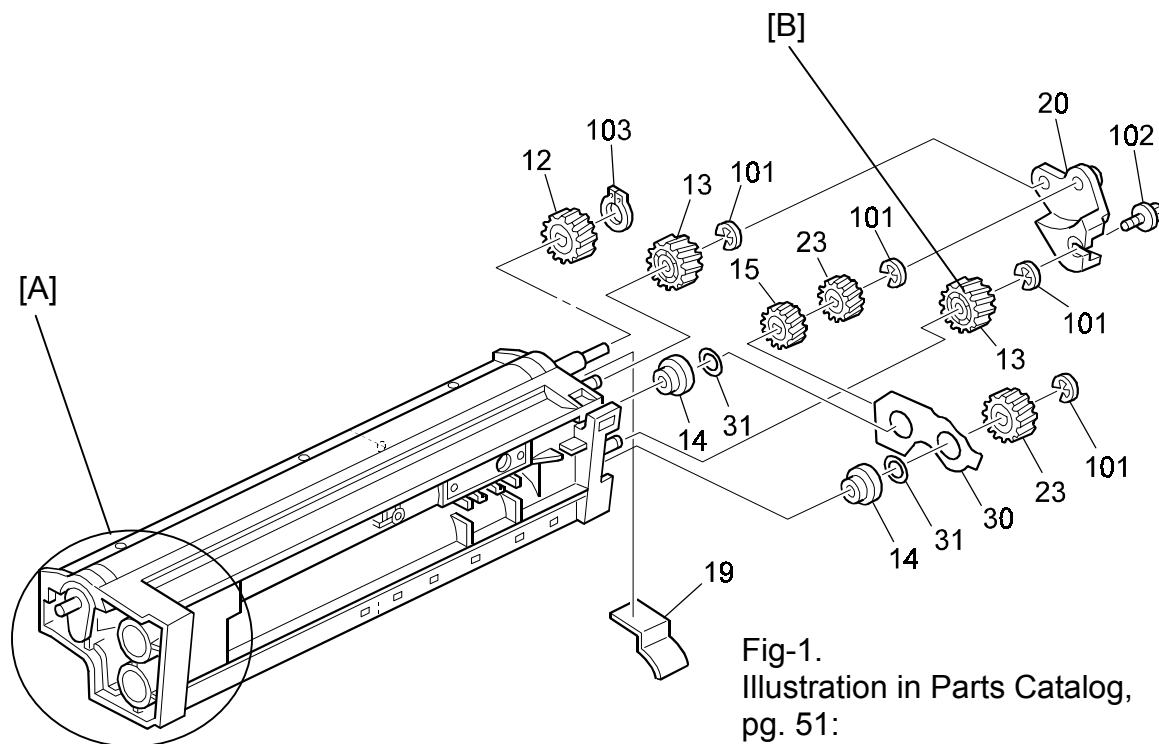
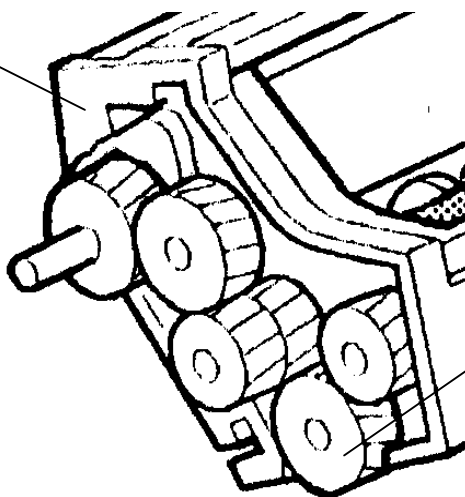
Development Unit

1. The material of the development idle gear has been changed from plastic to metal.  
A2573155 (plastic) → A2573158 (metal)
2. A strip of Mylar (A2573079: call-out #30, fig.1) has been added between the bearings and the development gears to protect the gears from development carrier.

Old: A2573155  
(plastic).

1. It is recommended to replace the "Gear – 26/48Z" (A2573219) at the same time. This is because if the development idle gear (A2573155) is prematurely worn out, the coupled gear (A2573219) may also be damaged.
2. For the machines in the field, it is not necessary to add the Mylar (A2573079).  
Replacement of the development idle gear (A2573155) is sufficient to ensure that the symptom will not occur.

2. Replace the development idle gear [B] (A2573155) with the new type (A2573158).

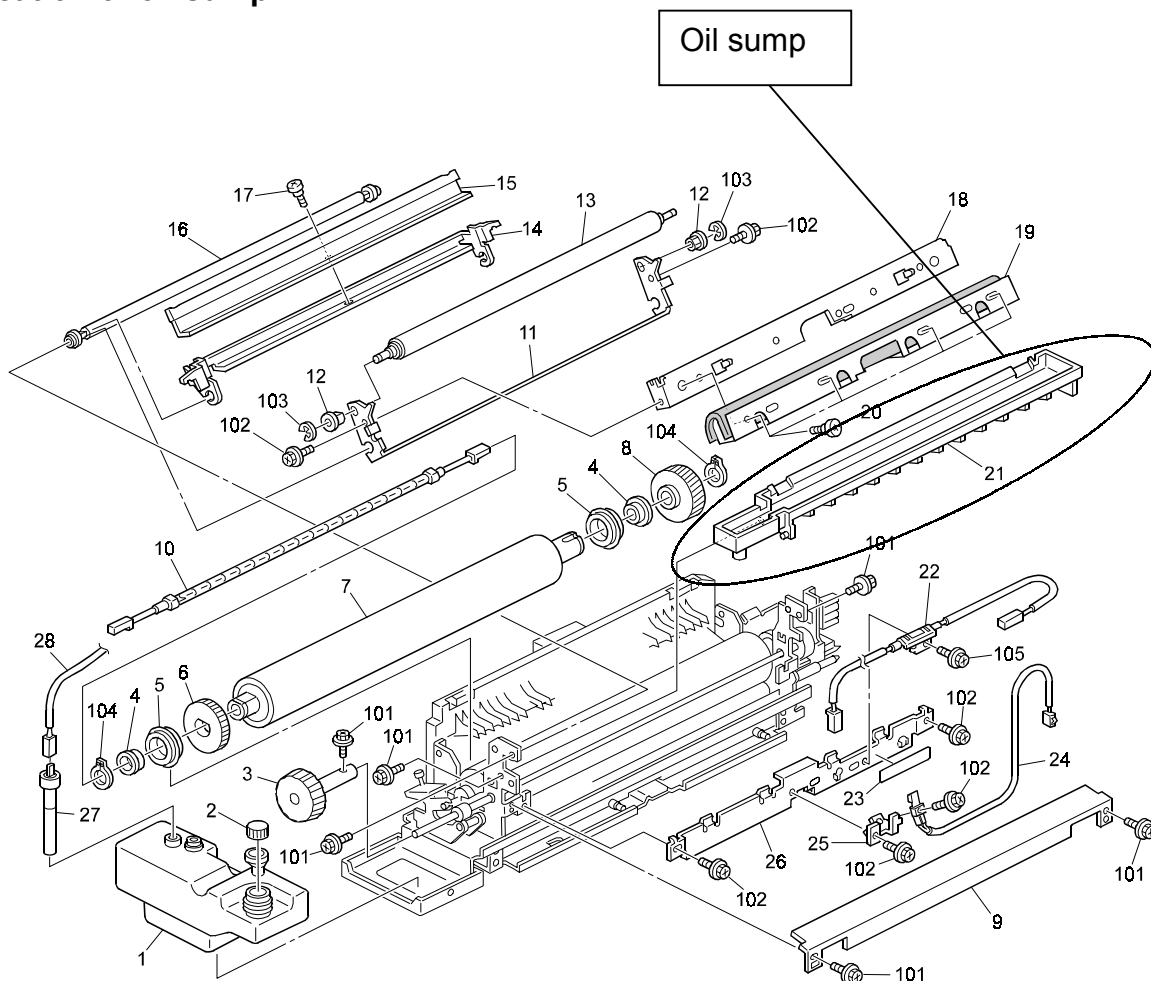
## Location of oil sump

Fusing oil leaks from a crack in the middle of the fusing entrance guide (A2574135). The crack occurs at the molding line, possibly due to the repetitive heating and cooling of the entrance guide. The molding line is formed at the middle of the entrance guide, where the two flows of plastic meet inside the plastic mold.

If you receive any customer complaints about oil streaks on copies, check the bottom surface of the fusing entrance guide for an oil leak. If any oil is found, replace the entrance guide with a new type.

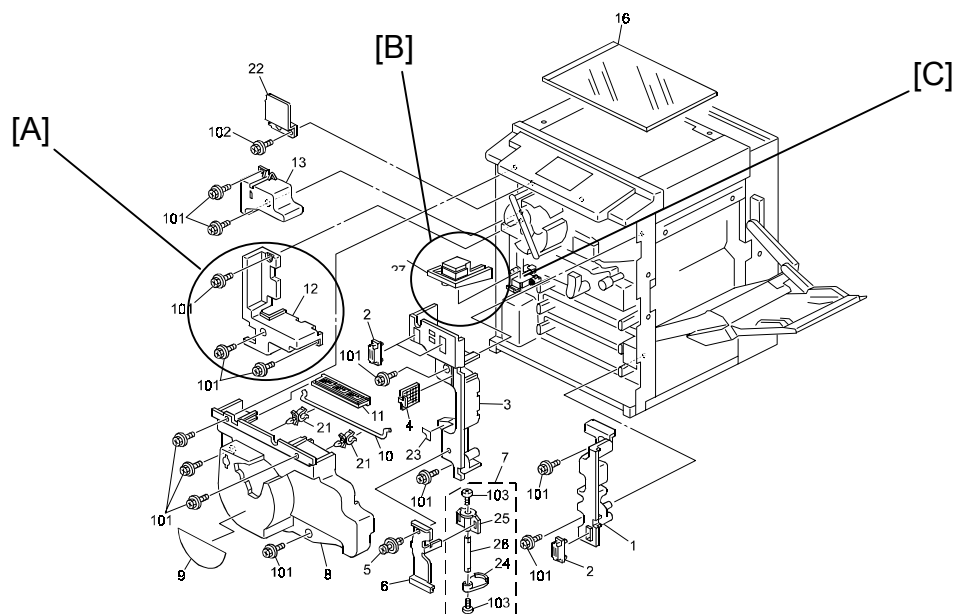
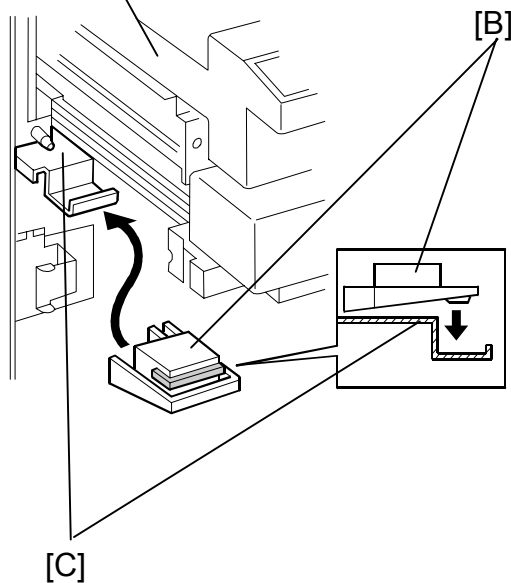
Fusing unit

If fusing oil should leak from the fusing unit, it may run down the harness and drip onto the main switch. If this happens, the resulting electrical sparks may cause some chemical compounds to form on the terminals ( $\text{SiO}_2$  or carbon compounds). These compounds increase the resistance of the main switch terminals, generating heat in these areas. In the worst case, this may cause the terminals to partially melt.

1. It is recommended to install the main switch cover on all existing units.
2. To prevent oil spillage, whenever transporting the machine following installation, always be sure to drain the fusing oil completely before moving the machine.

1. Remove the inner cover [A].
2. Attach the main switch cover (A2571295) [B] above the safety switch cover [C].

NOTE: No screws are required. Simply lay it on top of the safety switch cover [C].

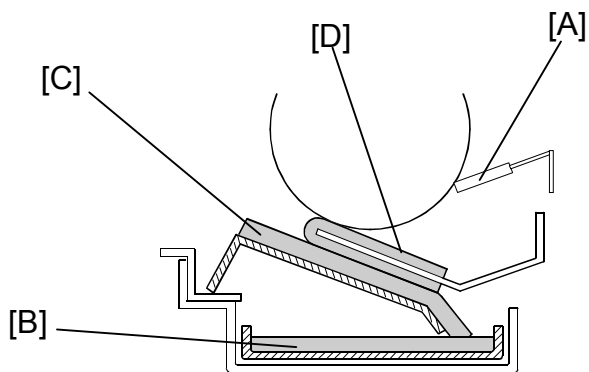
After the fusing oil is scraped off by the pressure roller blade [A], it is returned to the pressure roller via the pressure roller oil supply pad [D]. However, the actual amount of fusing oil collected varies, depending on conditions such as paper size and the number of copies per original. In some cases, the amount of oil removed from the pressure roller exceeds the amount returned to the roller.

An oil pan felt [B] has been added to absorb the accumulated oil in the oil pan. Another oil pan felt [C] has also been added to return the oil in the oil pan to the pressure roller, via the existing pressure roller oil supply pad [D].

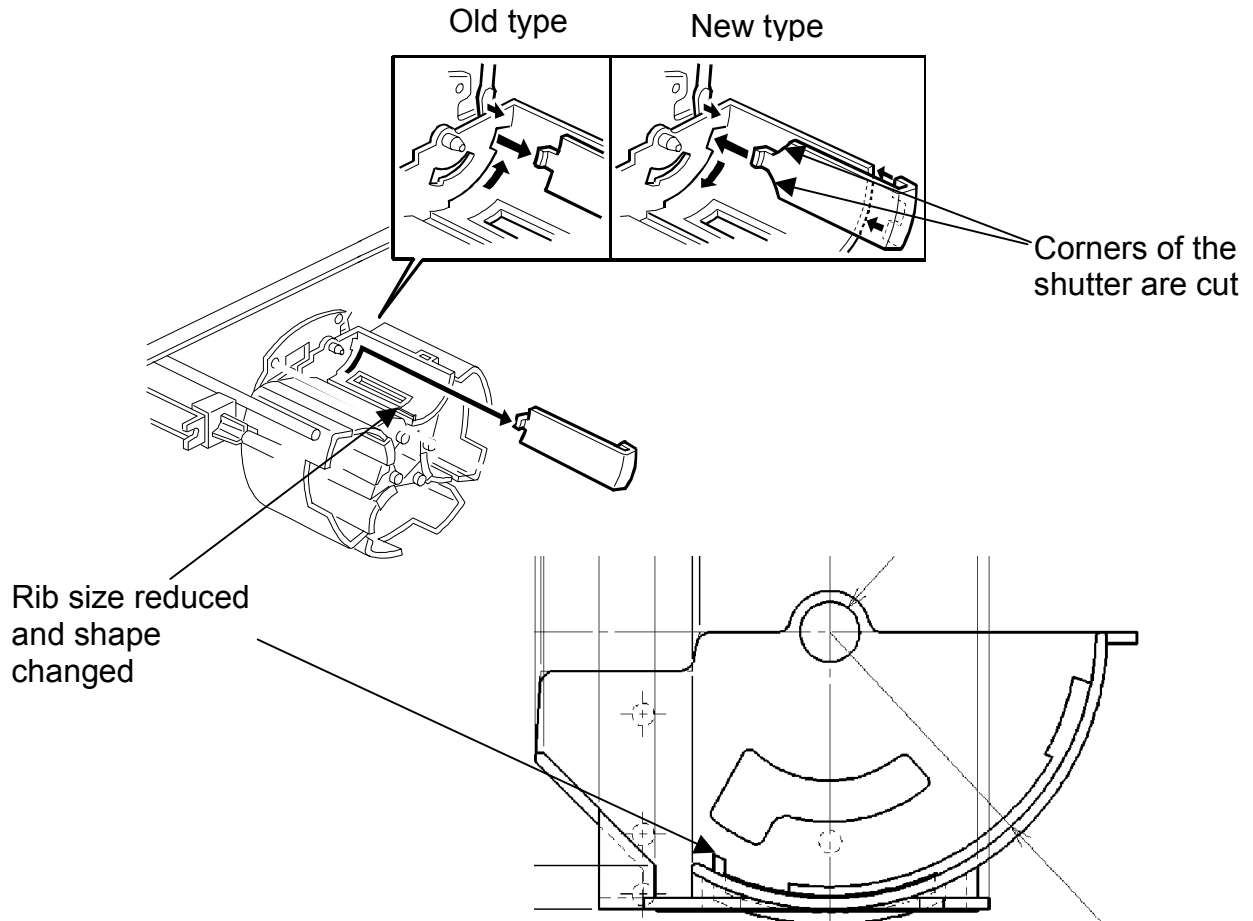
2. The shapes of the toner hopper shutter and toner hopper ribs have been modified. Before the modification, excessive torque was applied to the shutter during cartridge lever rotation, causing the edge of the shutter to catch on the toner hopper ribs. After the modification, the shutter does not catch on the toner hopper ribs.

Shutter for K: A2573340 (old) → A2573370 (new)

Shutter for Y: A2573341 (old) → A2573371 (new)

1. Replace the toner hopper shutter with the new type. In almost all cases, this will fix the problem.
2. If this replacement does not improve copy quality to the customer's satisfaction, replace the entire toner hopper assembly.

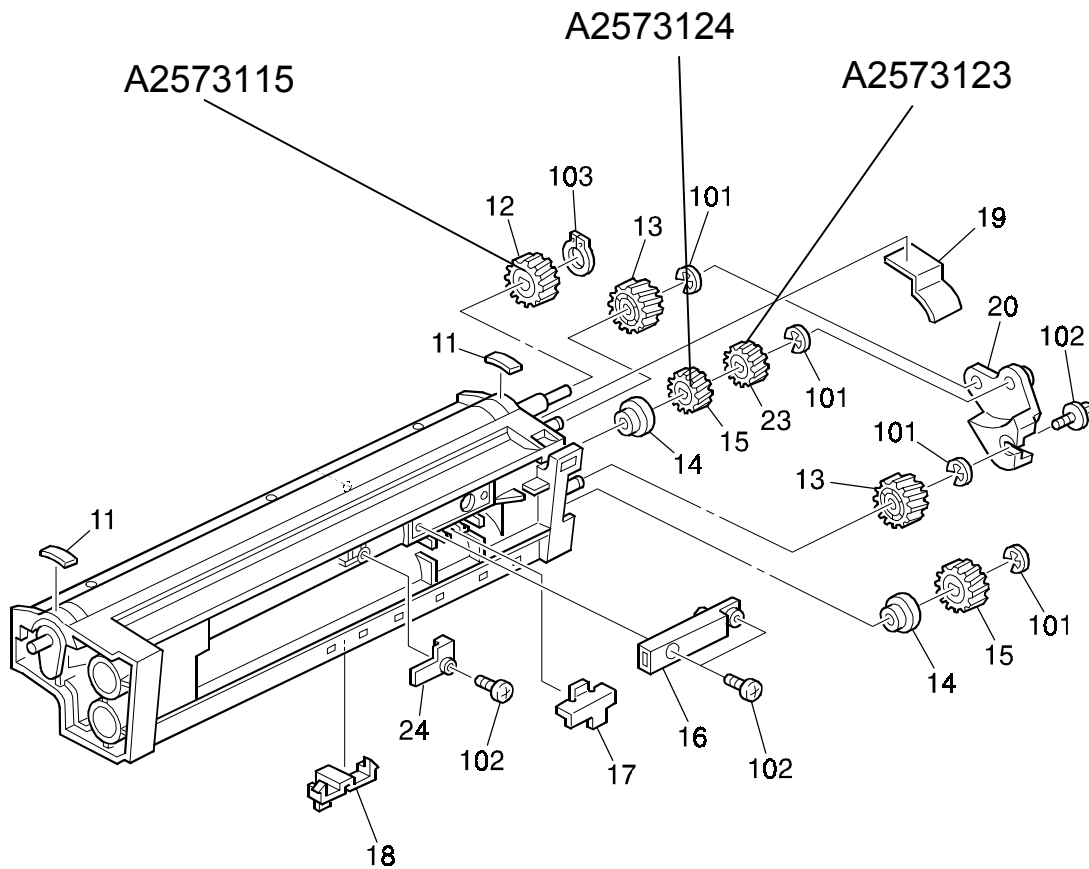
If more than 1 color toner is used, it causes uneven hue bands. For example, when printing a solid blue (cyan + magenta) image, bands with relatively dark magenta tend to appear. In addition, on printouts the bands appear in different phases for each toner color.

A2573157 (old) → A2573124 (new): Gear 21Z

A2573114 (old) → A2573123 (new): Gear

Please install the new gears mentioned above if a customer should voice dissatisfaction with the copy quality (if related to hue banding). As these cases will depend mainly on the customer's own requirements and the dimension precision of the gears already installed, it is possible that some customers will not be satisfied even after parts replacement.

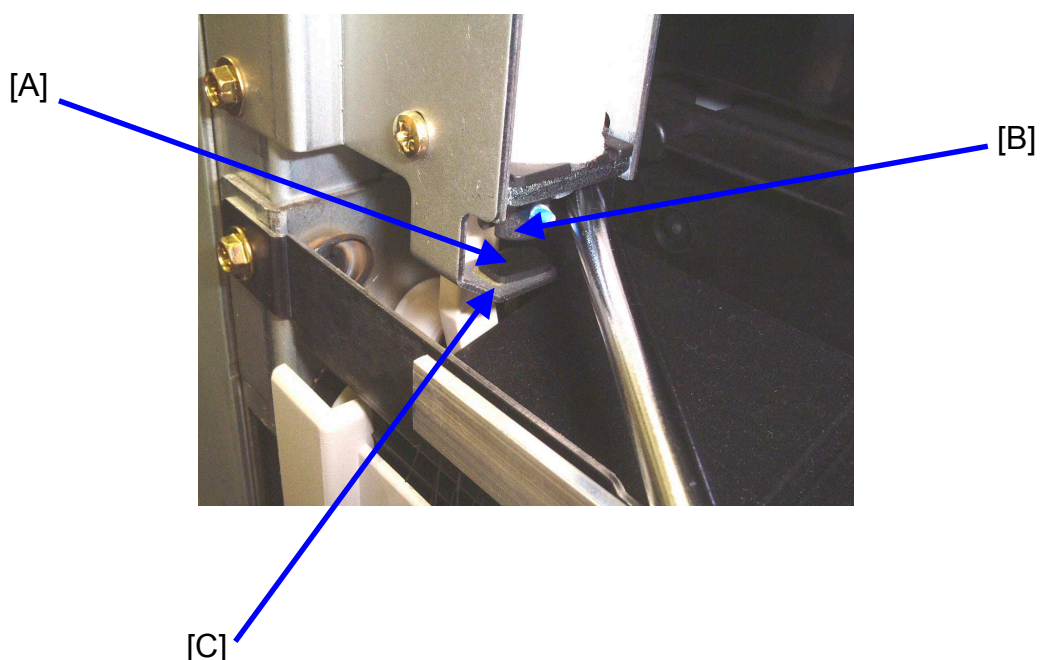
The shock-absorbent rubber plate [A] peels off the bracket (see the attached picture). After the plate comes off, the core of the solenoid [B] sticks to the solenoid bracket [C] (B0234463) because of magnetic attraction. Under this condition, the junction gate does not function correctly even though the solenoid is turned on.

Replace the solenoid bracket (B0234463), which includes the shock-absorbent rubber plate.

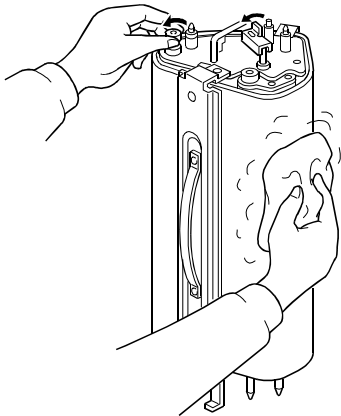
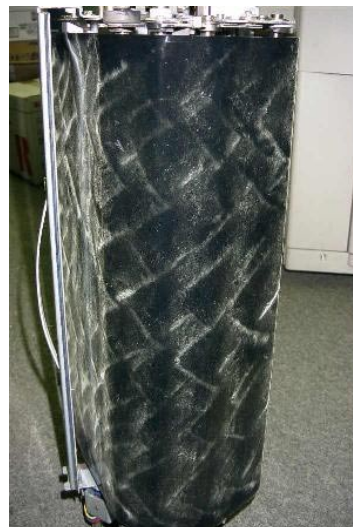
Following ITB replacement, the rubber positioning seals around the inside edge of the belt peel off at about 1-2 kD, causing SC326 or SC452.

1. Please be sure to apply ***a sufficient amount*** of setting powder to the entire surface of the belt at replacement. As a reference, the picture below shows the belt after a sufficient amount has been applied.

2. ***In addition to the above, replace the Brush Roller Ground Plate with the new type mentioned in MB #MA257119.***
