Model: Met-MF3		Date: 25-Jan-19	No.: RD0BL001
Subject: Announcement for Customer Engineer Tool		Prepared by: Y. Taniguchi	
From: Technical Support Sect., Service Strategy Dept.			
Classification:	<input type="checkbox"/> Troubleshooting <input type="checkbox"/> Mechanical <input type="checkbox"/> Paper path <input type="checkbox"/> Product Safety	<input type="checkbox"/> Part information <input type="checkbox"/> Electrical <input type="checkbox"/> Transmit/receive Other ()	Action required Service manual revision Retrofit information Tier 2 Tier 0.5

An SOP application which can support the maintenance operations is released.

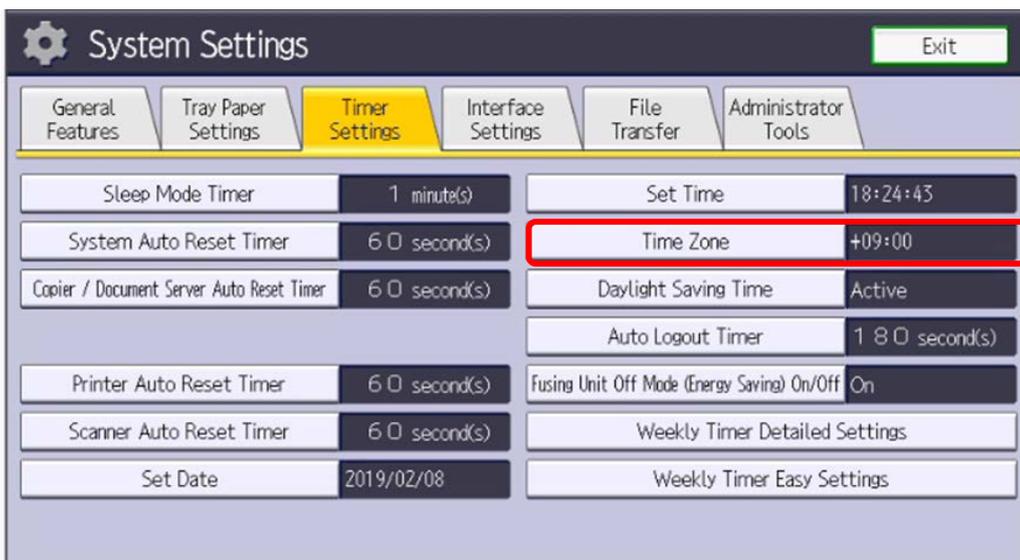
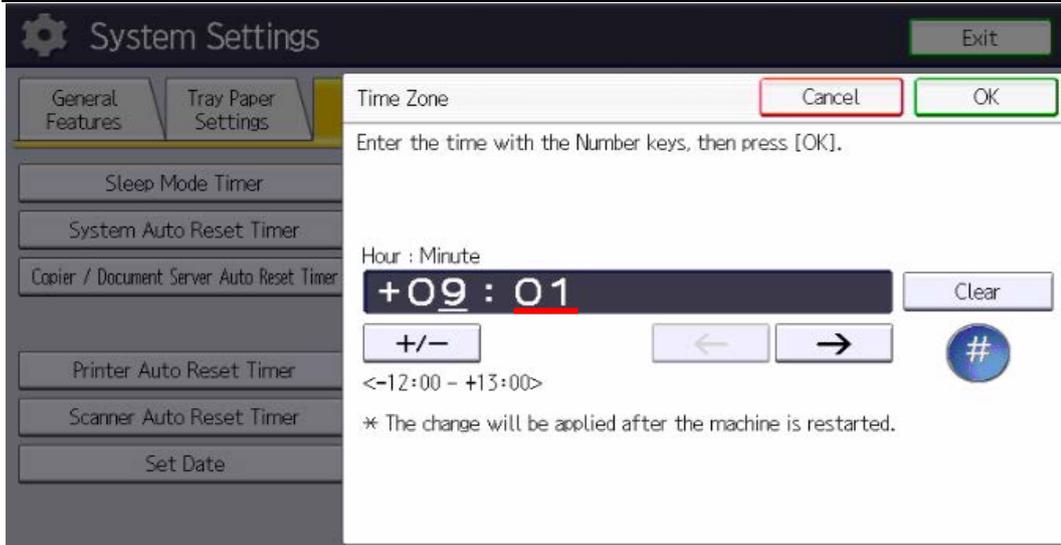
Cannot log into the MET-MF3 with Kerberos Authentication when the machine switches to Daylight Savings (Summer) time when the following conditions are met.

1. Increase the Time Zone setting by **one minute**.

Settings > Machine Feature Settings > System Settings > Timer Settings > Time Zone

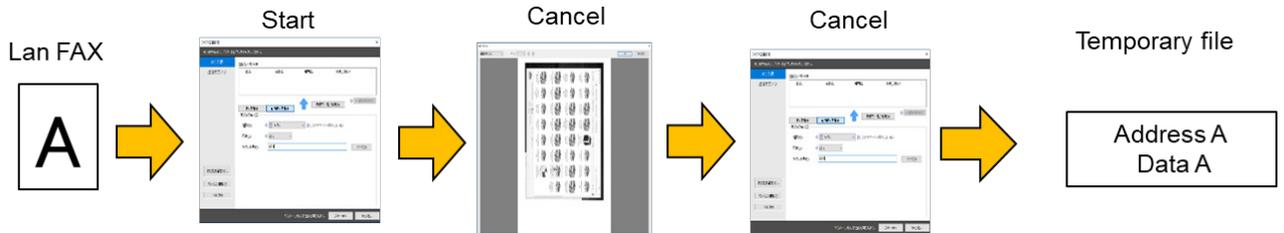
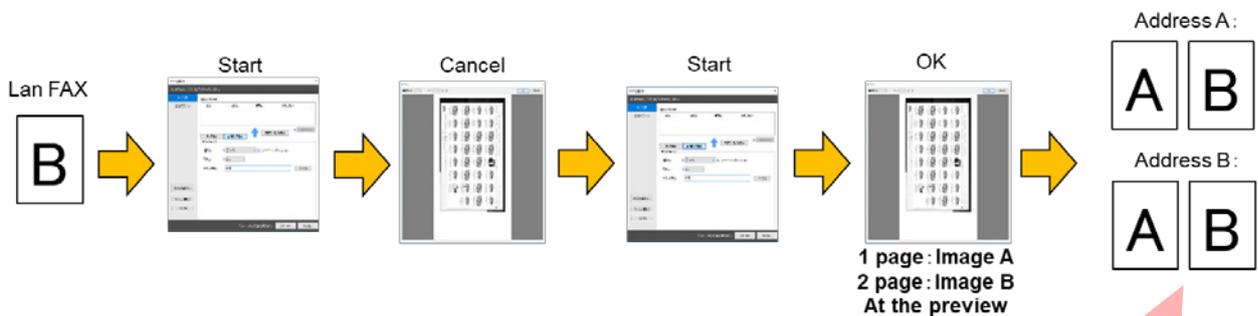
When these operations are performed, the image from the previous FAX job is sent along with the image of the current job to one or both destinations.

INCORRECT transmission
Both A and B are sent to Address A.
Both A and B are sent to Address B.

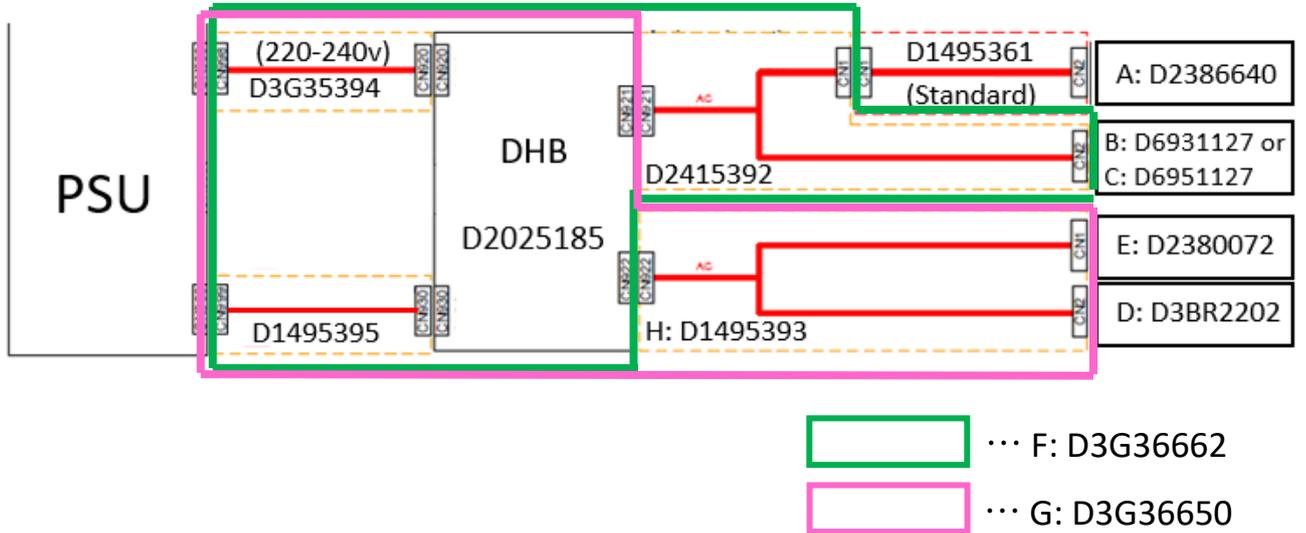
- If you do not, the heater will overheat and damage the tray and/or cause carbonization (Ex., If a 100V heater is installed on a 220V rated machine), or the heater will not be able to reduce enough moisture (Ex., If a 220V heater is installed on a 100V rated machine).

The part numbers shown above are for 220v-240v power. Make sure to install the heater(s) with the rated voltage that matches your country/region.

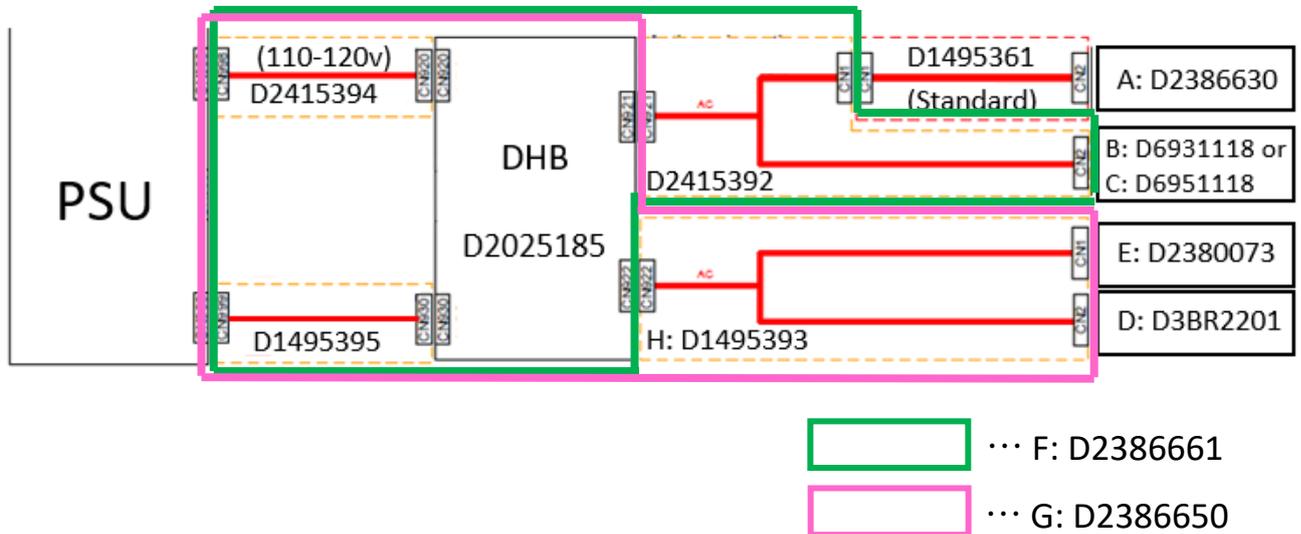
- If you do not, the heater will overheat and damage the tray and/or cause carbonization (Ex., If a 100V heater is installed on a 220V rated machine), or the heater will not be able to reduce enough moisture (Ex., If a 220V heater is installed on a 100V rated machine).

Make sure to install the heater(s) with the rated voltage that matches your country/region.

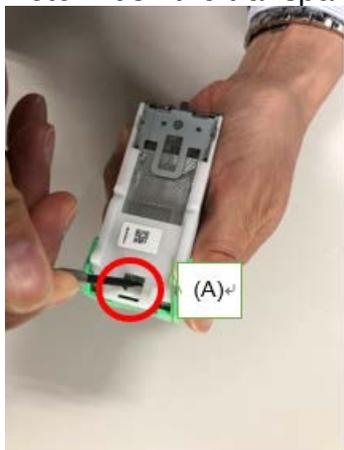
An ORT (On-going Reliability Test) was performed on the finisher at the factory, but the factory did not return the remaining number of staples to the initial value. As a result, the remaining number counter value became lower than the Near End threshold, triggering the Near End alert to be displayed. Since a new cartridge was replaced at shipment, a discrepancy occurred between the staple remaining counters and the actual number in the staple cartridge.

Push the hang (A) by the screw driver so that the stapler cartridge will pop up.

Note: Push the transparency cartridge case instead of white part.

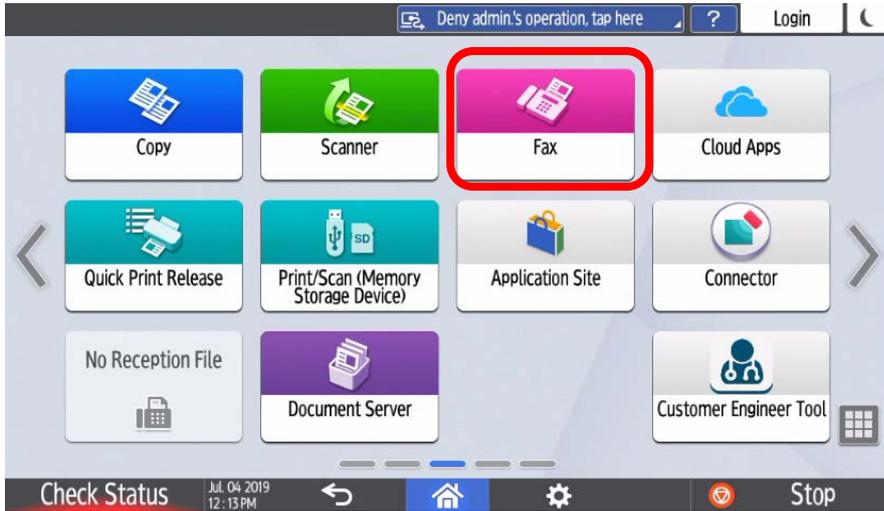
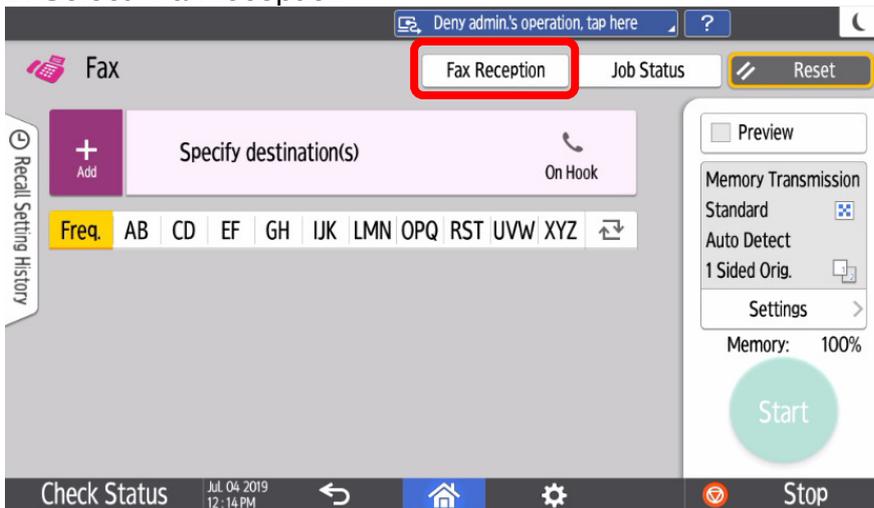
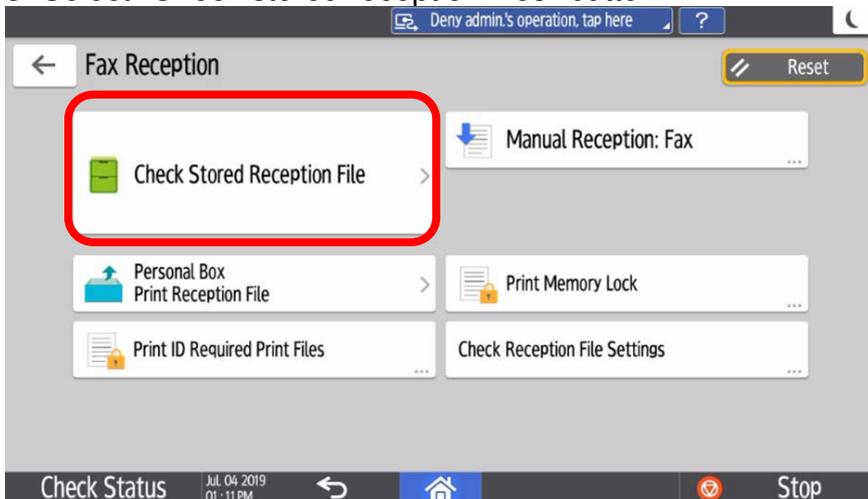
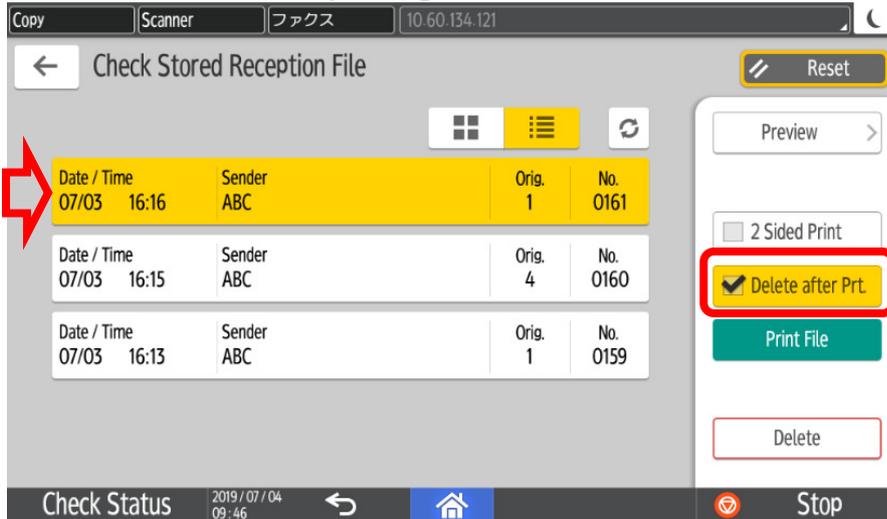
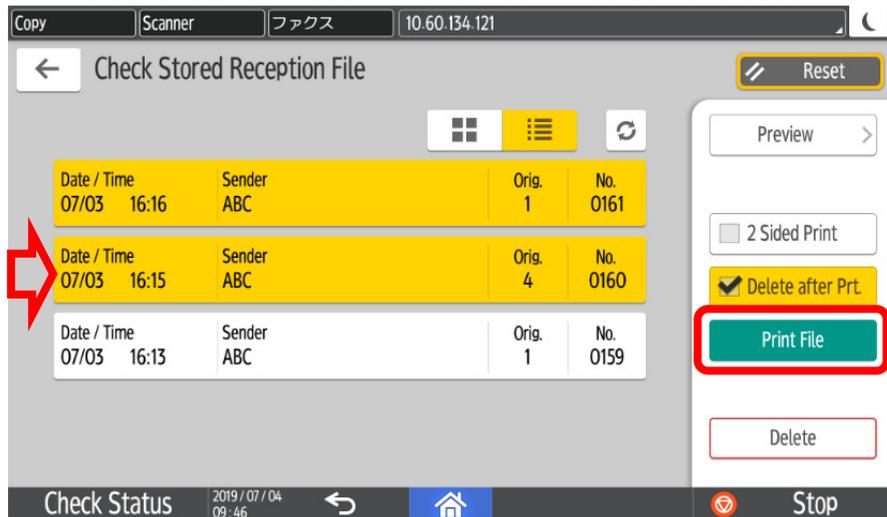
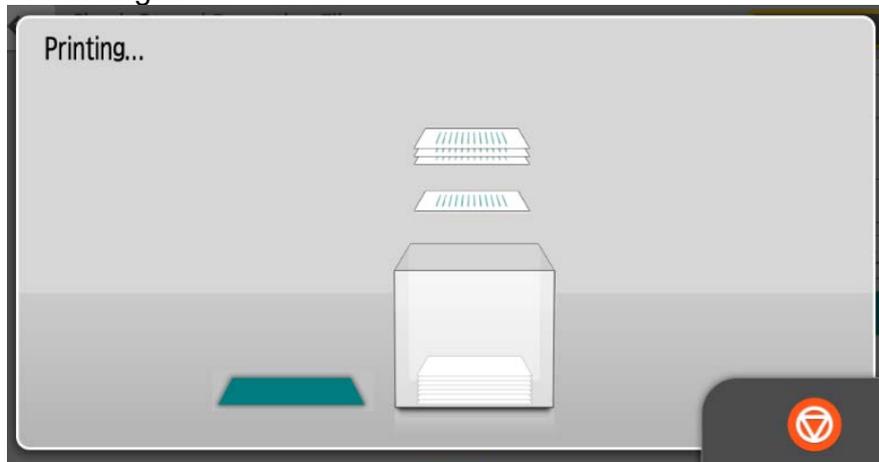
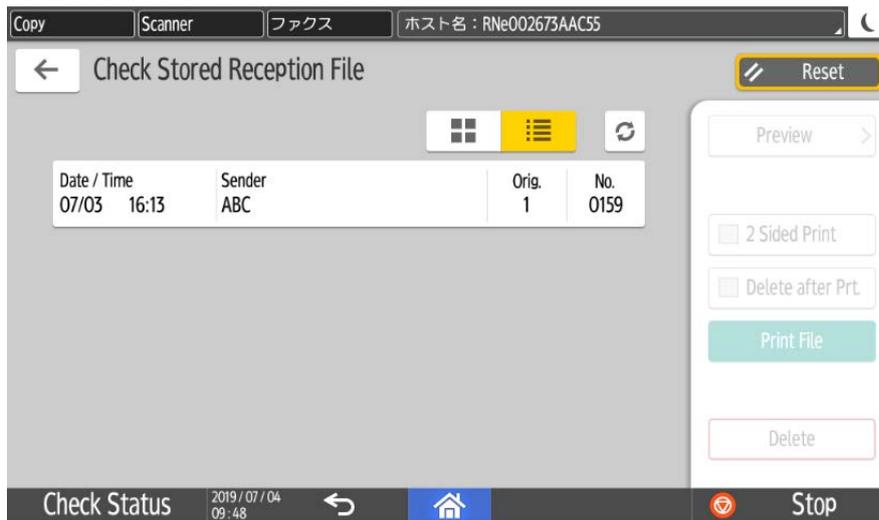
7. Both documents are erased.

Smart FAX firmware bug

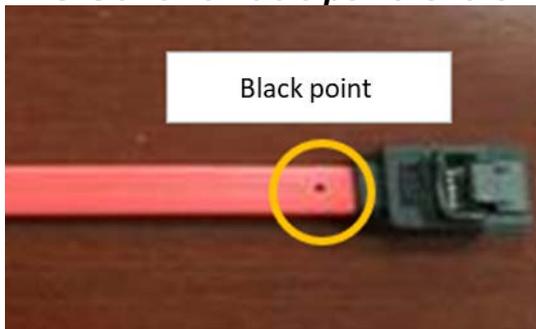
HDD cable provided from the vendor (D2415250:CABLE:HDD:SATA:210) is defective.

The HDD cable has been modified since July 2019 production.

This is a remarkable point for the new cable.

1. Replace the HDD cable when SC8XX occurs.
2. If the symptom still occurs, replace the HDD or other parts (see Service Manual for procedure).

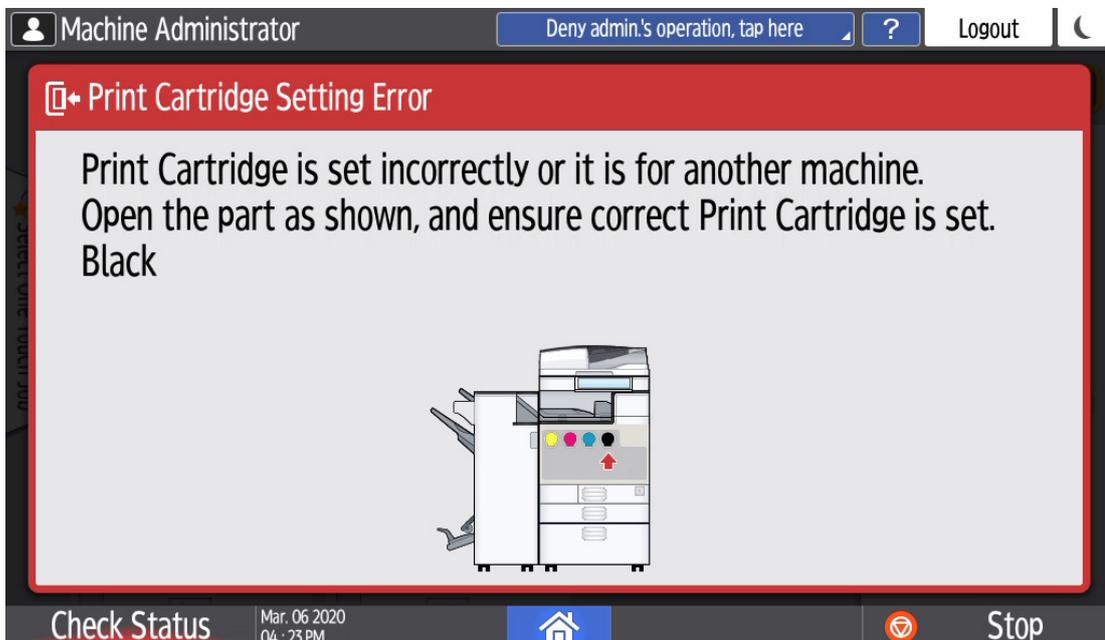
If the region code of the toner cartridge does not match the machine’s region, an alert message will appear on the screen and the printing features (Copy/Printer/FAX/Others) will be locked.

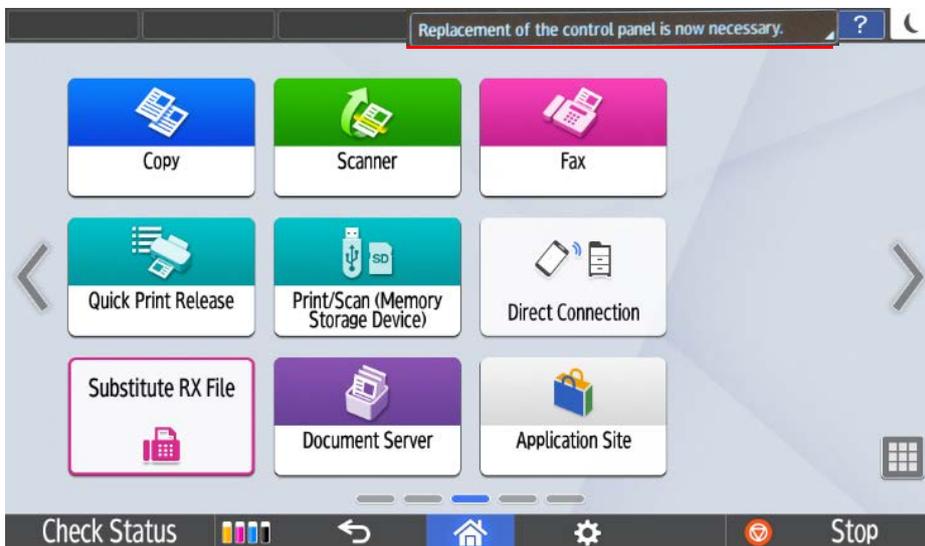
“Replacement of the control panel is now necessary” is displayed and SC843-02 occurs.

Affected models: RICOH IM C2000/C2500/C3000/C3500/C4500/C5500/C6000 series

Replace the PCB board for the Smart Operation Panel.

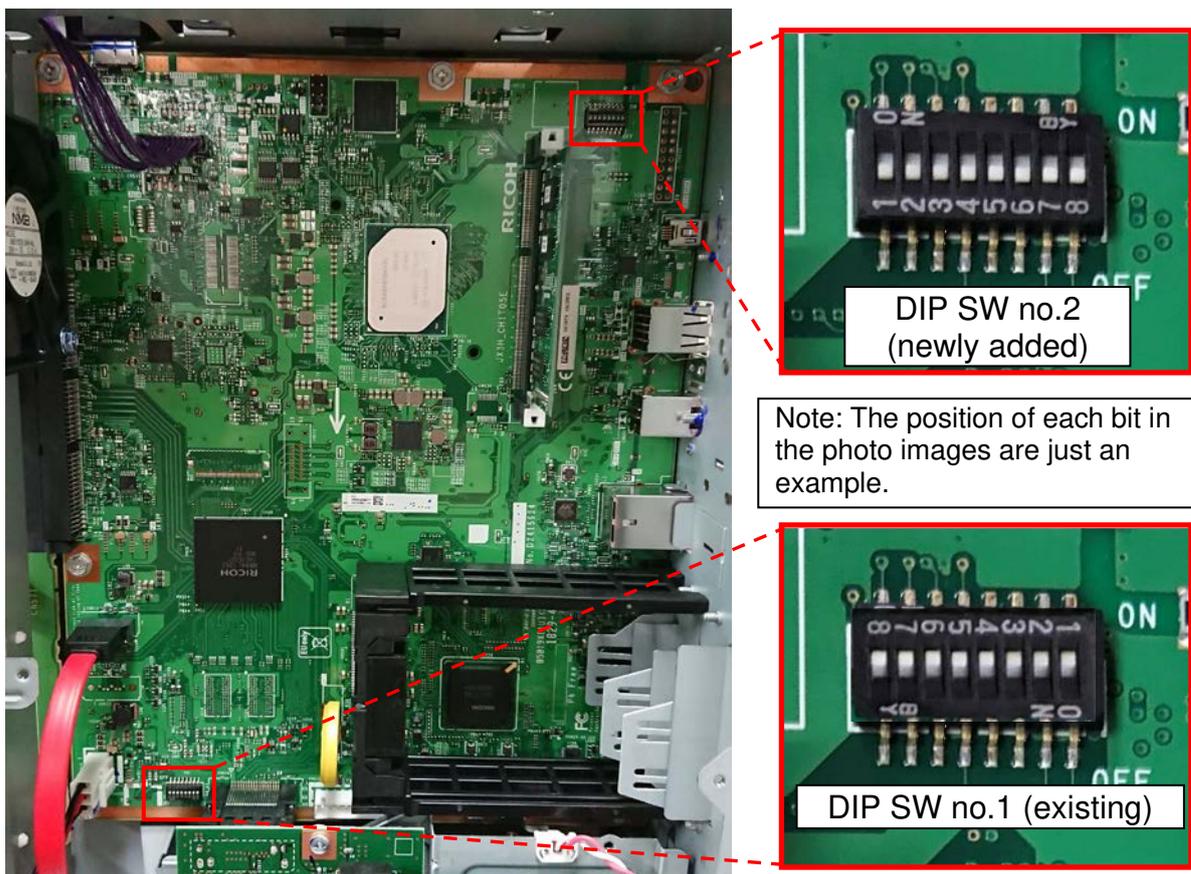
A DIP switch no.2 has been added on the Controller board as the following photo image. This is for the purpose of factory QA management so **no utilization for service operation in the field.**

Important: Please be sure not to change the settings of DIP SW no.1 and no.2 in the field. Correct setting depends on each Controller Board and SC672 or other symptom may occur if the machine is booted with an incorrect setting.
