Technical Bulletin

Model: Iris/Lilac Da			Dat	e: 30-Apr-99	No.: RA258001	
Subject: Color Controller Installation Procedure				Prepared by: Y. Sasaki		
From: Technical service Dept., GTS Division						
Classification:	Troubleshooting	Part info	ormat	tion 🗌 Action	n required	
	Mechanical Electrical		rical 🛛 🖾 Servi		ce manual revision	
Paper path Transmit		it/rec	eive 🗌 Retro	fit information		
	Other ()

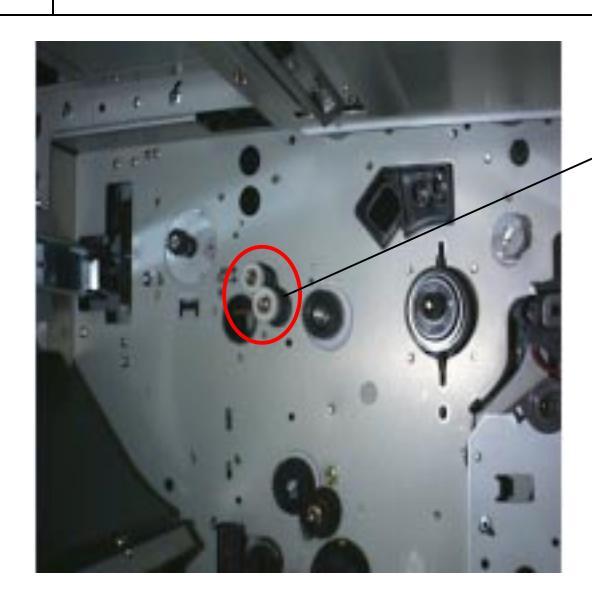
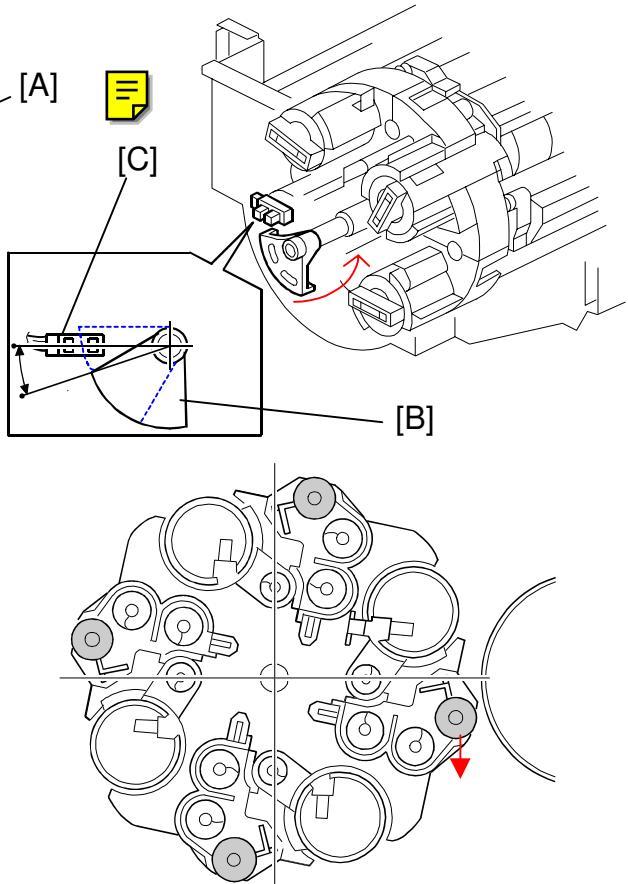
Production	Field		
1	It has been ensured that the motor was properly placed and secured in the correct position. This procedure has been reflected in production	When installing machines produced in February and March, check whether the toner supply motor is properly positioned after the drawer unit is pulled out and make sure that the plastic part (black) [A] is correctly placed in the cutout in the rear frame. (Please refer to the picture below this table.)		
	runs from April'99 onward.	If the motor is not correctly positioned, remove the motor.

• If the gears on the motor shaft are properly engaged, reposition the motor in the cutout properly.		
		 If the gears on the motor shaft are not properly engaged or the shafts have already been bent, replace the motor. 		
2	When inserting the drawe position so that there is su the drum. Insert the drawe	r unit into the machine, place the development unit in a ufficient distance between the development sleeve and er unit.		
	Rotate the revolver counterclockwise so that the actuator [B] is positioned inside the dotted lines as shown in the illustration.

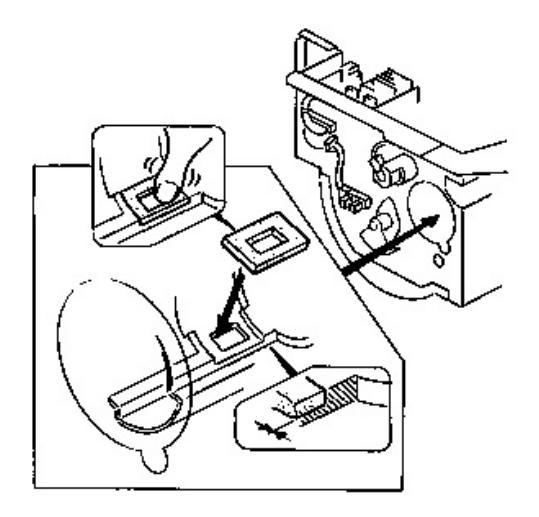
The toner hopper seal was damaged and peeled off as shown in the picture. This caused the fit of the toner bottle to become tight and/or the toner to leak and scatter.

- If this problem is found in the field, replace the seal by following the procedure described below.
- 1. Remove the toner bottle.
- 2. Pull out the drawer unit.
- 3. Remove the damaged seal and clean the surface of the toner hopper where the seal is attached using alcohol.
- **NOTE:** Make sure that no parts of the torn seal fall into the toner hopper. If this happens, white lines may result.
- 4. Attach the new seal. Make sure that it is properly fixed in place by pressing firmly.

NOTE: P/N of toner hopper seal : #A2593346.

5. Remove the toner collection tray (saucer) and reattach the parts removed.

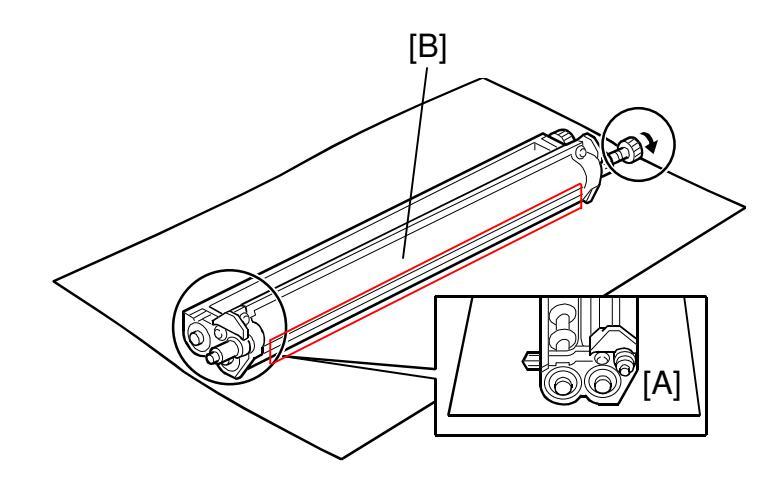
It was reported that developer spilled out from the development unit during developer initialization at the time of machine installation. To prevent any future occurrence, please make note of the following remarks regarding developer replacement and servicing of the development unit. (Some of these are explained in the service manual, page 3-15.)

3. After pouring developer in the development unit, place the development unit in the developer scoop-up position [A] as shown. Then, make sure that the developer brush on the sleeve [B] is properly inserted into the development unit by rotating the gear in the direction of the arrow as shown below. If the developer is not poured while the unit is on a flat level surface, the casing might be bent. This causes the developer to spill out from the development unit. If it happens, the developer should be removed and placed on a clean sheet of paper, then poured back into the unit.

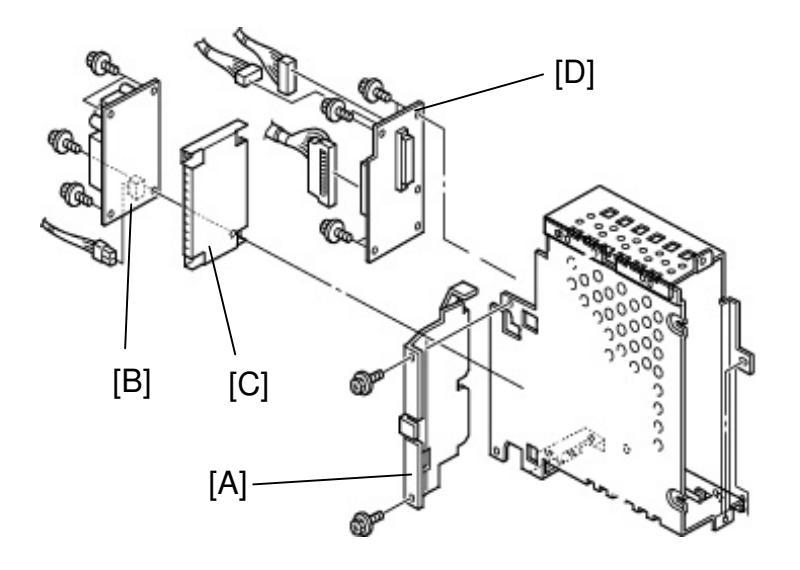
- BUSSW Board Replacement Procedure -

Normally, the input pins (#12 to 17) of IC18 on the BUSSW board are not used for the function of the IC18. However, due to an error in the software programmed in IC18, these pins were allocated as output pins. The resulting increase in power consumption causes the IC to heat up and malfunction.

- 1. Turn off the main switch and unplug the power cord.
- 2. Disconnect the cable(s) from the controller.
- 3. Remove the exterior covers (used toner cover and I/F unit cover).
- 4. Remove the controller from the I/F unit (6 screws).
- 5. Remove the cover plate [A] (2 screws).
- 6. Remove the AC drive board [B] (4 screws and 2 connectors).
- 7. Remove the shielding plate [C].
- 8. Replace the BUSSW board [D] (4 screws, 1 grounding screw, and 2 connectors).

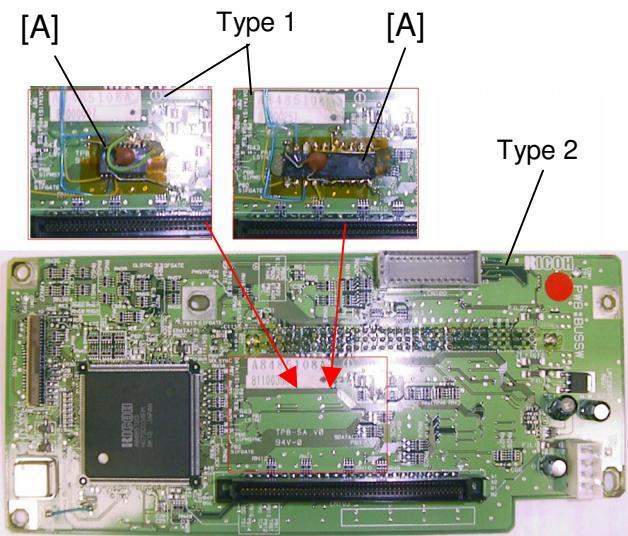
Type 1 is the board that was modified in the production (from #A8485105). This board contains one of the two ICs as shown in the picture to the right [A]. The only difference is in the size.

The function of the additional IC and IC18 is exactly the same. IC18 is soldered onto the reverse side of the Type 2 board.

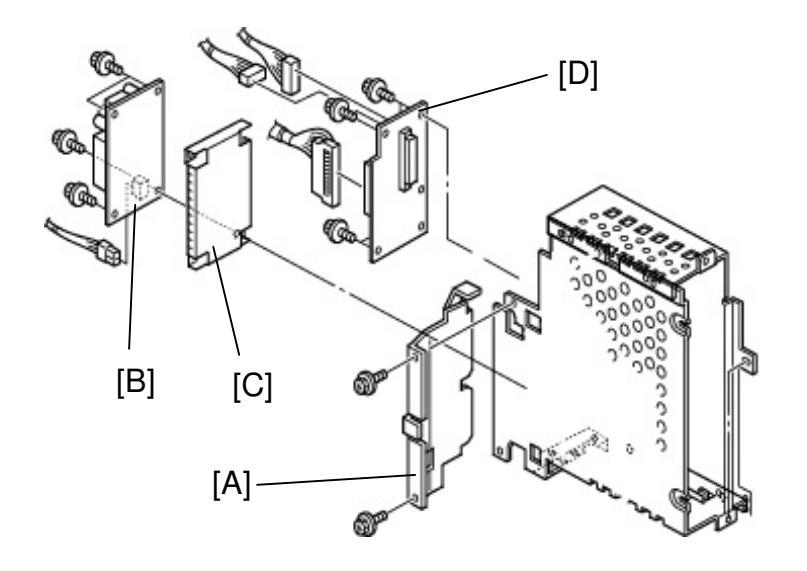
- BUSSW Board Replacement Procedure -

Normally, the input pins (#12 to 17) of IC18 on the BUSSW board are not used for the function of the IC18. However, due to an error in the software programmed in IC18, these pins were allocated as output pins. The resulting increase in power consumption causes the IC to heat up and malfunction.

- 1. Turn off the main switch and unplug the power cord.
- 2. Disconnect the cable(s) from the controller.
- 3. Remove the exterior covers (used toner cover and I/F unit cover).
- 4. Remove the controller from the I/F unit (6 screws).
- 5. Remove the cover plate [A] (2 screws).
- 6. Remove the AC drive board [B] (4 screws and 2 connectors).
- 7. Remove the shielding plate [C].
- 8. Replace the BUSSW board [D] (4 screws, 1 grounding screw, and 2 connectors).

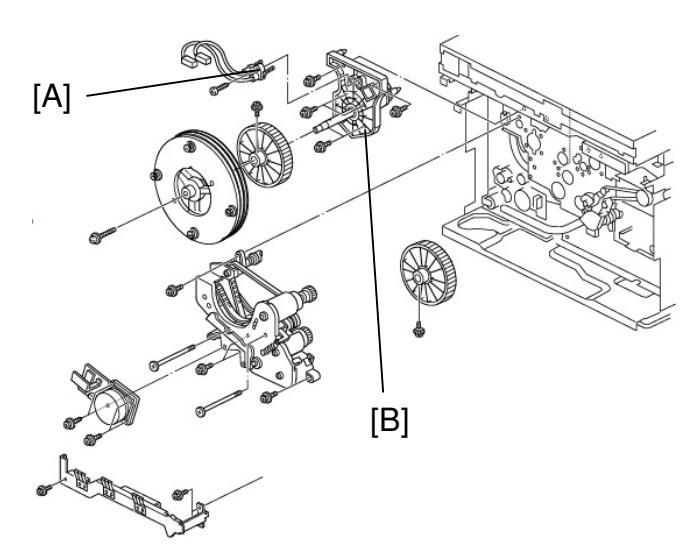
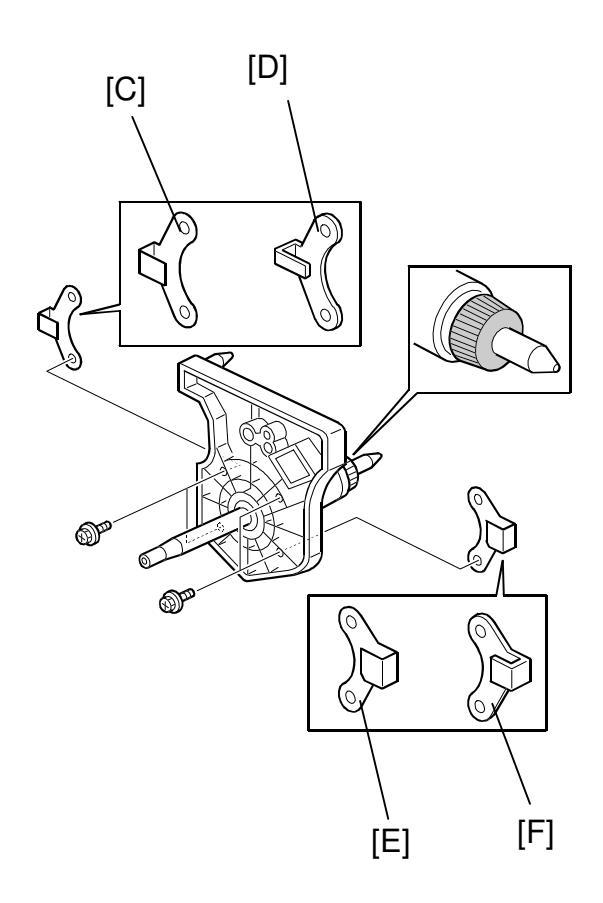
[2] 1.5-mm Banding : Drum Shaft Holder Replacement Procedure

Туре	Mo	ode	Cause	Solution	
	Сору	Print		Production	In the field
1.5- mm	No	Yes	The coupling of the drum vibrates and generates a specific frequency. This frequency causes 1.5-mm banding only in 2/3 speed mode.	The material of the coupling located in the drum shaft holder (#A2592251) has been changed from plastic to metal. P/N: #A2592251 NOTE: The part number has not been changed; but the old part was never stocked at the SPC in Japan.	 Replace the drum shaft holder. Refer to page 5/8.
6-mm	No	Yes	The rotation speed stability of the drum motor varies part by part. If the rotation speed is not constant, the image development process is affected (especially in 2/3 speed mode, causing 6-mm banding).	The rotation speed stability of the drum motor has been improved. P/N changed: #AX060162 -> #AX060197	Replace the motor. Refer to page 6/8.
8-mm	No	Yes	The AC current of the paper separation corona generates noise, which affects the paper transfer corona. The frequency of the AC current causes 8-mm pitch banding only in 2/3 speed mode.	The frequency of the AC current has been changed on the high voltage supply board (T2, D). P/N changed: #A2595055 -> #A2595058	 Replace the high voltage supply board (T2, D). If the new board is not available, rerouting the high voltage cable of the paper transfer corona may solve the problem. If not, the board should be replaced with a new one. Refer to page 6/8.

- 2. Follow steps 1-8 of the replacement procedure for 12-mm banding (see page 7/8 of this RTB.)
- 3. Remove the receptacle [A] (1 screw).
- 4. Replace the drum shaft holder [B] (6 screws).

The number of spring plates installed is different from machine to machine, depending on the angle at which the frame is tilted.

When replacing the drum shaft holder, it is also necessary to replace the plates (if present).

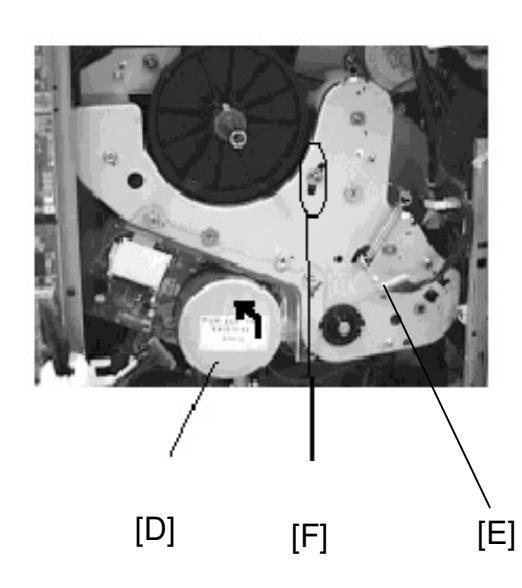
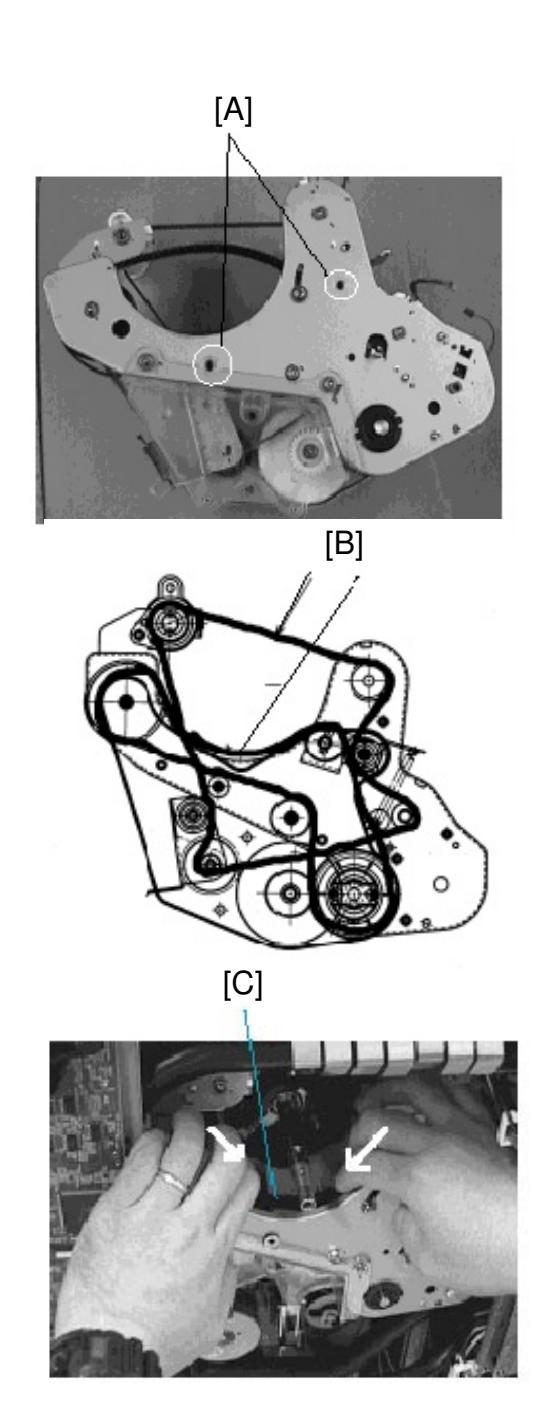
[5] 12-mm Banding : Gear Replacement Procedure

12-mm	Yes	No	The frequency generated by the gears in the drum drive unit causes 12-mm banding only in standard speed mode.	The gears have been modified to reduce the specific frequency generated when the gears rotate. P/N changed: #AB017512 -> #AB017521 #AB017477 -> #AB017520	 Replace the gears with modified ones. Refer to page 7/8 to 8/8.

- Remove the following parts: Rear covers / Fly-wheel [A] / Stay [B]
- 2. Remove the 3 screws securing the PSU and the 4 screws securing the I/O control board. Then, move these two parts aside to make space to remove the drum drive unit [C].
- **NOTE:** It is not necessary to remove the PSU and I/O board.
- 3. Disconnect the connector of the drum motor [D].
- Rotate the drum motor counterclockwise manually so that the screw [E] of the drum pulley [F] faces downward.
- 5. Loosen the screw [G] and remove the tension spring [H].
- 6. Remove the drum motor (4 screws) and drum pulley (1 screw)
- 7. Remove the 3 connectors from the drive unit and remove the unit (4 screws and 2 stud screws).
- 8. Remove the tension spring [I]. Then, remove the unit cover plate [J] (3 screws).

- (1) Before opening the drive unit, note the routing of the timing belts as well as the positioning of the pulleys. This will make it much easier to put the belts and pulleys back after the procedure.
- (2) Do not open the drive unit completely. If this is done, the timing belt and pulleys will come off the unit. Open the cover just enough for gear replacement (see the photo).
- Replace the white and black gears [K]. (The black gear is secured with 2 screws.)

Before securing the screw, the motor should be rotated after hooking the spring. If this is not done, the proper tension will not be applied to the belt, causing the timing belt to jump during operation. This may cause a partial color shift image.

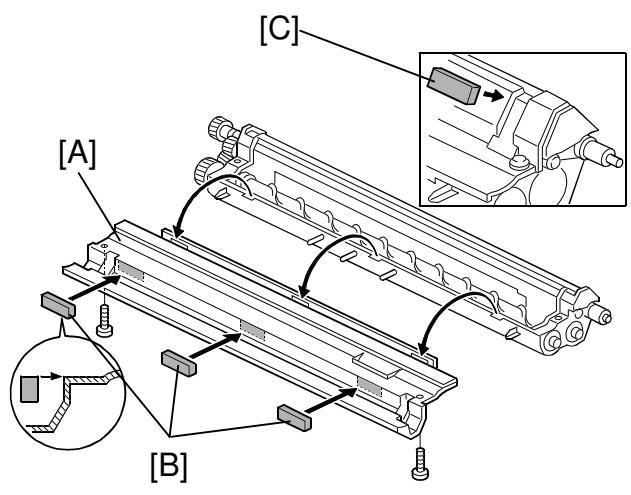
To absorb the vibration, four foam rubber pads have been attached to the development cover. If the squeaking noise occurs in the field machines, please follow the procedure described below. Please refer to MB #22 (Iris) and #19 (Lilac) for the cut-in serial number information.

- 1. Make a full color copy and check when the noise occurs (i.e. at which color in the development process).
- 2. Turn off the main switch.
- 3. Pull out the drawer unit.
- 4. Remove the drum unit and place a few sheets of paper on the unit to prevent the drum from developing light fatigue.
- 5. Remove the relevant development unit(s).
- 6. Remove the development cover [A] (3 screws).
- With damp and dry cloths, clean the areas on the front and reverse sides of the development cover where the pads will be attached.

8. Attach 3 foam rubber pads [B] to the reverse side of the development cover as shown.
