SUBJECT: Service Manual Correction

LILY
(A172 / A199)

SUBJECT: Grease for Transfer Belt Unit and Transfer Roller Unit

Model: Lily		Date: 28-Feb-97	No: 003	1/2
Subject: Transfer Belt Tension Release Wedge			Prepared by: N. Kaiya	
From: QAC 1st Field Information Dept.			Checked by: T. Inoue <i>T. Inoue</i>	
Classification:	<input type="checkbox"/> Troubleshooting	<input type="checkbox"/> Part information	<input type="checkbox"/> Action required	
	<input type="checkbox"/> Mechanical	<input type="checkbox"/> Electrical	<input type="checkbox"/> Service manual revision	
	<input type="checkbox"/> Paper path	<input type="checkbox"/> Transmit/receive	<input type="checkbox"/> Retrofit information	
	<input type="checkbox"/> Other ()

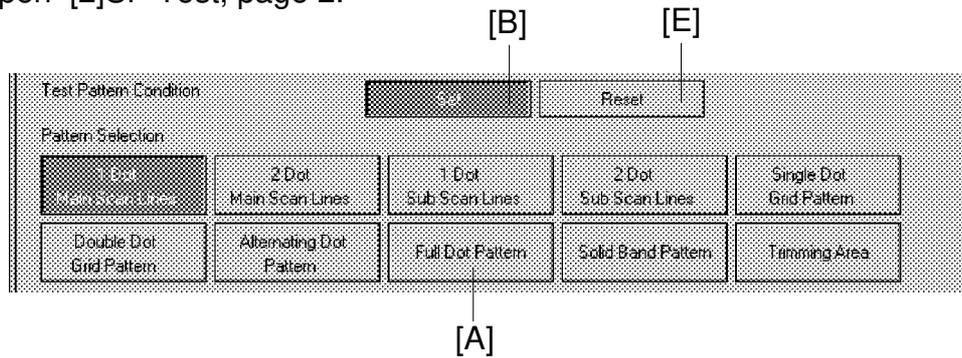
7. Select "Full Dot Pattern" [A] in **Pattern selection** and select "Start" [B] in **Test Pattern Condition**.

8. Touch the "Copy in SP" key and select "Black" copy mode.

3) Note that "**Printer Free Run**" must be used at step 10 of "3.4 INSTALLING A NEW DRUM".

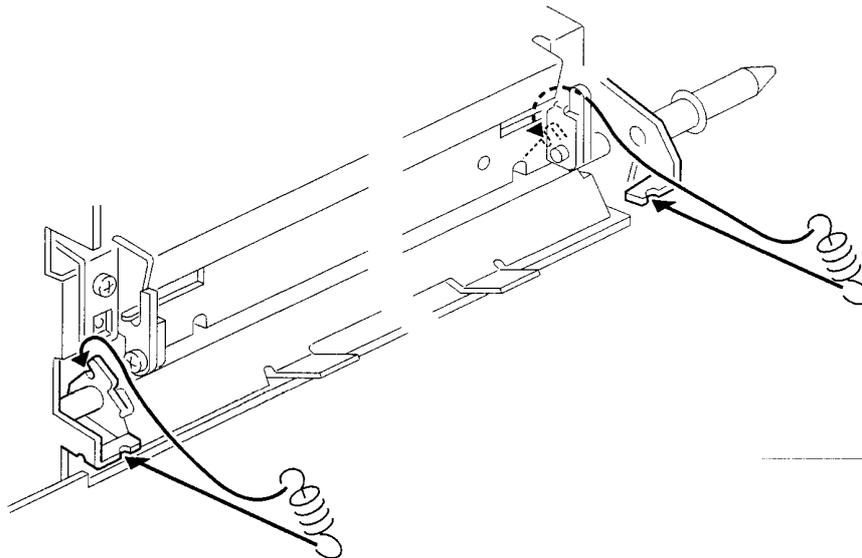
Pressure Roller Cleaning Blade

The calcium carbonate deposits on the surface of the pressure roller when there is less silicone oil on the surface of the pressure roller than usual. This condition only exists after a long series of single-color copies. This is because when making single-color copies, the sheets of copy paper are fed to the fusing unit with only a small interval between them. When making full-color copies, the fusing unit idles during four development cycles, so the pressure roller has sufficient time to receive silicone oil on its surface.

1. Remove the two pressure roller cleaning blade springs.
2. Remove the cleaning blade by sliding it out from the pins on the front and rear fusing unit side frames.
