Model: Bellini-C3 (Katana)	Date: 11-May-06	No.: RB234001b
----------------------------	-----------------	----------------

Subject: Controller firmware (Animation) release note for B-C3		Prepared by: T.Tadokoro	
From: PPBG QA/Service Planning Dept.			
Classification:	<input type="checkbox"/> Troubleshooting	<input type="checkbox"/> Part information	<input type="checkbox"/> Action required
	<input type="checkbox"/> Mechanical	<input type="checkbox"/> Electrical	<input type="checkbox"/> Service manual revision
	<input type="checkbox"/> Paper path	<input type="checkbox"/> Transmit/receive	<input type="checkbox"/> Retrofit information
	<input type="checkbox"/> Product Safety	<input type="checkbox"/> Other (     )

Subject: Controller firmware (Engine) release note for B-C3		Prepared by: T.Tadokoro	
From: PPBG QA/Service Planning Dept.			
Classification:	<input type="checkbox"/> Troubleshooting	<input type="checkbox"/> Part information	<input type="checkbox"/> Action required
	<input type="checkbox"/> Mechanical	<input type="checkbox"/> Electrical	<input type="checkbox"/> Service manual revision
	<input type="checkbox"/> Paper path	<input type="checkbox"/> Transmit/receive	<input type="

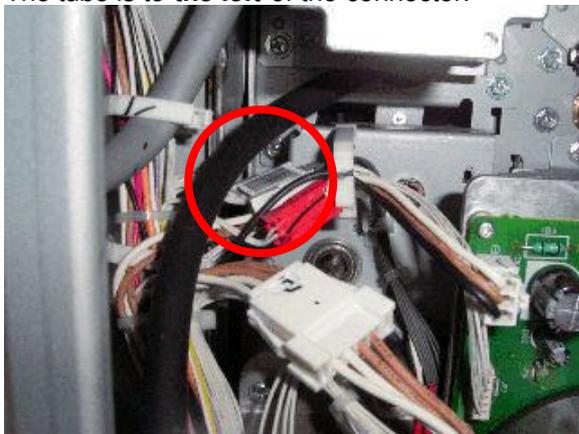
**Correct position:**

The tube is to **the left** of the connector.

**Important:** Position the tube to the **left of the connector** shown in the photo above.

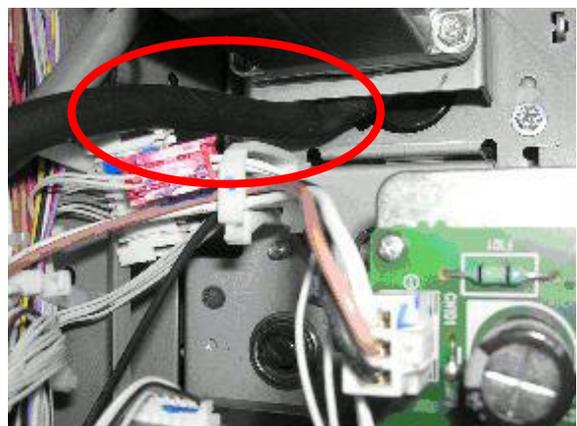
**Incorrect position:**

The tube is on top of the connector.

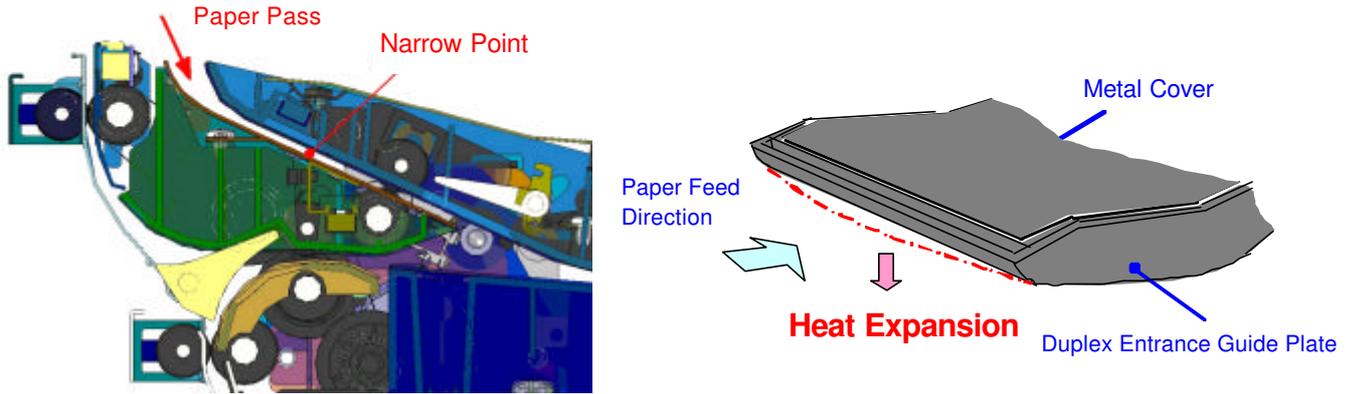
The entrance guide plate is bent due to heat expansion. In addition, the metal cover on the duplex entrance guide encourages heat expansion of the guide plate. This will cause the gap in the paper path to be narrow and a duplex entrance jam occurs.

1. If the Duplex Cover Kit (B2349901) is available, do the Permanent Solution below.
2. If the Duplex Cover Kit is not available yet, first do the Temporary Solution below. Then, after the Duplex Cover Kit is available, do the Permanent Solution.

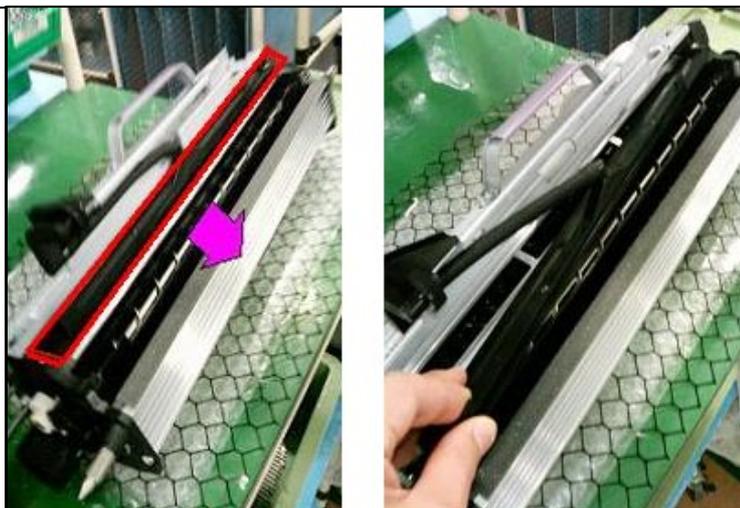
**P/N: B2343151**

The duct path that is attached to the development unit is blocked due to a defect in the die. The internal pressure of the development unit rises, and after a while, the toner leaks out from the unit.

1. Replace the duct unit at machine installation, or at the next service visit. To do this, use the duct unit kit: P/N **B2349902**.  
**See Page 4 below for the procedure.**

**Remove the duct unit  
(inside the red box in  
the photo).**

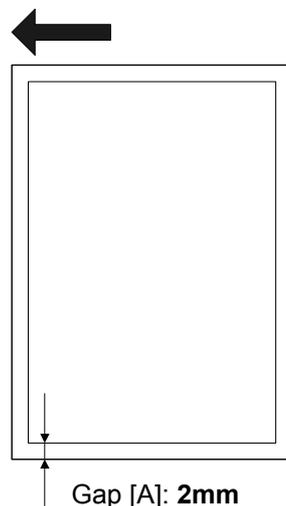
**Note:** The goal of this procedure is to adjust “Gap [A]” in the illustration below to about 2mm for all paper trays.

1. Set **Sp1911-001 to 008** to a value of “0”.  
**Note:** This turns off the CIS function for all trays.
2. Print out the Trimming Area Pattern (**SP2902-003**, No.27) from tray 2.
3. Measure the gap between the front trim line and the edge of the paper (Gap [A]).
  - Gap [A] should be about **2mm**. If it is not, adjust **Sp1002-002** so that it becomes about 2mm.

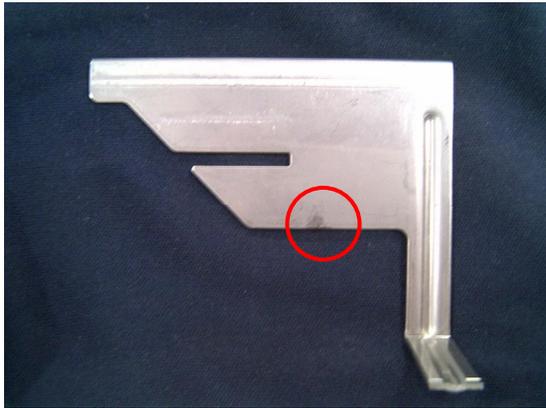
Defective rear fence:

Trace of stapler head:

Check the rear fence at the next service visit, and replace the rear fence with a inspected rear fence (P/N **B2349905**, FOC) under these conditions:

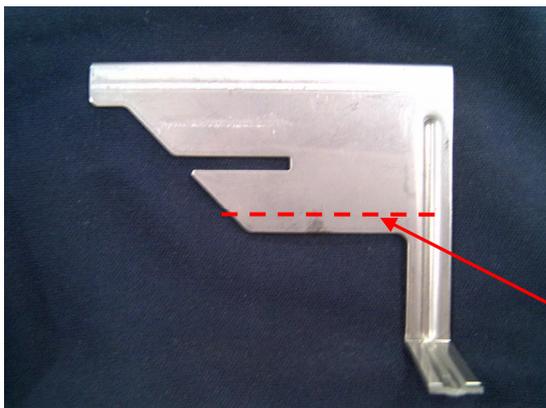
This area will be removed

- The part of the rear fence that can contact the stapler head will be removed.
- A new factory inspection will be added for the rear fence.

**Applied from:** September 2007 production (new P/N and S/N to be announced by MB).

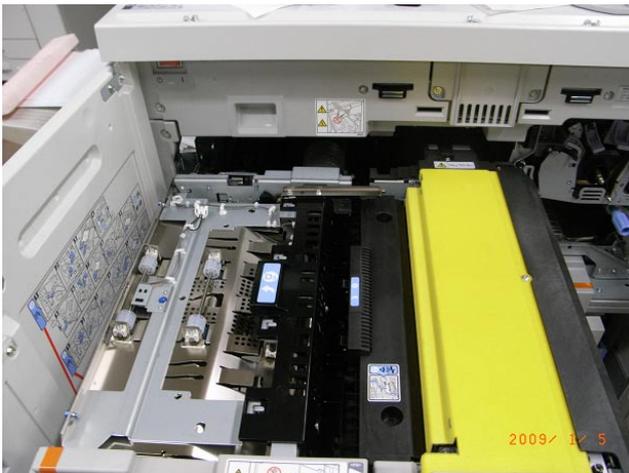
1. Pull the Exit Unit.

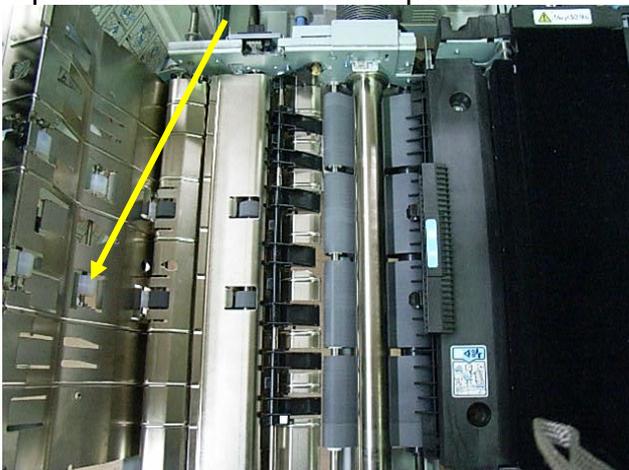
2. Open the Exit Guide Plate upward.

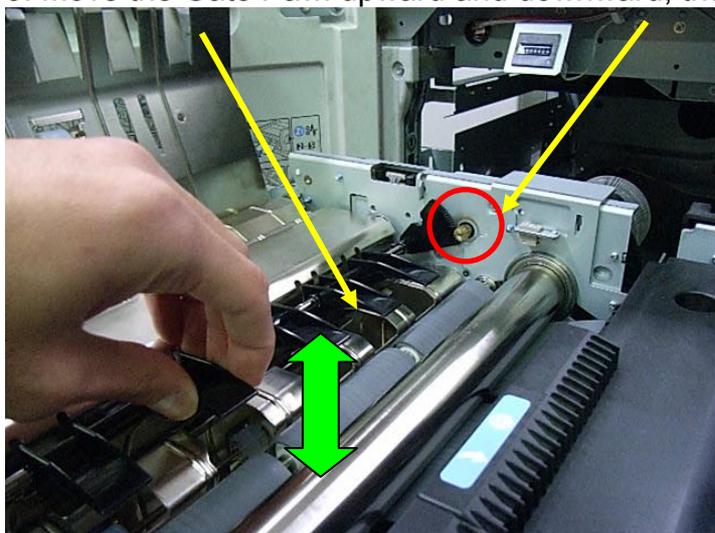
3. Move the Gate Pawl upward and downward, then rotate the gear of the stepper motor.

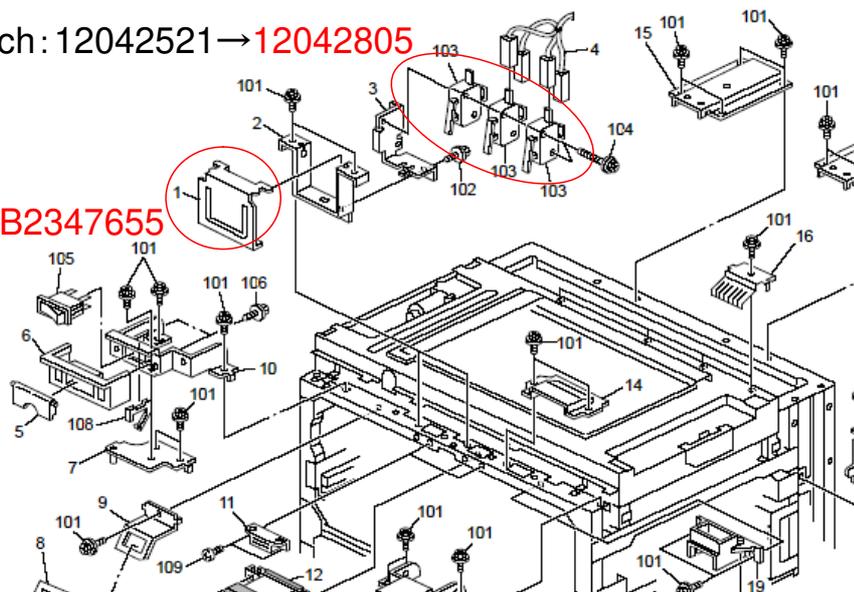
Since the Switch was replaced, the part number of the Switch has been changed from "12042521" to "12042805." Simultaneously the Lever has also been changed from "B2347653" to "B2347655". Combination exists between the Switch and the Lever.

Switch: 12042521 → **12042805**

Lever: B2347653 → **B2347655**

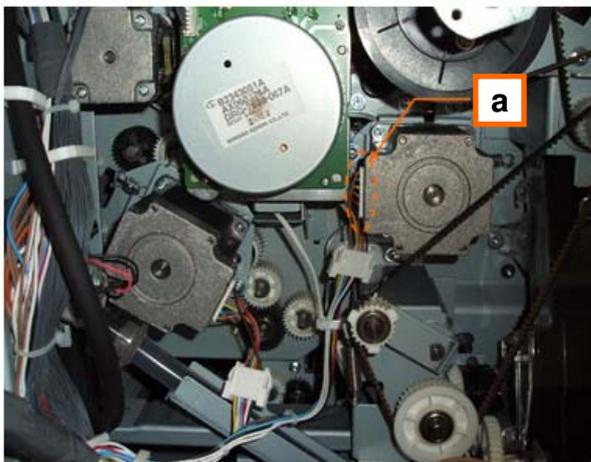
Old

**Reason:** To prevent possible damage to the registration motor harnesses

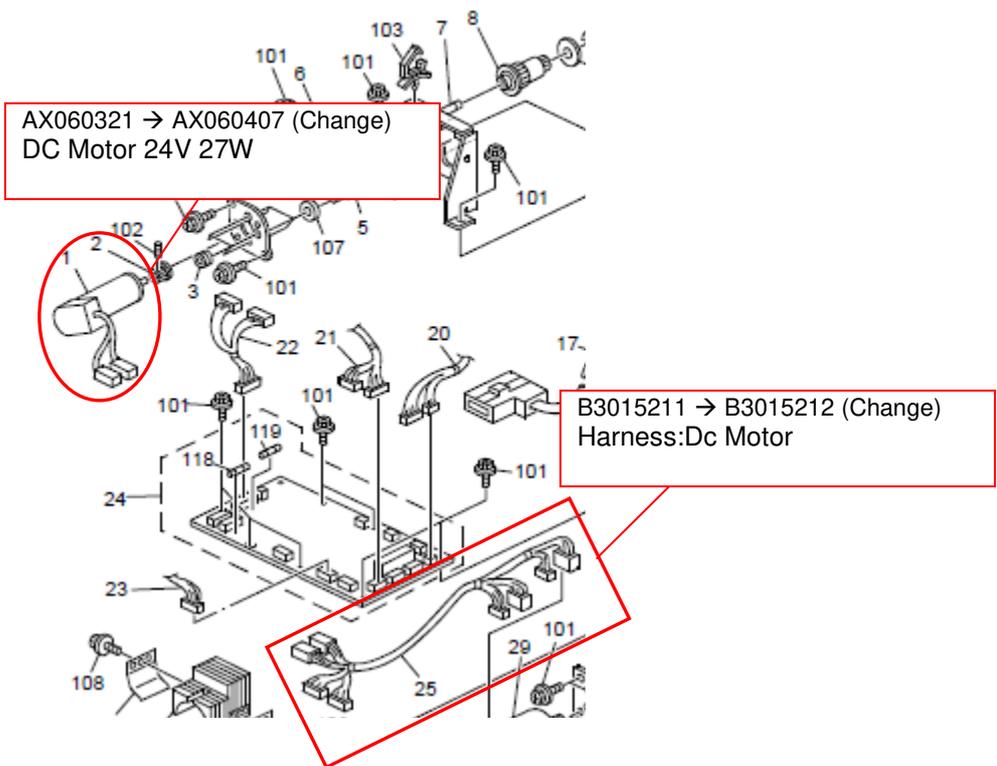
**114.ADF 9 (D095)**

**Reason:** The factory of the motor has changed; the harness connecting the motor needs to be replaced together with the motor.

Old Part Number	New Part Number	Description	Q'ty	Int	Page	Index	Note
B3015211	B3015212	Harness:Dc Motor	1	X/X	253	25	Replace as set
AX060321	AX060407	DC Motor 24V 27W	1	X/X	253	1	Replace as set

NOTE: Motor and Harness need to be replaced as a set.  
 Motor and Harness interchangeability is X/X individually, and O/O.as a set.  
 This change has been applied from 2011 November production.  
 This change is also applied to ProC900S, ProC720S
