Model: K-C4	Date: 22-Jan-13	No.: RD158002a
-------------	-----------------	----------------

Subject: Firmware Release Note: PowerSaving Sys		Prepared by: Y.Saitoh	
From: 2nd Tech Service Sect., MFP/Printer Tech Service Dept.			
Classification:	<input type="checkbox"/> Troubleshooting <input type="checkbox"/> Mechanical <input type="checkbox"/> Paper path <input type="checkbox"/> Product Safety	<input type="checkbox"/> Part information <input type="checkbox"/> Electrical <input type="checkbox"/> Transmit/receive <input checked="" type="checkbox"/> Other (Firmware)	<input type="checkbox"/> Action required <input type="checkbox"/> Service manual revision <input type="checkbox"/> Retrofit information <input checked="" type="checkbox"/> Tier 2

This RTB has been issued to announce the firmware release information for the **PowerSaving Sys.**

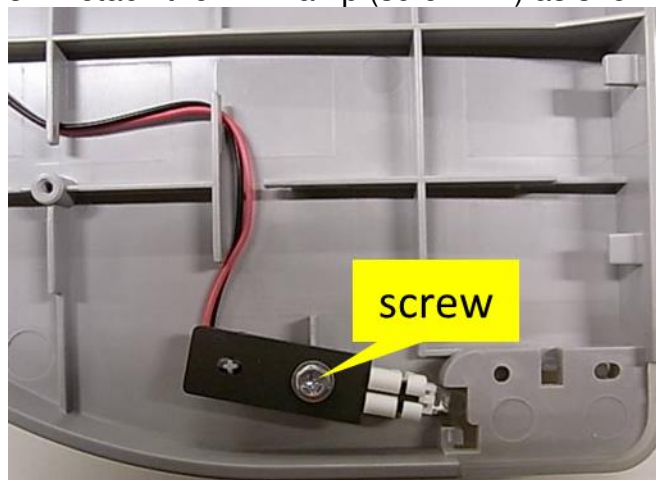
3. Detach the LED lamp (screw x 1) as shown.

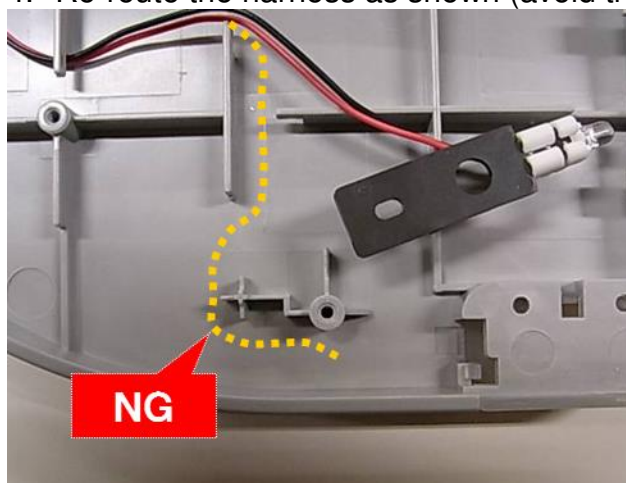
4. Re-route the harness as shown (avoid the path shown by the yellow dotted line).

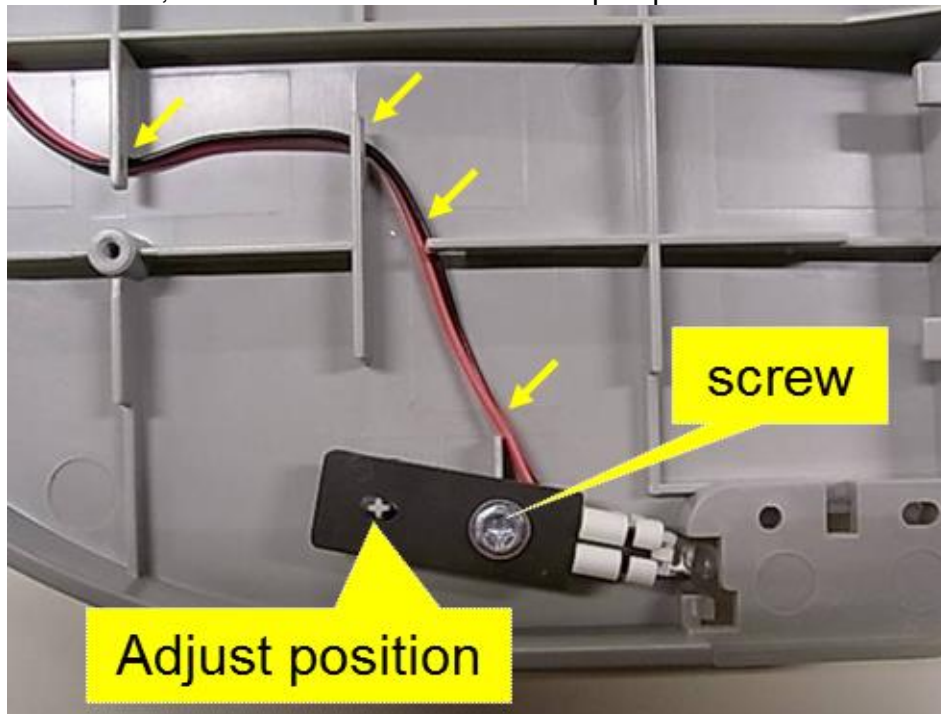
5. Adjust the position of the convex part of the LED lamp inside the elliptical hole in the bracket, and then secure the LED lamp in place with the screw.

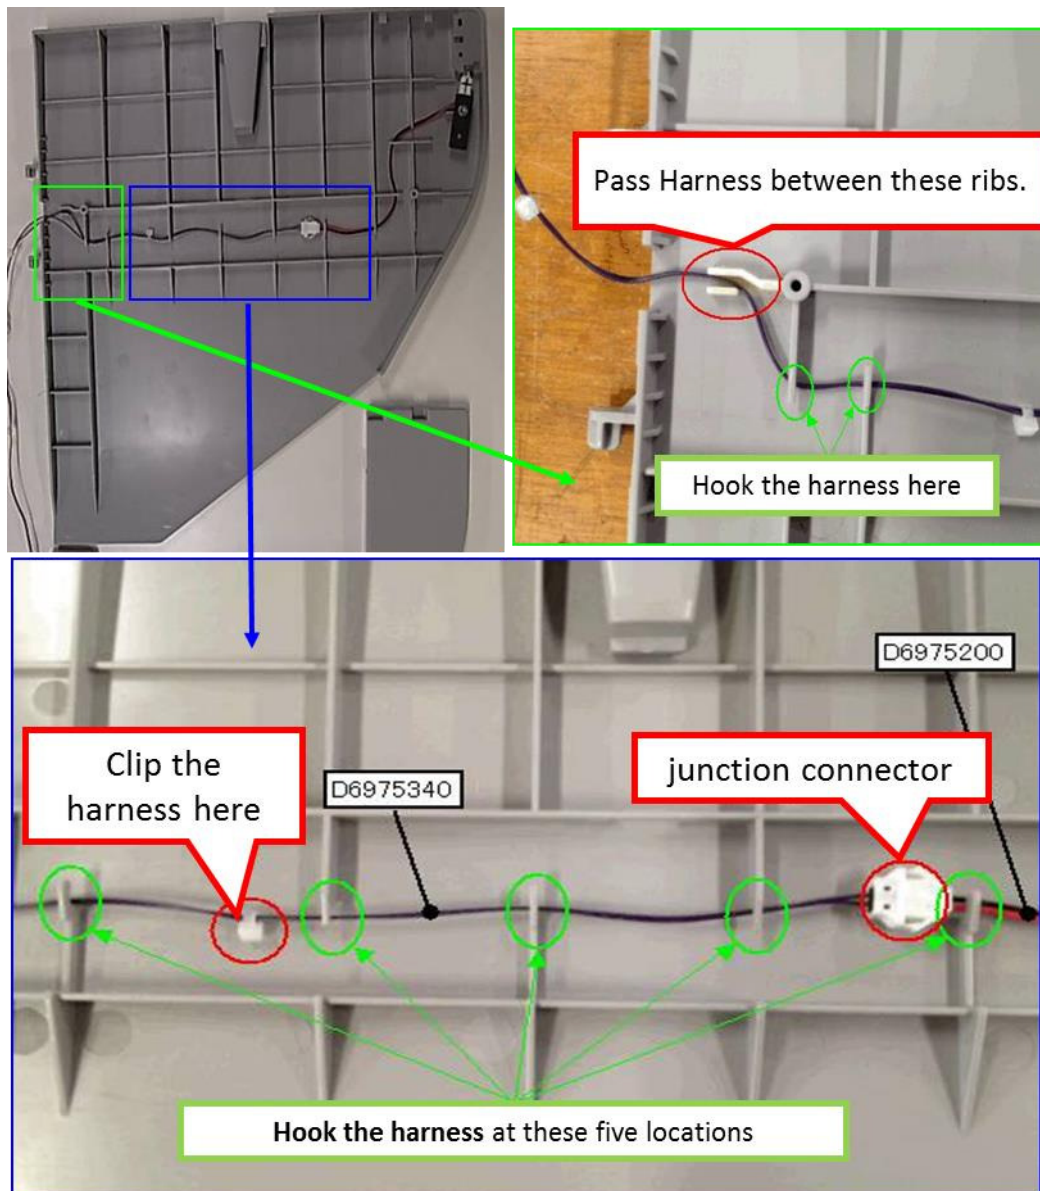
6. Re-route the harness as shown in the following photos.

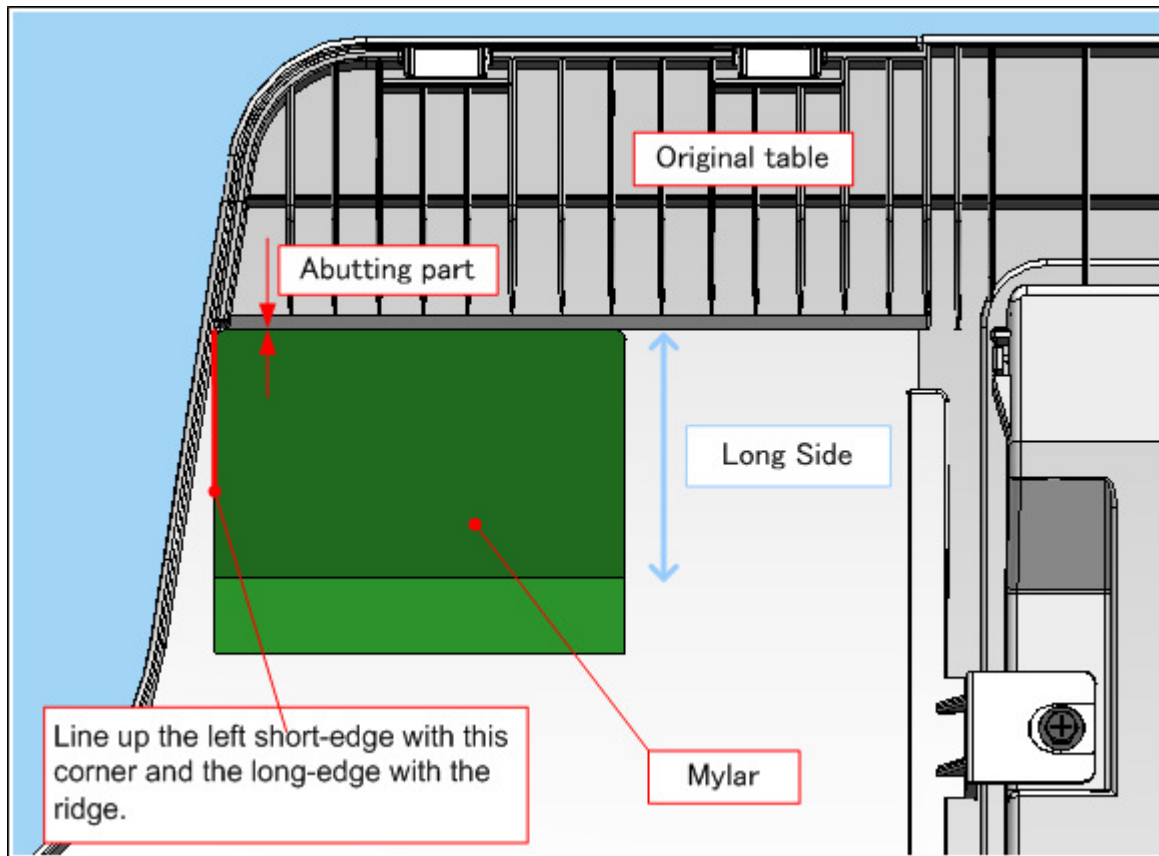
3. Attach the Mylar as follows:

- Line up the left long-edge with the corner, and the ridge, as shown in the diagram below.

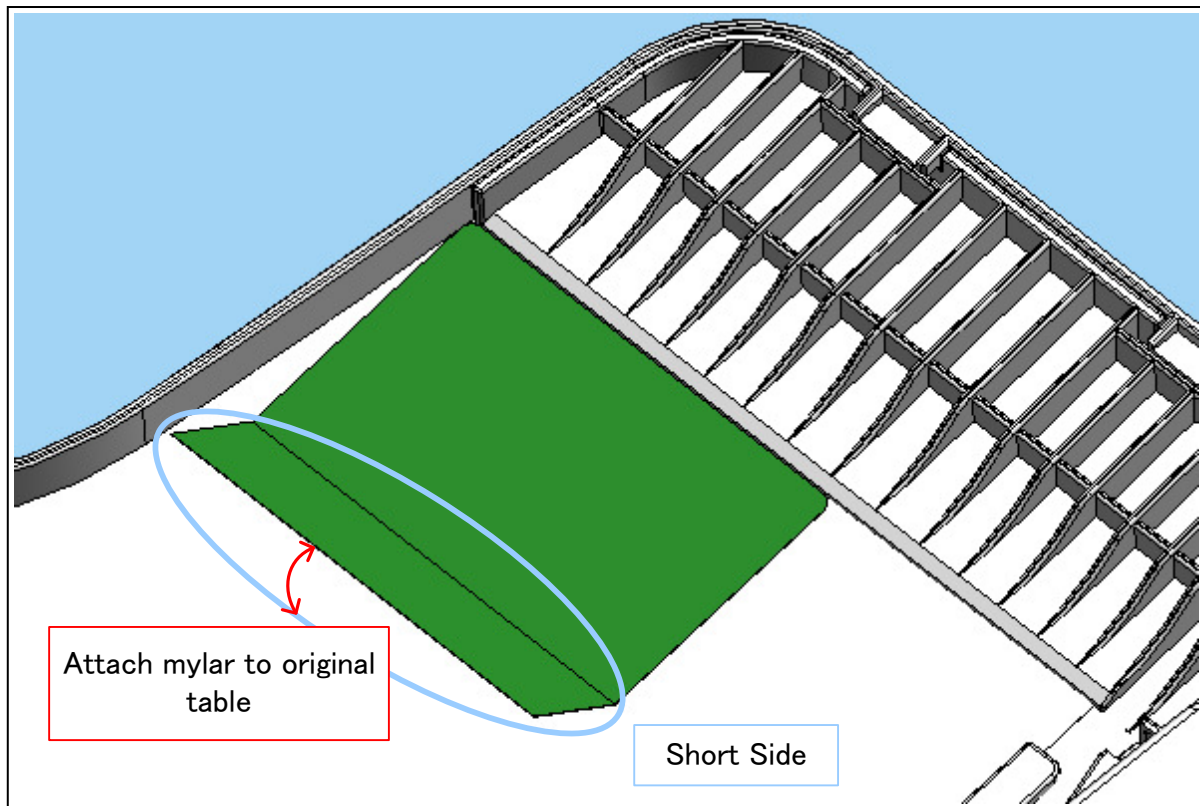
4. Peel off the adhesive covering (paper) from the **short side** of the Mylar.
5. Attach the short side to the original table, as shown.
