Model: K-C4L/C4a	Date: 28-Dec-12	No.: RD160001g
------------------	-----------------	----------------

Subject: Firmware Release Note: BICU_IC		Prepared by: Y.Suzuki	
From: 2nd Tech Service Sect., MFP/Printer Tech Service Dept.			
Classification:	<input type="checkbox"/> Troubleshooting <input type="checkbox"/> Mechanical <input type="checkbox"/> Paper path <input type="checkbox"/> Product Safety	<input type="checkbox"/> Part information <input type="checkbox"/> Electrical <input type="checkbox"/> Transmit/receive <input checked="" type="checkbox"/> Other (Firmware)	<input type="checkbox"/> Action required <input type="checkbox"/> Service manual revision <input type="checkbox"/> Retrofit information <input checked="" type="checkbox"/> Tier 2

Model: K-C4L		Date: 1-Sep-14	No.: RD160007
Subject: How to adjust the LE registration		Prepared by: Y.Saitoh	
From: 2nd Tech Service Sect., MFP/P Tech Service Dept.			
Classification:	<input checked="" type="checkbox"/> Troubleshooting <input type="checkbox"/> Mechanical <input type="checkbox"/> Paper path <input type="checkbox"/> Product Safety	<input type="checkbox"/> Part information <input type="checkbox"/> Electrical <input type="checkbox

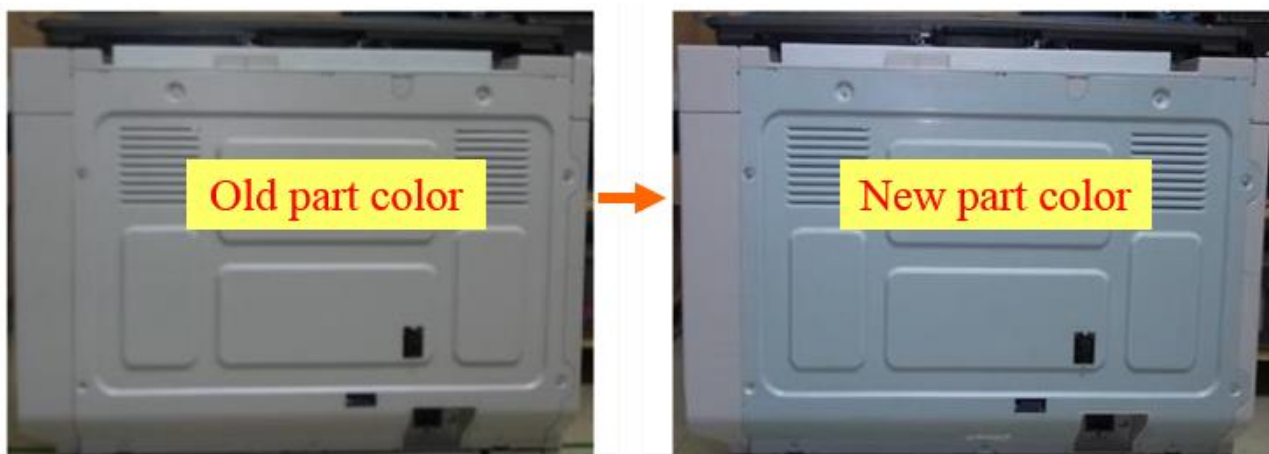
**Reason:** The material was changed.

**Note:** There is no difference in function between the old and new rear covers. The part number was changed for control purposes. Therefore, these parts do not have to be replaced as a set if the color difference is acceptable to the customer.
