# Technical Bulletin

Model: Bc-C1		Date: 06-Jul-15		15	No.:RD245001	
Subject: Cleaning points for preventive maintenance				Prepared	d by: H.M	Iorishima
From: 2nd Tech Service Sect., MFP/P Tech Service Dept.						
Classification:	Troubleshooting	] Part info ] Electrica ] Transm ] Other (	ormat al it/rec	tion eive )	<ul> <li>Action</li> <li>Servio</li> <li>Retrol</li> <li>Tier 2</li> </ul>	n required ce manual revision fit information

Model: BC-C1			Date: 03-Dec-15			No.:RD245006
Subject: Modified polygon mirror housing to prevent blurred image and low image density					d by: A.Is	hida
From: 2nd Tech Service Sect., MFP/P Tech Service Dept.						
Classification:	Classification:       Image: Troubleshooting       Image: Part in the part in		ormat al it/rec	tion eive )	<ul> <li>Action</li> <li>Servic</li> <li>Retrof</li> <li>Tier 2</li> </ul>	n required ce manual revision fit information

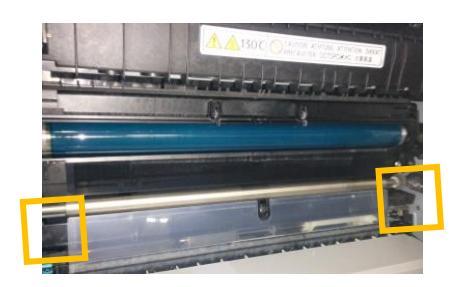
5. Around the PCU

Remove the drum to clean around the PCU.

Effective for: Stains on paper edges, Streaks

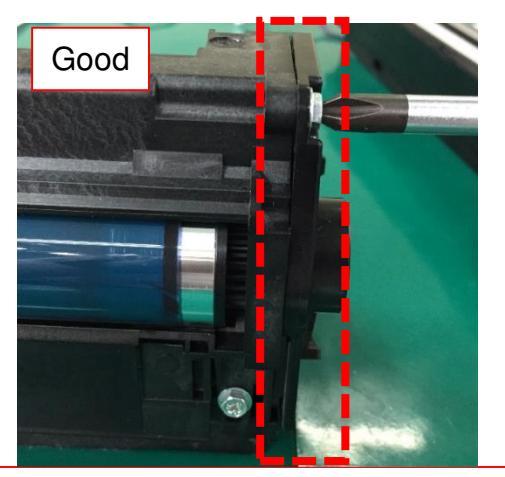
# Fasten the face plate with screws. **DO NOT** press the top surface of the frame. Doing so may narrow the development gap.

Hold the area indicated with the dotted line when fastening the screw. Then, install the coupling.

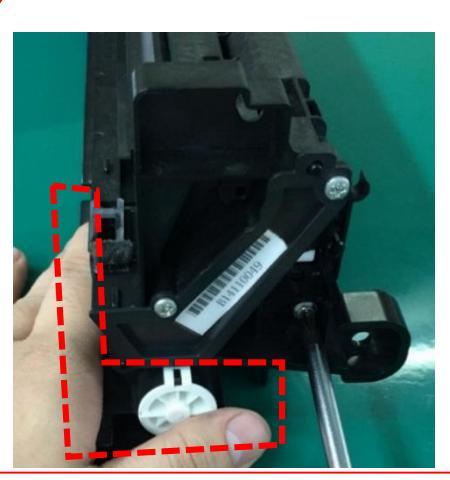
**DO NOT** press the top surface.

Support the area indicated with the dotted lines when fastening the screw. **Never press the top surface.**

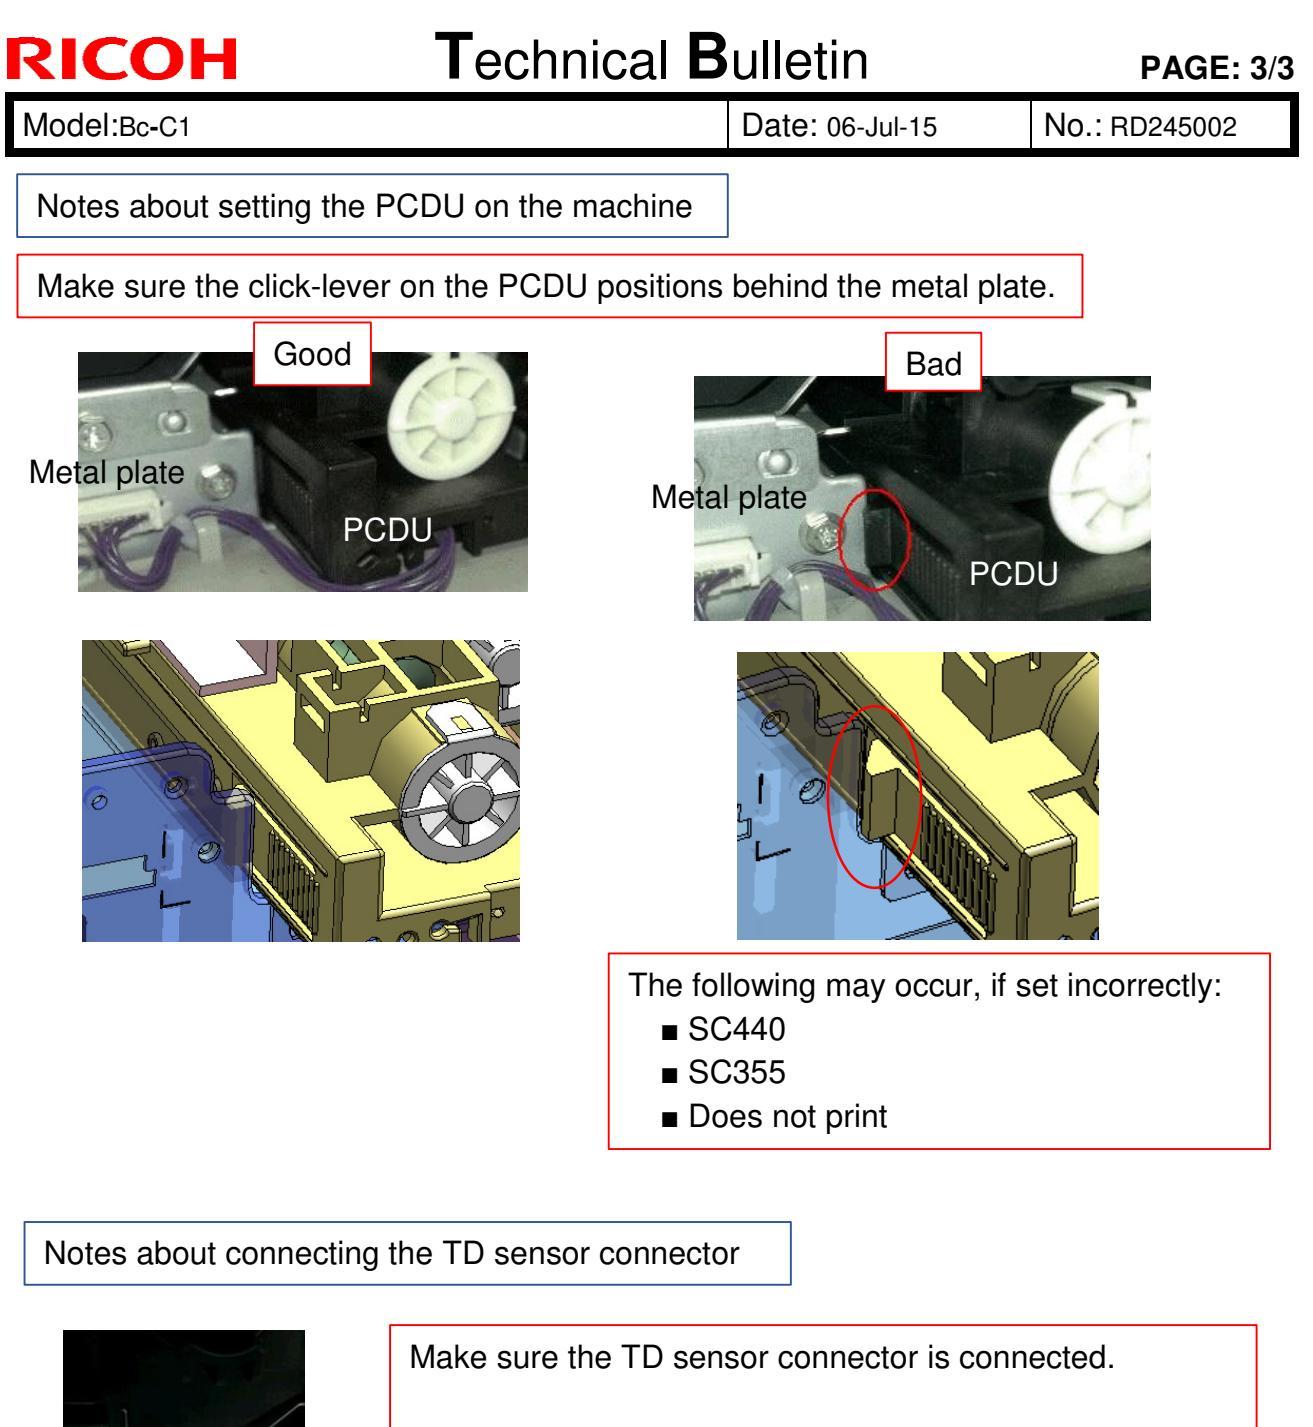
- If the connector is disconnected, the machine will not boot and remain displaying "Warming Up."
- If the connector is connected but the machine will not boot with the message "Warming Up" displayed,
   → pins 1~3 are snapped.

If the connector is connected but the machine posts SC362 (Abnormal TD sensor output),
 → pins 4~6 are snapped.

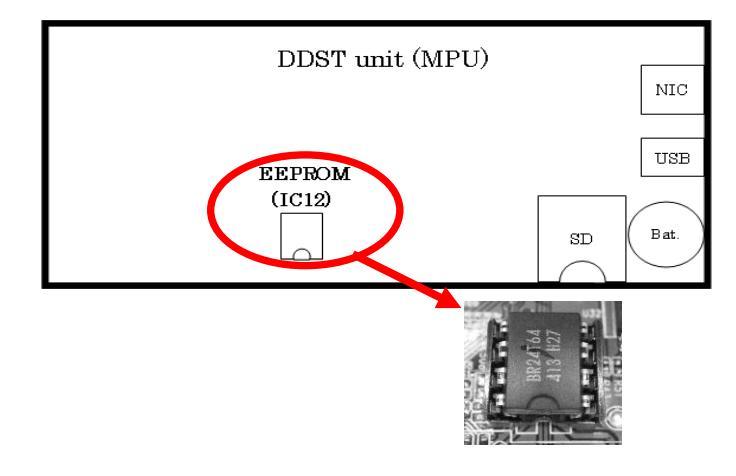
When replace with a new EEPROM, manually retrieve the original values including following 3 items by referring to the SMC sheet stored inside the front door of the machine.

- Language setting in UP (default: English)
- Model type (SP5-882-001)
   "0": MP2014
   "1": MP2014D
   "2": MP2014AD
- Serial No. Setting (SP5-811-001)

Otherwise, one or more of the following symptoms may be observed after replacing the EEPROM:

- The ADF does not work.
- The duplex unit does not work.
- Language setting switches to English.

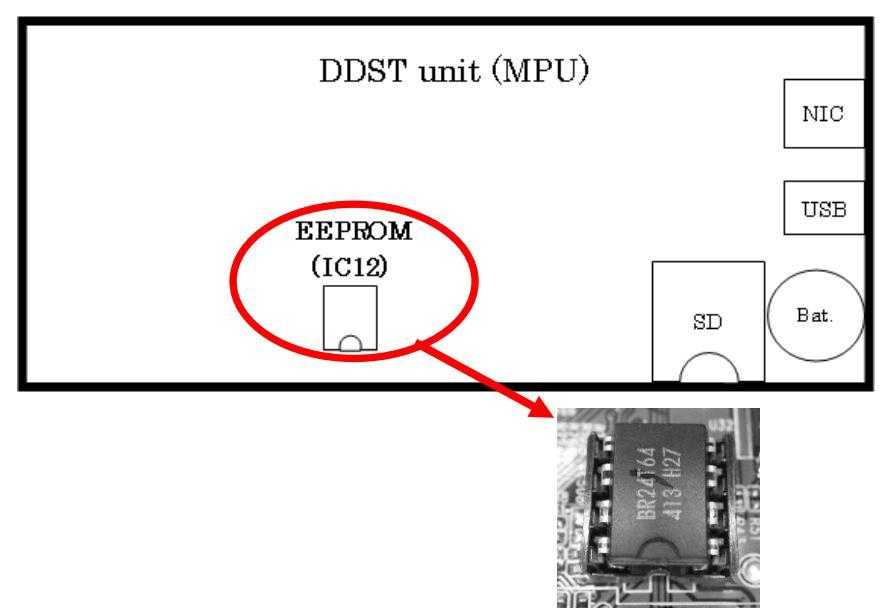
## Serial number missing after installing DDST unit

When installing the DDST unit or replacing the MPU board, install the EEPROM from original board on the new MPU board (DDST/service part).

Note: The EEPROM on the new MPU board is not needed.

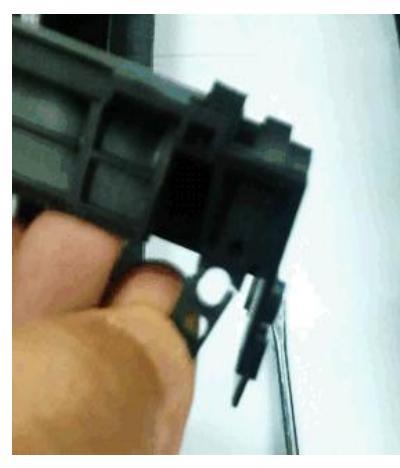
# Issues at installation (1): Cover of development unit broken

The hook of the development unit cover breaks easily during installation.

Hold the edges of the case as shown and lift up the frame. This will release the bosses on both ends of the case.

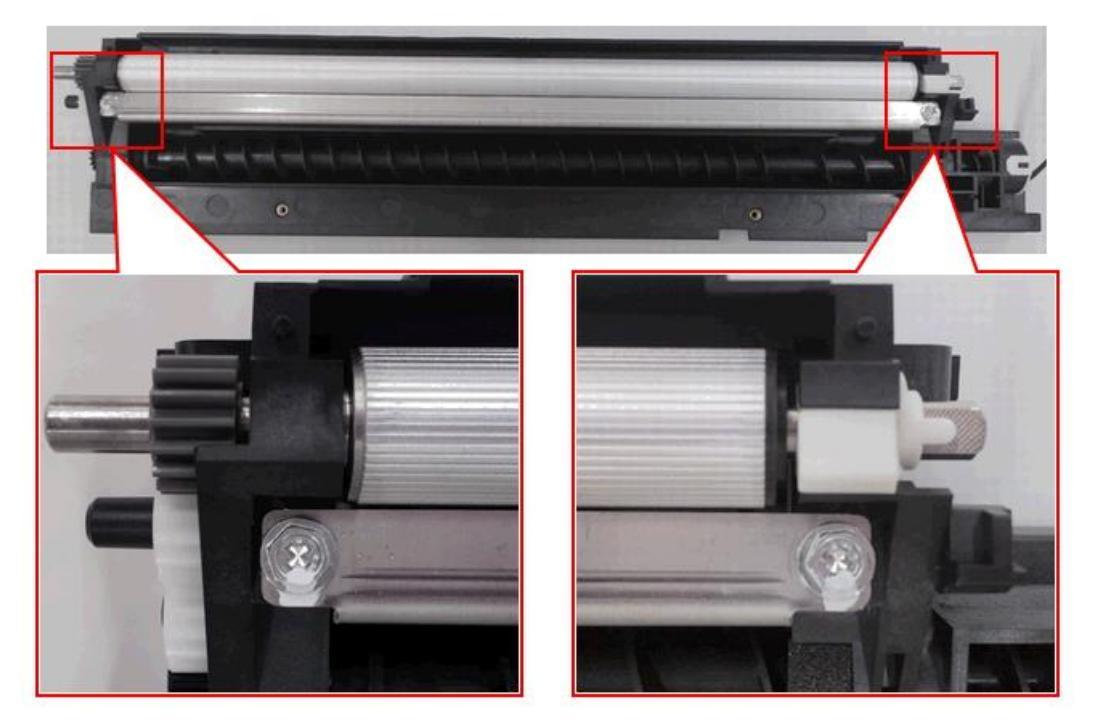
Replace the PCDU (adjustment cannot be performed in the field).

**Note:** The screws will be paint-locked on the production line (beginning from February 2016 production) to ensure they do not come loose.

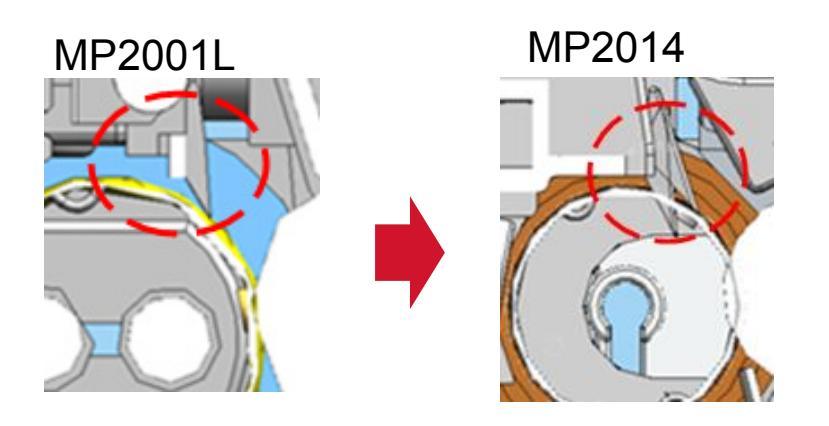
### Improvement 1: (Jam at fusing unit)

- a) The location of the separation pawl and angle of paper contact were changed.
- => Improves paper flow
- => Prevents the pawls from coming loose
- b) The nip position at fusing was changed
  - => The paper is fed straight forward to the fusing unit.

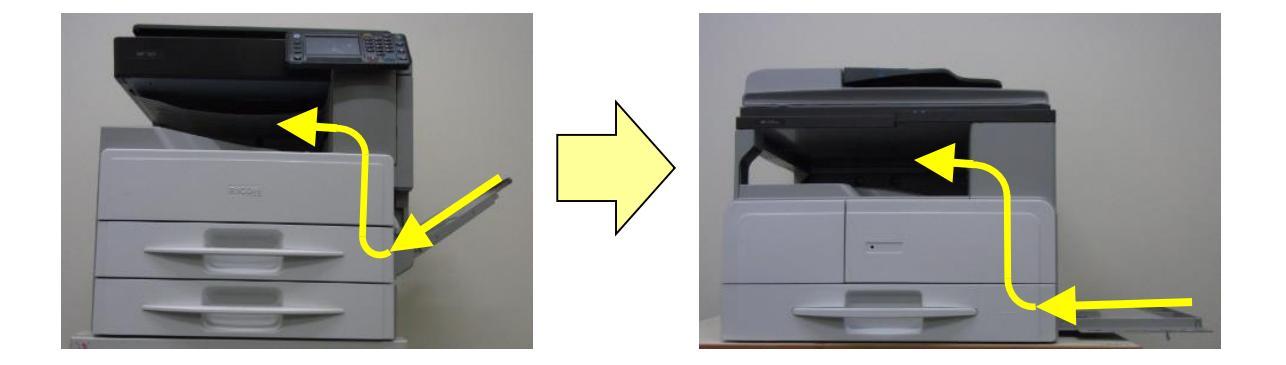
### Improvement 3: (Paper feed pass for bypass tray)

The paper feed route was improved, decreasing the load on the paper feed system.

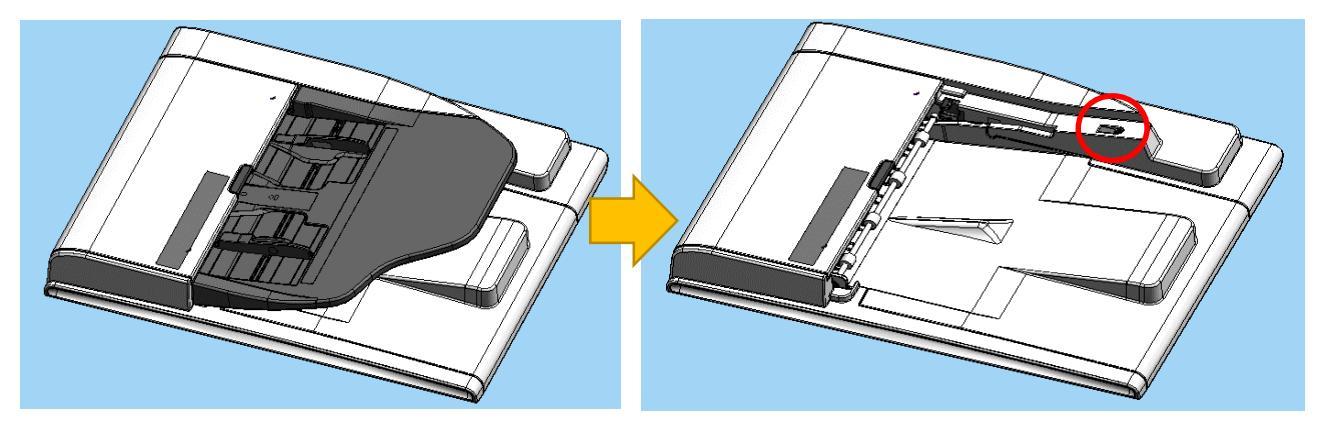
Image skews when copied from the ADF.

Rattling occurs between the side fences and the original table.

Replace the side fences with the modified side fences below. Make sure to change these fences together as a set.

1. Lift up the original table and remove this screw.

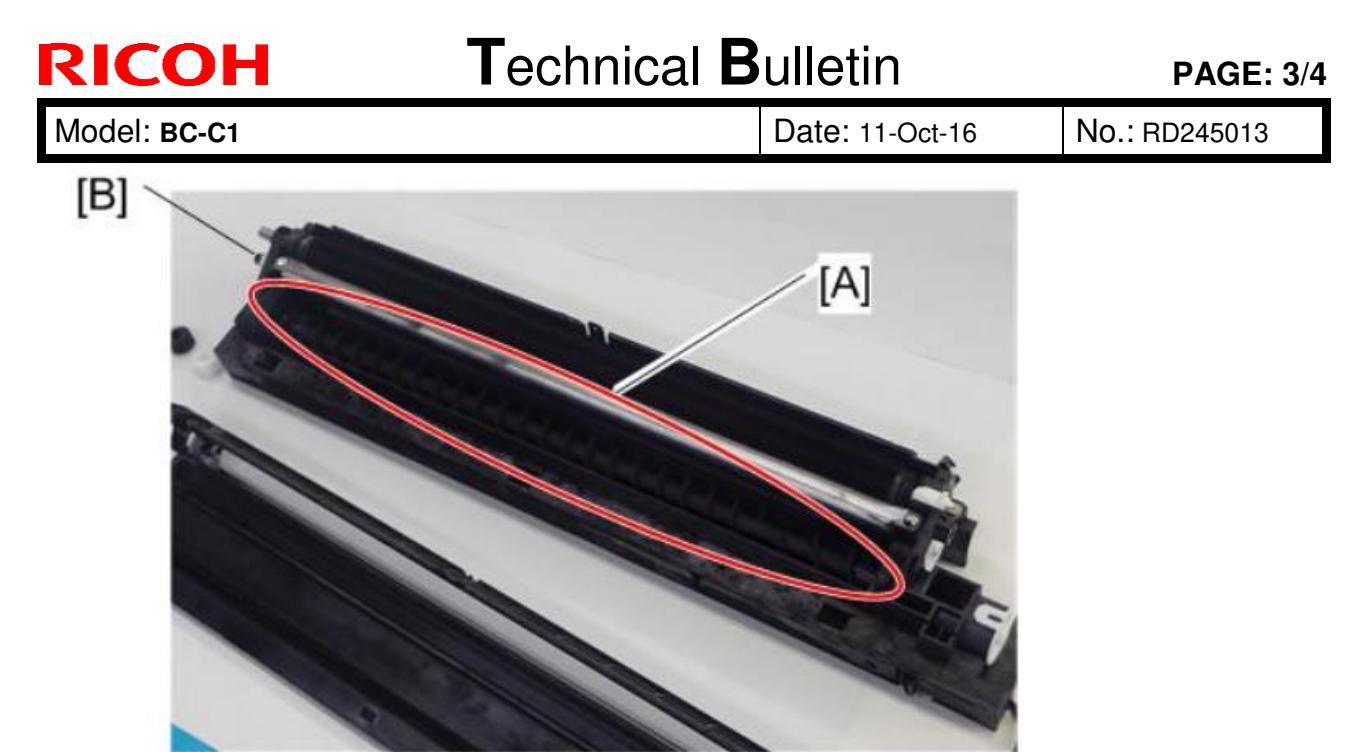
d245z0016

Do not spill the developer on the gears [B]. If you have spilled it, remove the developer by using a magnet or magnetized screwdriver.

NOTE: Do not rotate the development roller while pouring in the developer as this will cause the developer to accumulate on the rib under the development roller and make the setting of the upper case difficult.

14. Distribute a pack of developer to all openings [A] equally.

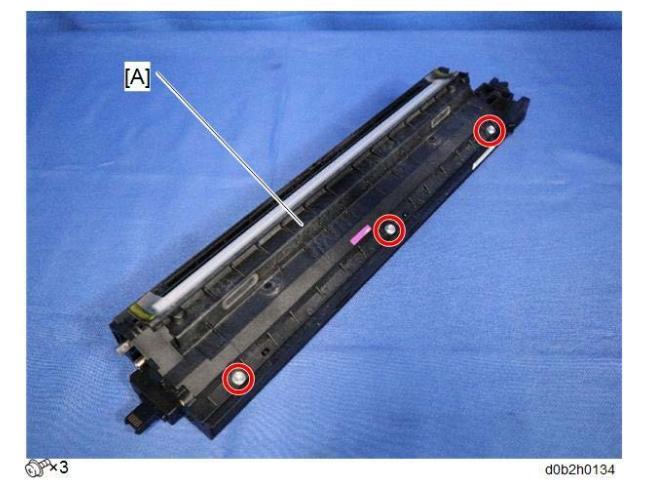
- 1. After separating the development unit from the OPC drum section, do the following.
- 2. Remove the top part [A] of the development unit.

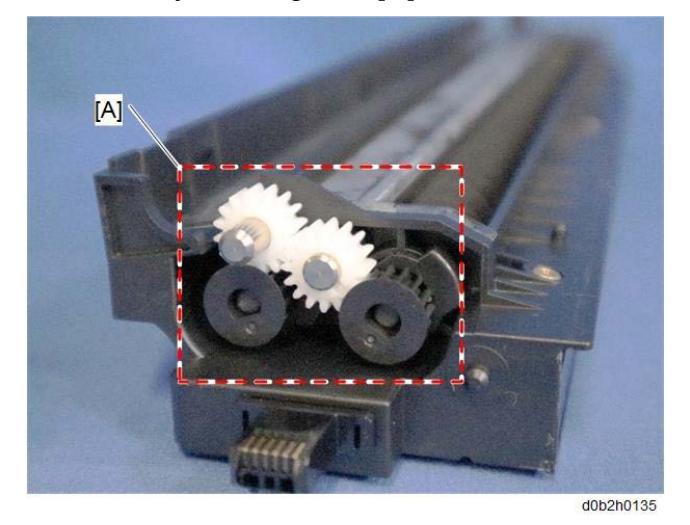
Note: If any of the gears [A] fall off, attach them as shown below.
