Model: OR-C1	Date: 12-Sep-11	No.: RD120001c
--------------	-----------------	----------------

Subject: Firmware Release Note: Fax		Prepared by: J. Kitagawa	
From: 1st Tech Service Sect.MFP/Printer Tech Service Dept.,			
Classification:	<input type="checkbox"/> Troubleshooting <input type="checkbox"/> Mechanical <input type="checkbox"/> Paper path <input type="checkbox"/> Product Safety	<input type="checkbox"/> Part information <input type="checkbox"/> Electrical <input type="checkbox"/> Transmit/receive <input checked="" type="checkbox"/> Other (Firmware)	<input type="checkbox"/> Action required <input type="checkbox"/> Service manual revision <input type="checkbox"/> Retrofit information <input checked="" type="checkbox"/> Tier 2

This RTB has been issued to announce the firmware release information for the **Fax**.

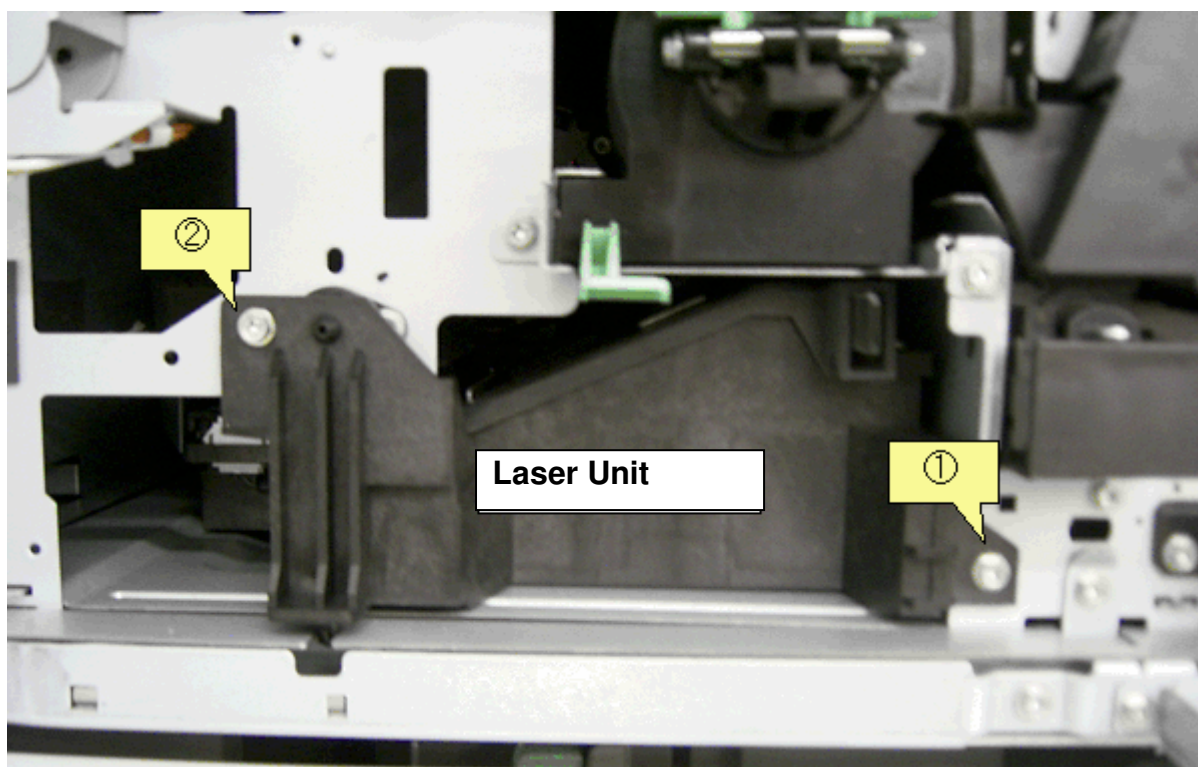
Part of the image is missing on the right side along the sub-scan direction, as shown in the photo below.

If the symptom occurs, or whenever you replace the laser unit or PCU **on a machine produced before the Cut-in S/N**, adjust the attachment position of the laser unit as follows.

- 1) Open the duplex unit.
- 2) Remove the upper front cover (screw x 1, hook x 1).
- 3) Remove the front cover (pin x 2).
- 4) Remove the front inner cover (screw x 5).
- 5) Loosen the two screws ("(1)" and "(2)" in the photo) that fix the laser unit in place.
Important: If you are replacing the laser unit, remove these screws and then attach the new unit.
- 6) Lift up the **right** side of the laser unit as far as it will go, and hold the unit there while you tighten **screw (1)**.
- 7) Tighten screw (2) on the left side of the unit.
- 8) Reattach the front inner cover, front cover, and upper front cover, and then close the duplex unit.
- 9) Check the image quality and make sure the symptom does not occur.

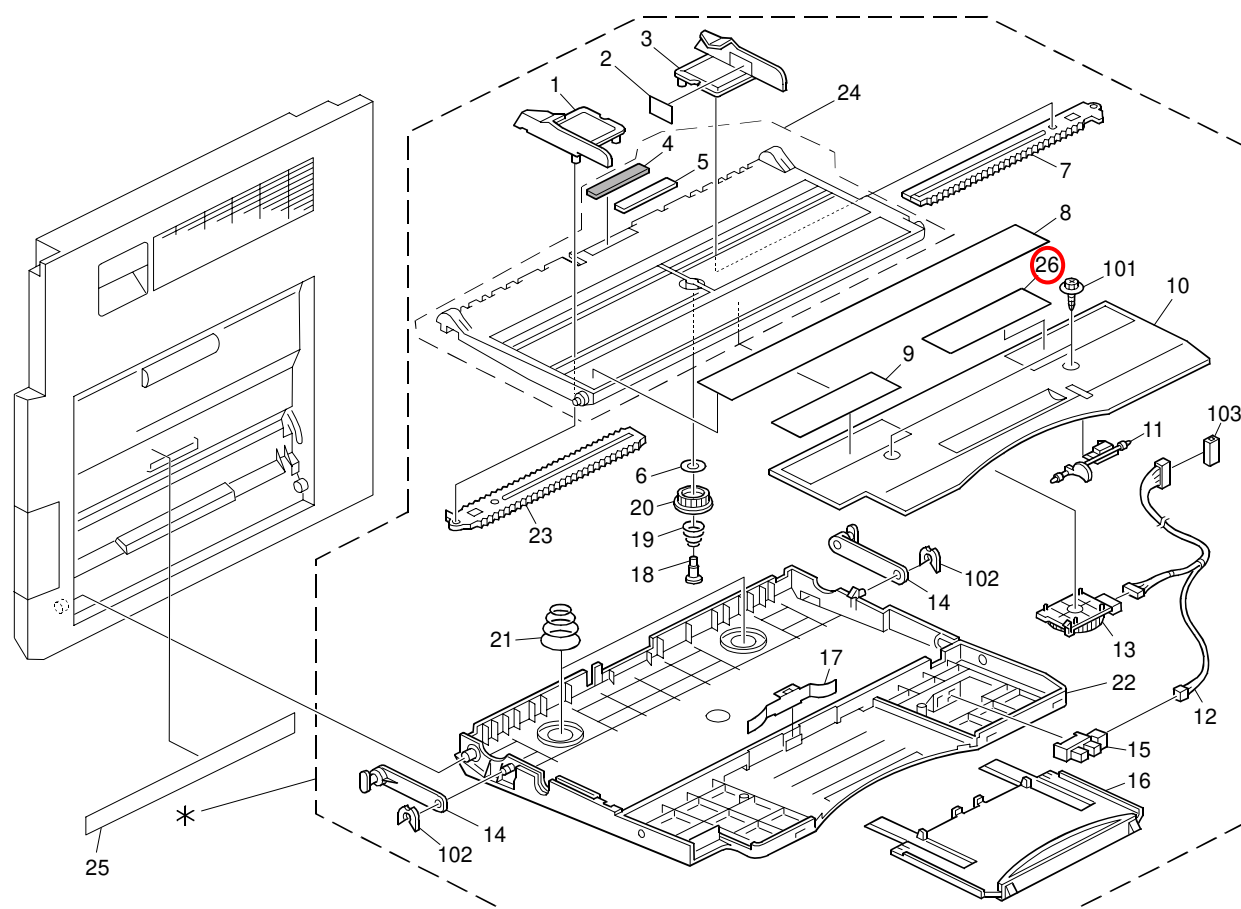
Change: A decal was added that urges the operator to extend the tray extension when feeding A3 sheets from the bypass tray.

Reason: To ensure that bypass jams do not occur when A3 sheets are fed from the bypass tray. (This can happen if the operator does not extend the extension tray, since the machine cannot detect the paper size correctly).

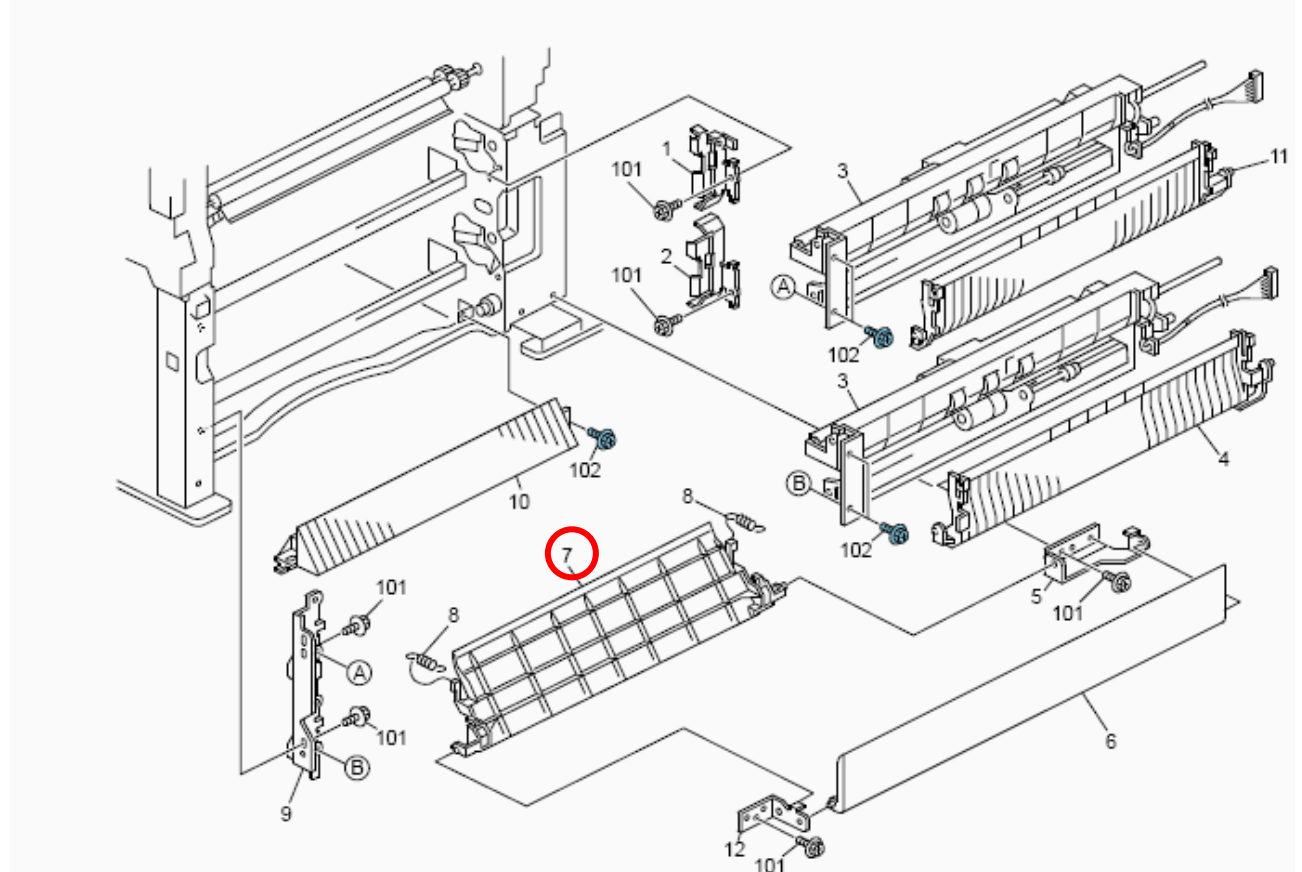
9.Paper Feed Section 1 (D120/D121/D122/D139/D140/D141)

The person installing the machine carries it by the bottom right section of the frame (circled in red below), instead of using the correct holding positions. As a result, the right vertical transport guide is damaged, and the paper cannot be fed correctly.

Part number	Description	Q'ty	Page	Index
D1202962	GUIDE PLATE:VERTICAL TRANSPORT:RIGHT	1	25	7

An instructional sheet will be taped to the right side of the machine, as shown in the photo below. Make sure all installers are aware of the correct way to carry the machine.

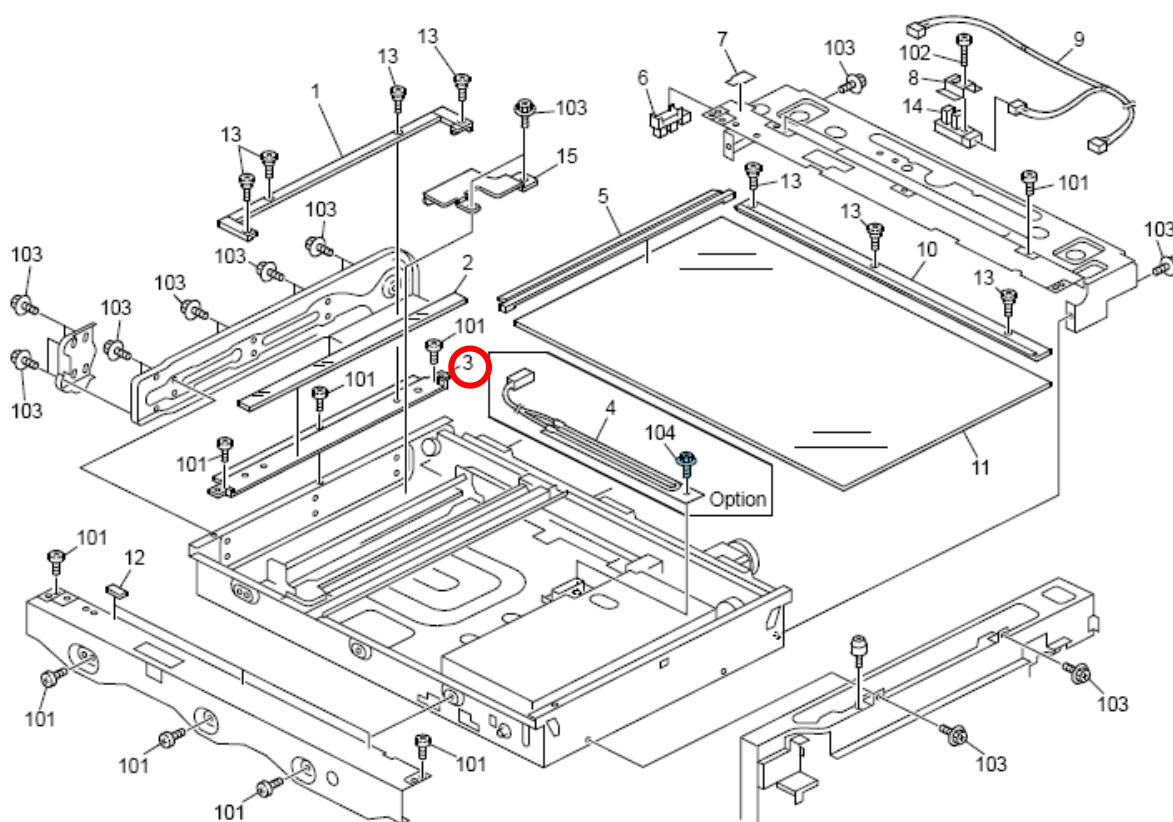
5.Scanner Section1 (D120/D121/D122/D139/D140/D141)

In some cases, the shape of the DF bracket causes the clearance between the DF exposure glass and DF itself to decrease. As a result, it is easier for thin paper types (those with low stiffness) to jam.

Replace the document feeder bracket with the following service part:

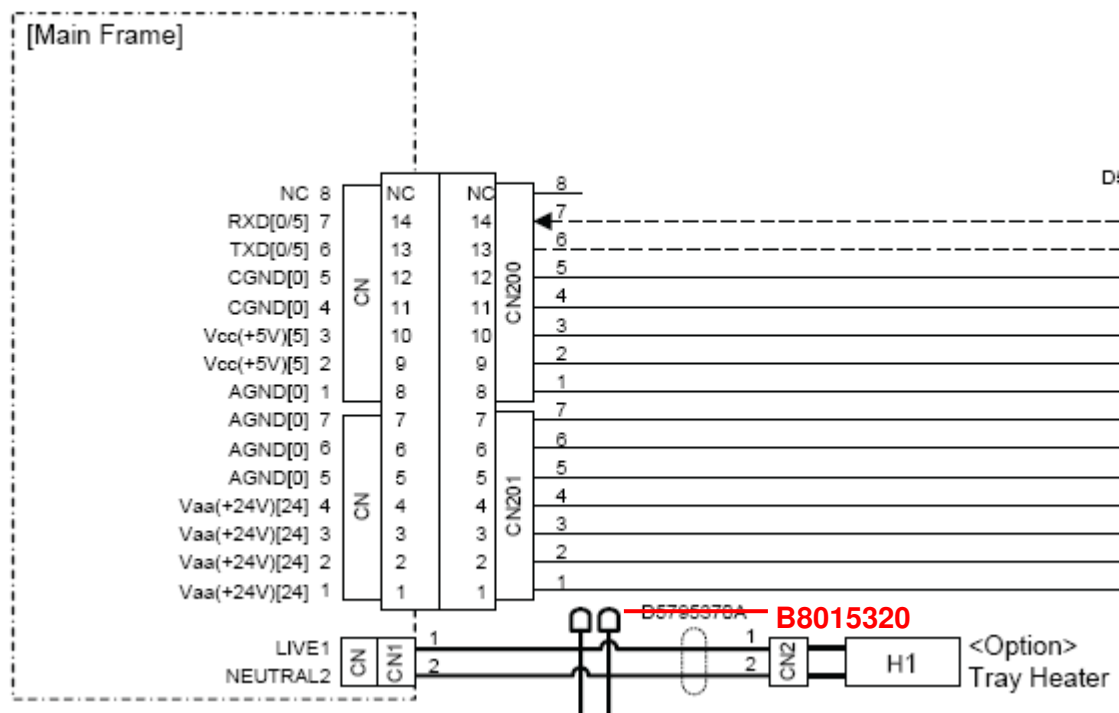
D579 (PB3120 Paper Feed Unit) Point To Point Diagram (8/29)

Incorrect P/N	Correct P/N	Name	Page
D5795370	B8015320	HARNESS - HEATER	8/29

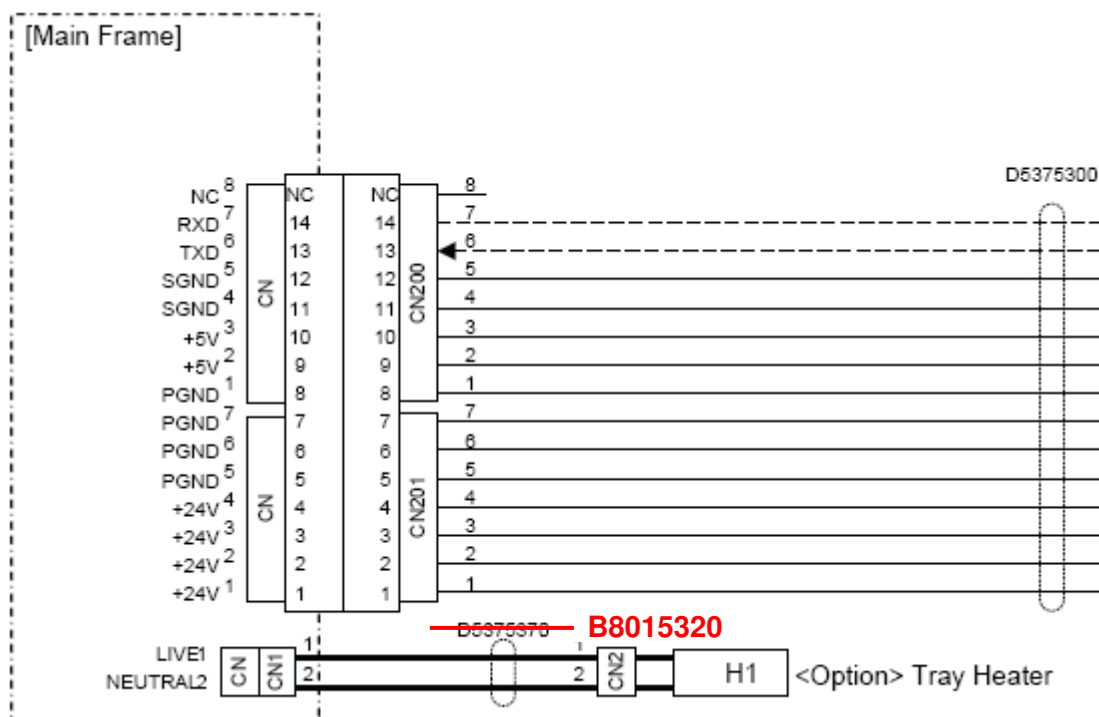
D581 (PB3140 Paper Feed Unit) Point To Point Diagram (12/29)

Incorrect P/N	Correct P/N	Name	Page
D5375370	B8015320	HARNESS - HEATER	12/29

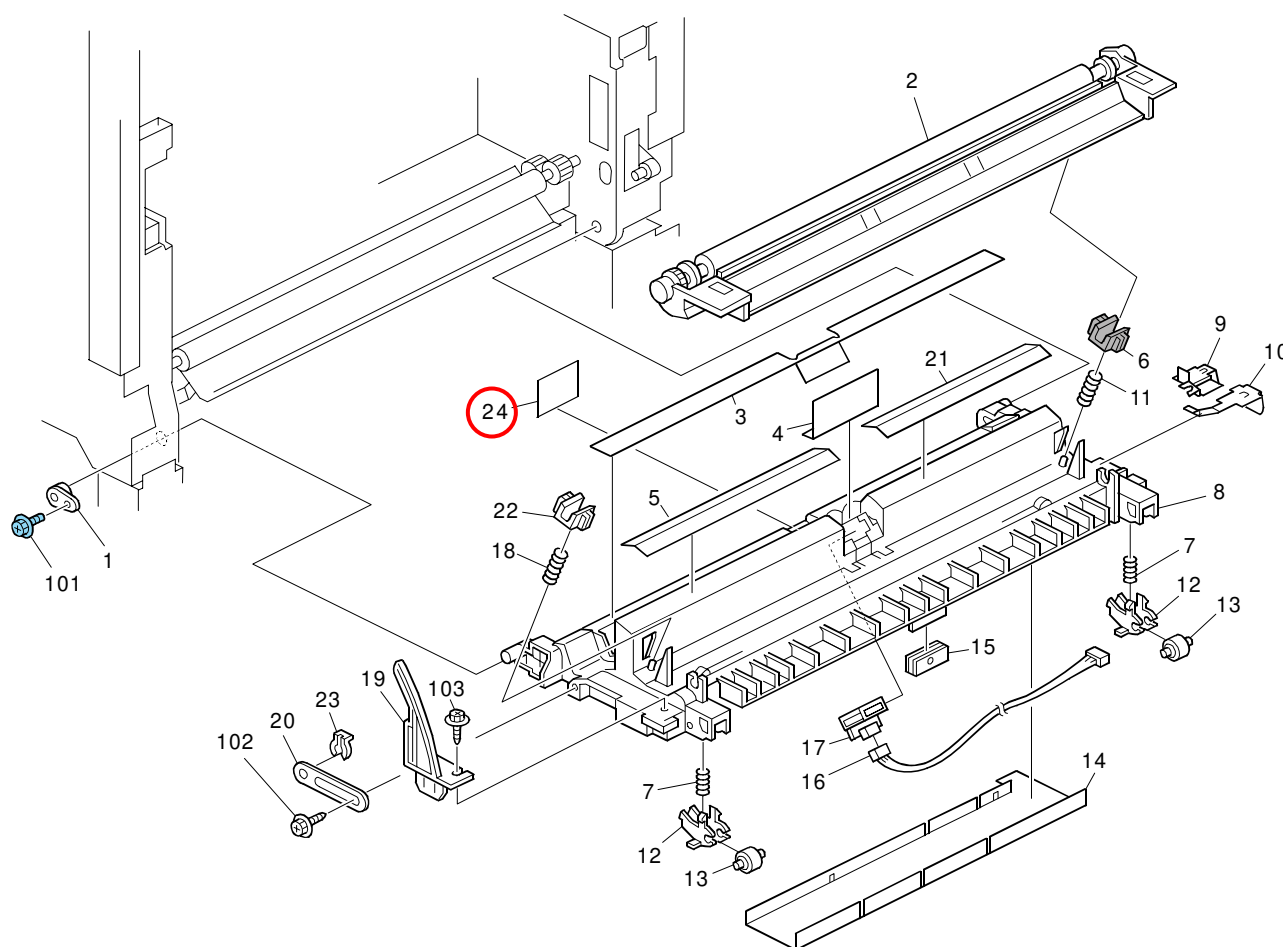
Reason: To further improve registration detection.

Old part number	New part number	Description	Q'ty	Int	Page	Index	Note
	D1202851	SHEET:REGISTRATION SENSOR:OPPOSED	0-1		39	24

See page 2 for diagrams showing the attachment position.

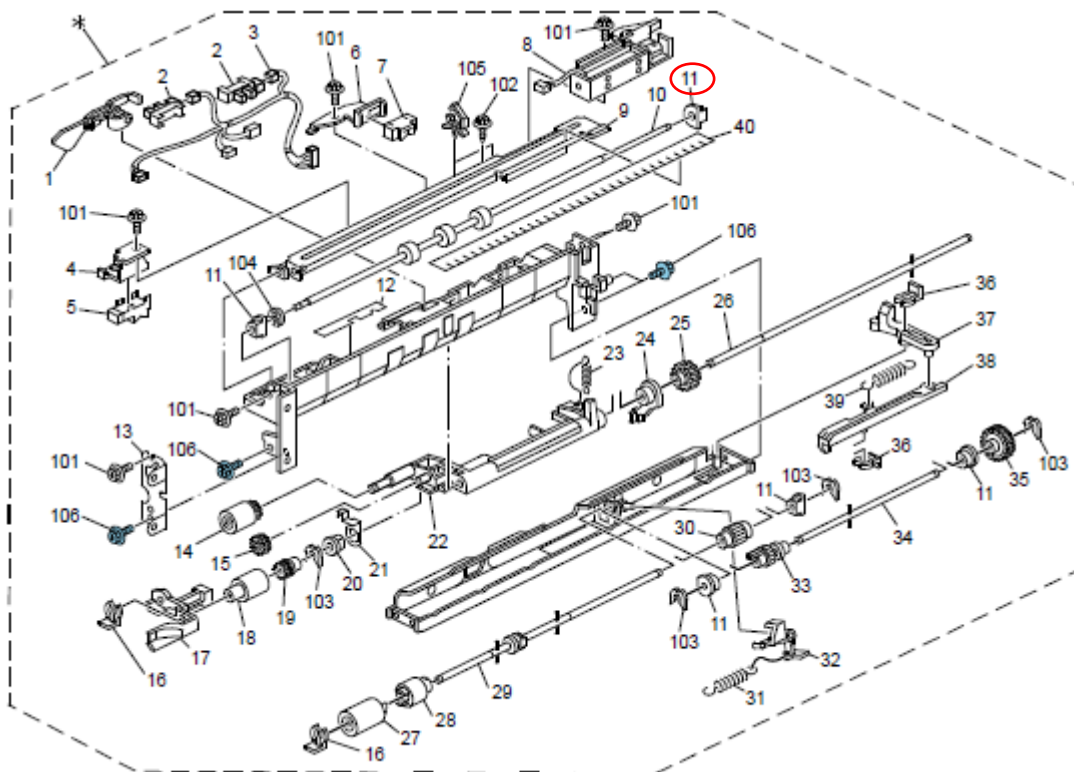
The part circled in red below shrinks in low temperatures, which can sometimes cause the transport roller (index #10) to lock up.

Replace the bushing (index #11) with the modified one.

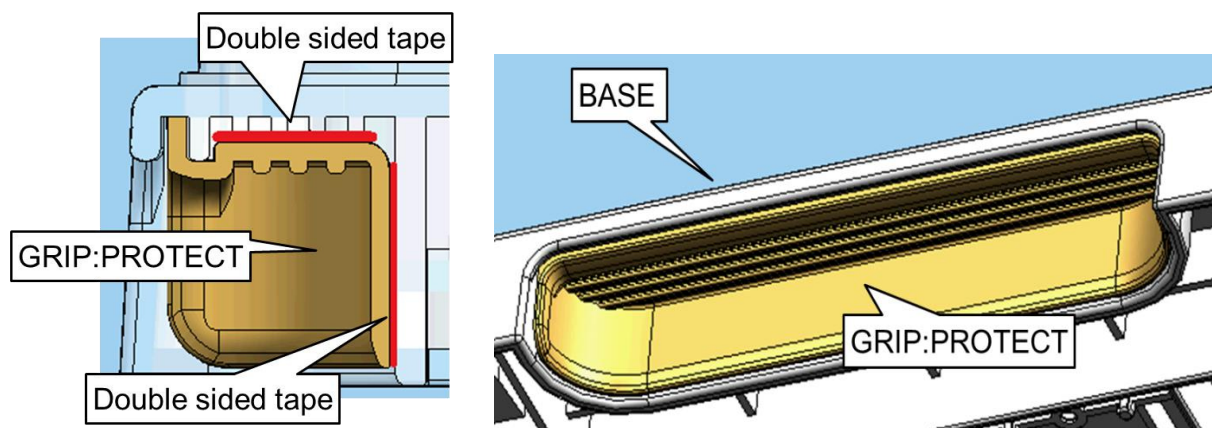
Note: The handgrip can be damaged when the DF is opened/closed repeatedly.

Important: Attach the grip to the base using double-sided tape.

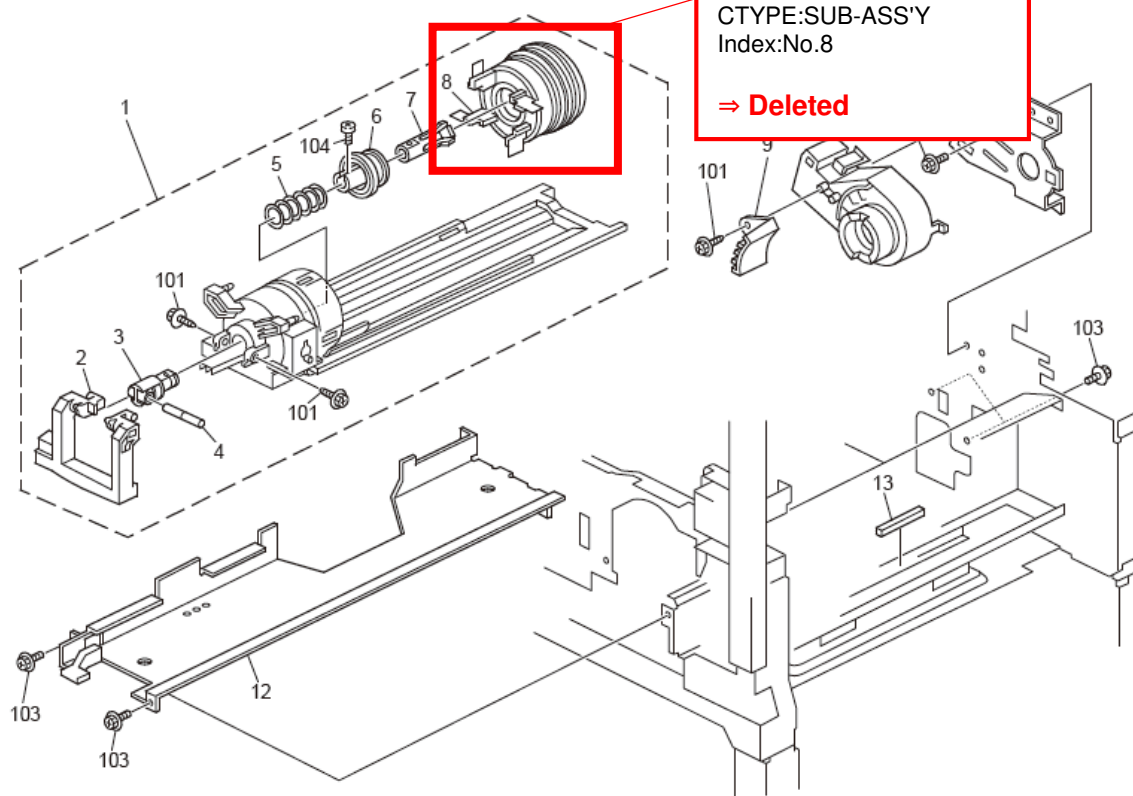
14.Toner Supply Unit (D120/D121/D122/D139/D140/D141)

Reason: Replacing this part in the field has the risk of causing toner leakage.

Note: Procure the assembly unit (p/n: D1203505) when required to replace the toner bottle cover.

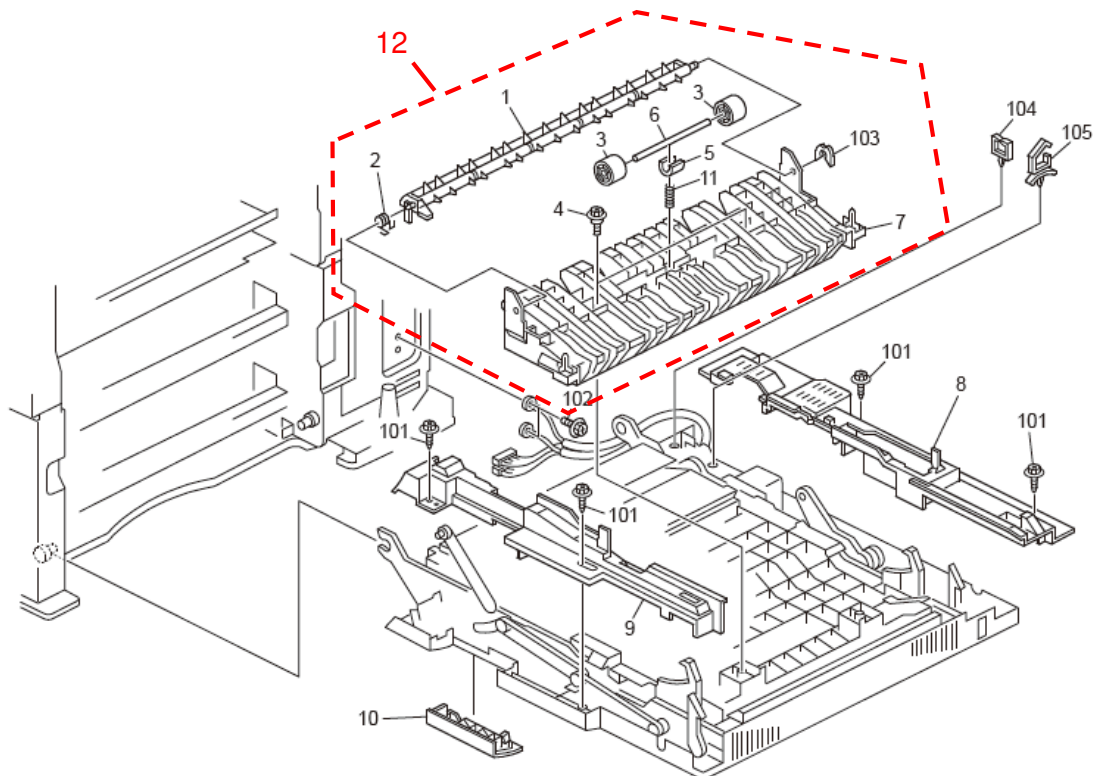
21.Duplex Section 1 (D120/D121/D122/D139/D140/D141)

Change: Part number of the Guide Plate was added.

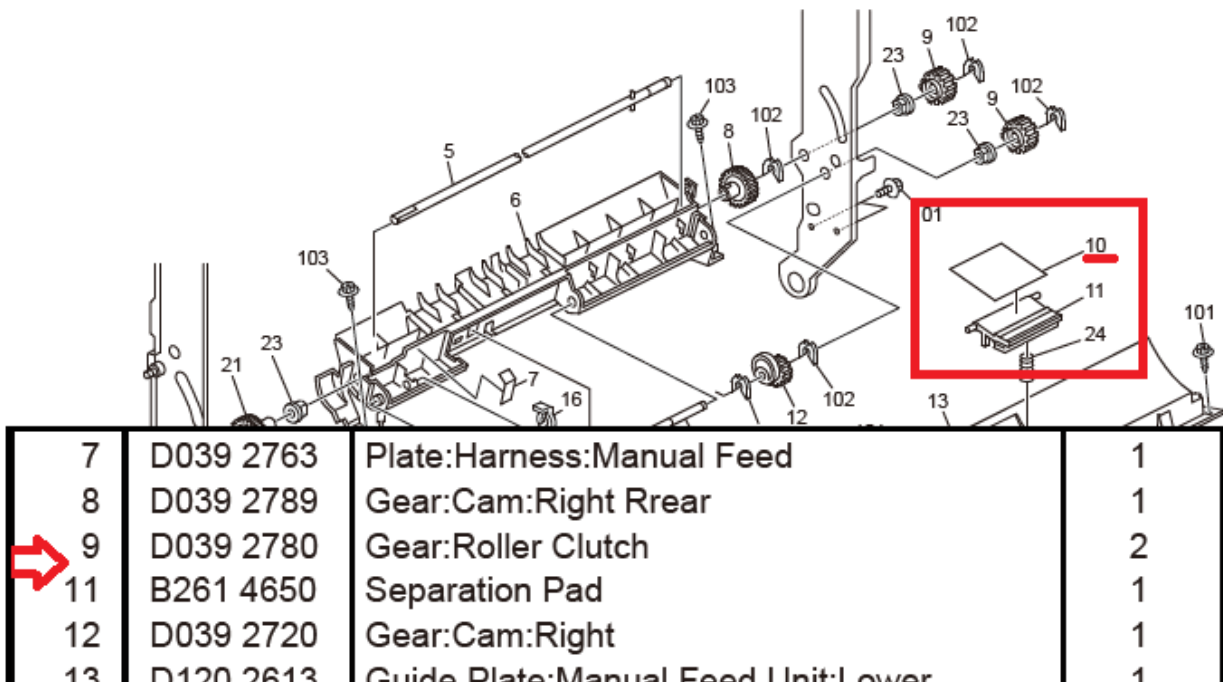
25.Duplex Section 5 (D120/D121/D122/D139/D140/D141)

Parts Number of Duplex section 5, Item #10 isn't given in the Parts Catalog.
 The part number is **D1202614**.
 For the part number in the Parts Catalog, refer to the following figure.

#10 D1202614 (mylar)
