Model: PR-C1		Date: 29-Jun-07	No.: RD010001
Subject: ROM History for Engine for PR-C1		Prepared by: Yuichiroh Murata	
From: 1st Tech. Support Sec. Service Support Dept.			
Classification:	<input type="checkbox"/> Troubleshooting <input type="checkbox"/> Mechanical <input type="checkbox"/> Paper path <input type="checkbox"/> Product Safety	<input type="checkbox"/> Part information <input type="checkbox"/> Electrical <input type="checkbox"/> Transmit/receive <input checked="" type="checkbox"/> Other ()	<input type="checkbox"/> Action required <input type="checkbox"/> Service manual revision <input type="checkbox"/> Retrofit information

We hereby inform you of the Engine firmware history for the PR-C1.

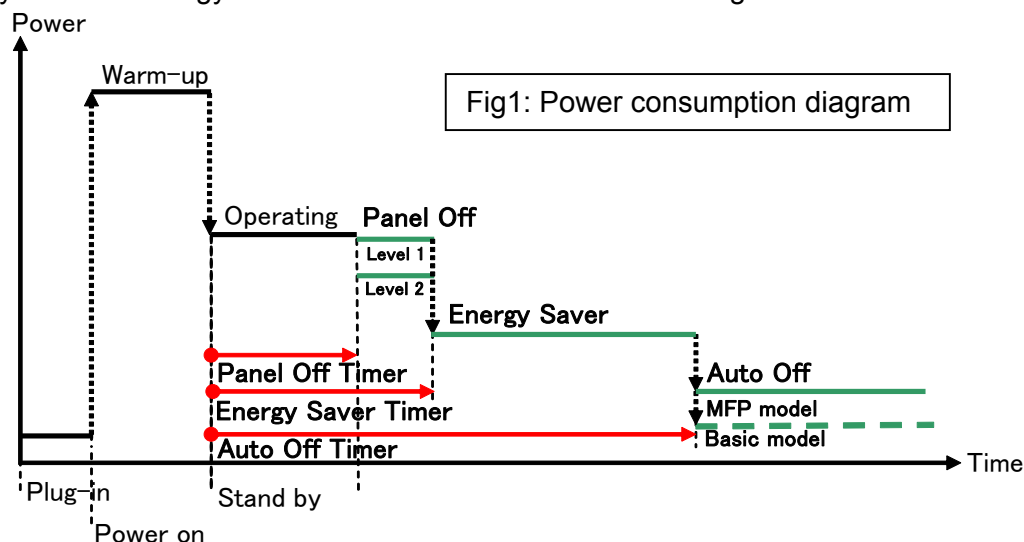
Ricoh products are designed to help our customers to reduce their power consumption. The following table shows Ricoh recommended setting values for Panel off timer, Energy saver timer and Auto off timer for energy saving.

Note: We cannot change the default settings to be the recommended settings, because we already took the Energy Star certification with the default settings.
