Model: OR-C2		Date: 20-Sep-13	No.: RD184001
Subject: Data Overwrite Security Unit Type I		Prepared by: T. Nihei	
From: 2nd Tech Service Sect., MFP/P Tech Service Dept.			
Classification:	<input type="checkbox"/> Troubleshooting	<input type="checkbox"/> Part information	<input type="checkbox"/> Action required
	<input type="checkbox"/> Mechanical	<input type="checkbox"/> Electrical	<input checked="" type="checkbox"/> Service manual revision
	<input type="checkbox"/> Paper path	<input type="checkbox"/> Transmit/receive	<input type="checkbox"/> Retrofit information
	<input type="checkbox"/> Product Safety	<input type="checkbox"/> Other ()	<input type="checkbox"/> Tier 2

Service Manual Revision

Data Overwrite Security Unit Type I (D362)

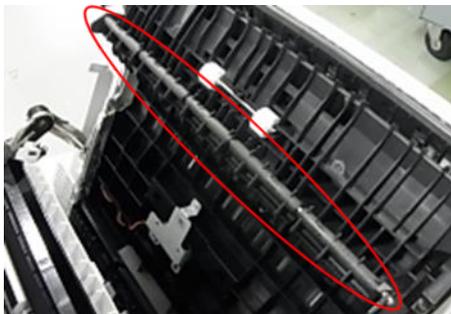
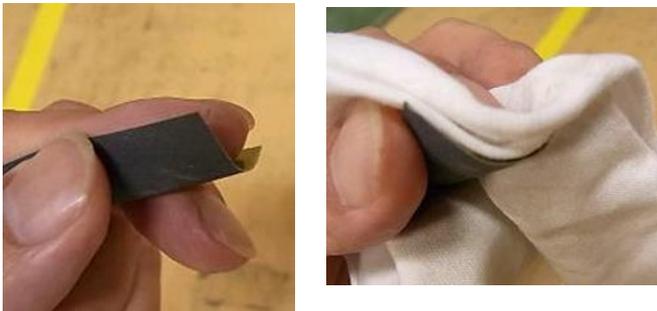
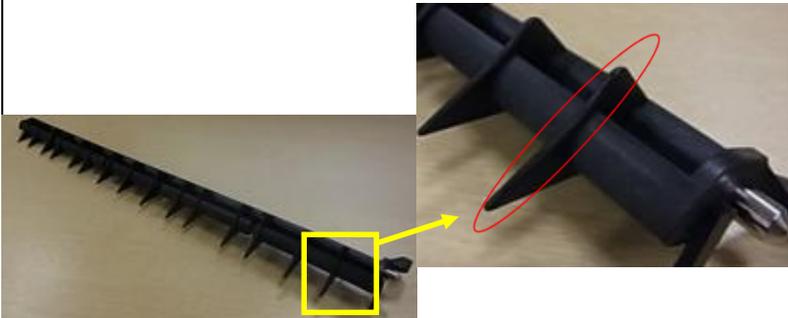
<p>Touch both tips of the gate pawl and check for any sharp or rough edges.</p>

<p>-Open the machine's right cover. -Remove the lower gate pawl (AF025045).</p>
2	<p>Sandpaper</p>

<p>-Bend the sandpaper and hold it as shown in the photo on the left.</p> <p>Note: You can also use a cloth between the sandpaper and your finger, as shown in the photo on the right.</p>
3	<p>GATE PAWL:LOWER (AF025045)</p>

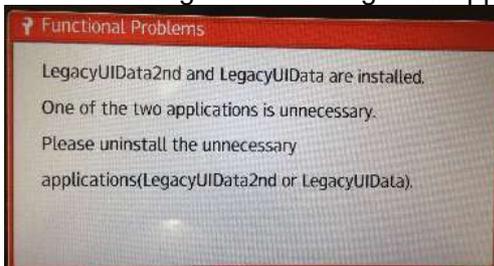
Do not install “LegacyUIData2nd”. In addition, updating “LegacyUIData” is not necessary. If “LegacyUIData” and LegacyUIData2nd are both accidentally installed, the following error message will appear. In this case, please delete “LegacyUIData2nd”.

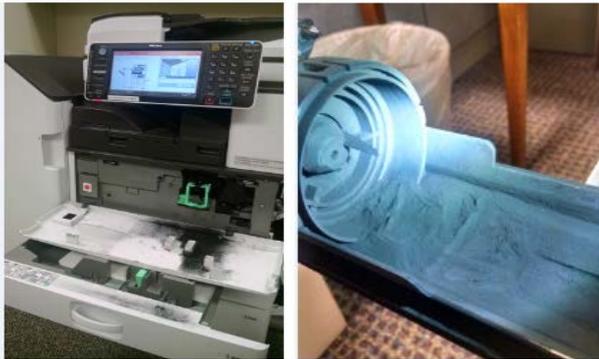
The toner spills out when the bottle is pulled out of the machine.

Partial peeling of the seal on the toner supply unit (Factory assembly problem).

Replace the toner supply unit with P/N D1203505.

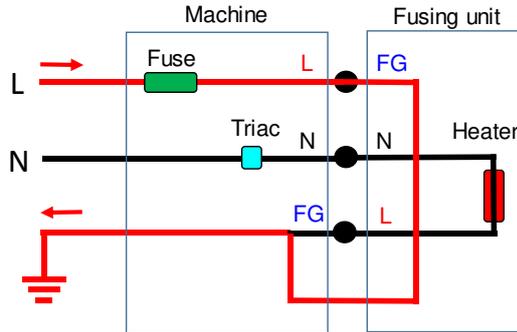
#1. Case

- LN: Normal
- Grounding

Overcurrent

- Fuse blows
- Circuit Breaker trips
- Electrical leakage breaker trips

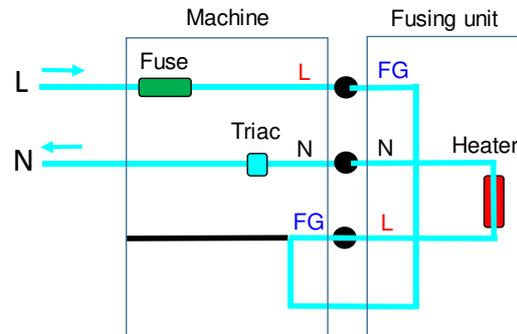
#2. Case

- LN: Normal
- No grounding

No overcurrent

- No blown fuse
- No circuit breaker trip
- No electrical leak, breaker trips

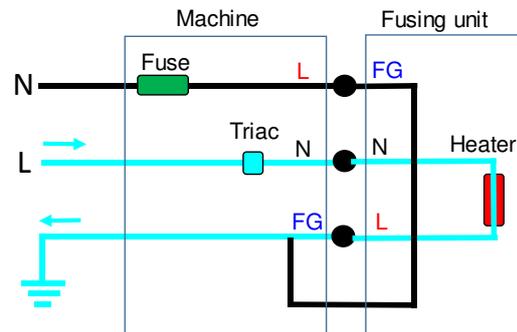
- LN: Opposite
- Grounding

No overcurrent

- No fuse blow
- No circuit breaker trip
- Electrical leakage breaker trips

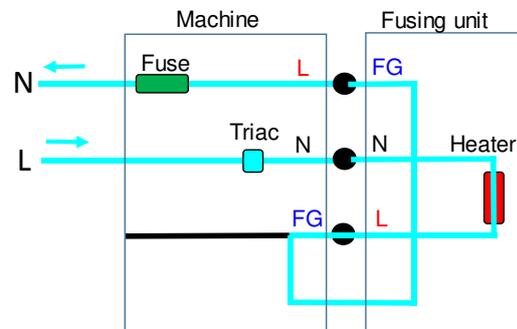
- LN: Opposite
- No grounding

No overcurrent

- No blown fuse
- No circuit breaker trip
- No electrical leakage, breaker trips

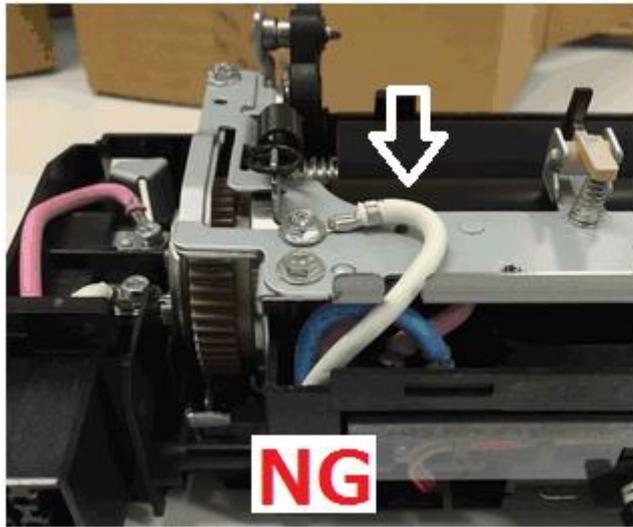
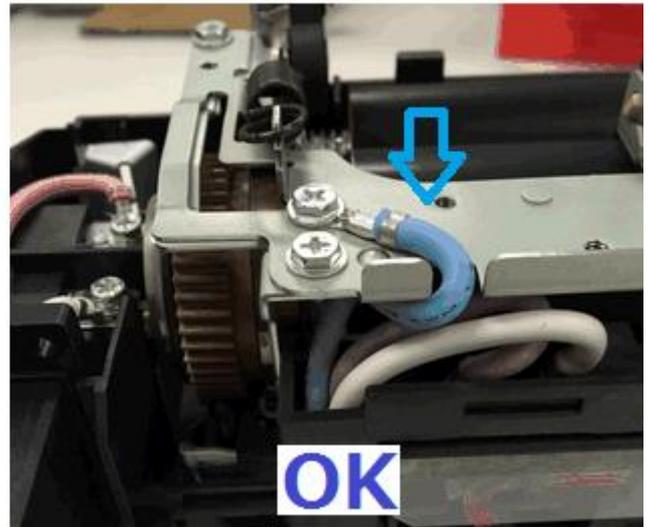
The wiring was done incorrectly at the factory. Specifically, the blue wire (FG) should be screwed to the metal frame, but instead, the white wire (L) is used for grounding. In addition, the testing device used to detect such errors was not working properly.

- When you replace the fusing unit in the field (with a new service-parts unit), make sure that the blue lot is wired to the frame on the new unit, as shown in the “OK” photo above.
- ~~**If the harness has been incorrectly wired, do not use this unit. Report this to your regional headquarters together with the S/N of the unit, and order a new unit.**~~
- **If the wiring is incorrect, please rewire it correctly.**

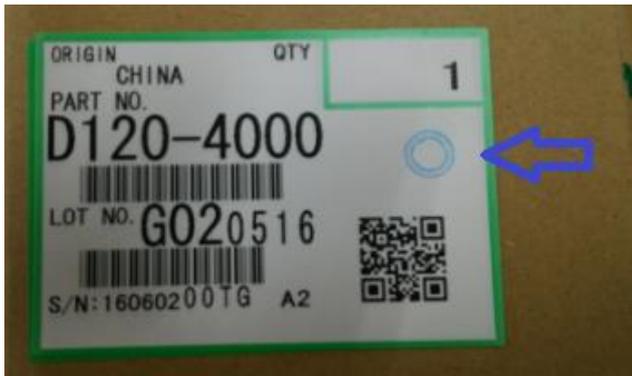
- If there is a blue circle stamped on the label of the service-parts box, this means that the unit has been checked and has undergone insulation and pressure resistance testing (at the Service Parts Center).
- ***If the lot number is G010616 or later, the unit has undergone insulation and pressure resistance testing. (There is no blue circle stamped.)***

**Reading the lot number:*****G020516: 2nd May 2016 production (G: suffix, DD, MM, YY)***
