Model: S-C5	Date: 21-Mar-12	No.: RD127001b
-------------	-----------------	----------------

Subject: Firmware Release Note: (Java VM v10 for eDC)		Prepared by: H. Tamaki	
From: 1st Tech Service Sect., MFP/Printer Tech Service Dept.			
Classification:	<input type="checkbox"/> Troubleshooting	<input type="checkbox"/> Part information	<input type="checkbox"/> Action required
	<input type="checkbox"/> Mechanical	<input type="checkbox"/> Electrical	<input type="checkbox"/> Service manual revision
	<input type="checkbox"/> Paper path	<input type="checkbox"/> Transmit/receive	<input type="checkbox"/> Retrofit information
	<input type="checkbox"/> Product Safety	<input checked="" type="checkbox"/> Other (Firmware)	<input checked="" type="checkbox"/> Tier 2

This RTB has been issued to announce the firmware release information for the **Java VM v10 for eDC**.

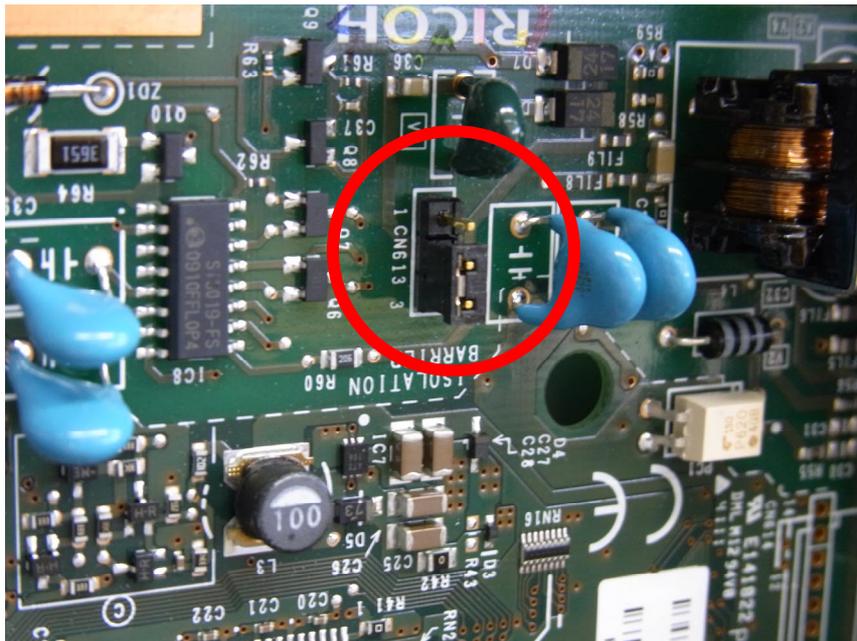
Note: In its default position, the switch covers the middle and "3" pin.

For installation in Brazil, move the jumper switch (CN613) on the fax board so that the edge is anchored at "1" (so that the middle pin and the "1" pin are covered).

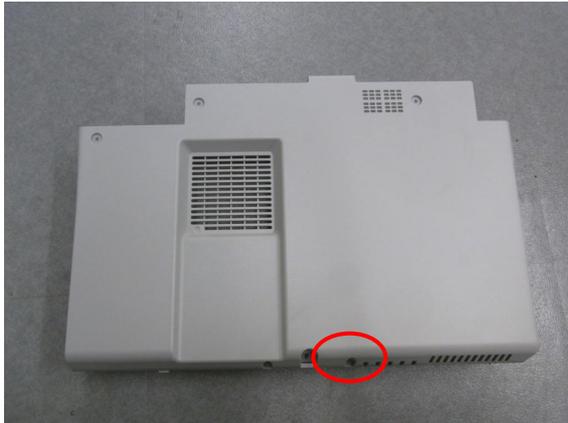
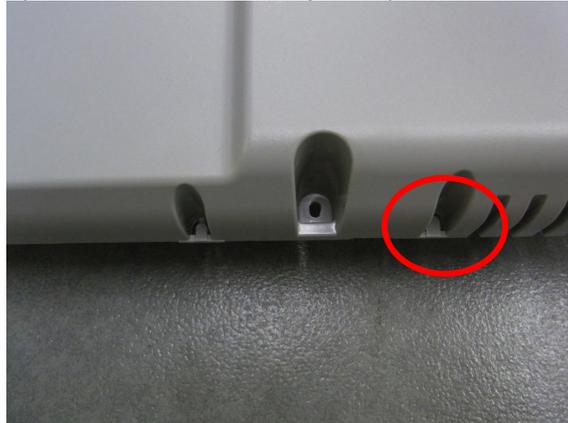
1. Remove the rear cover.
2. Remove the cut-out in the rear cover (circled in red in the photo).

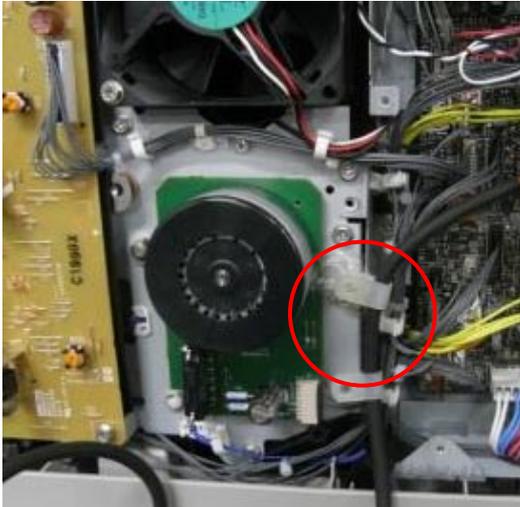
7. Connect the vendor's harness for the external key counter device to **CN4** (20 pins) on the **MKB**.

Important: Secure the vendor's harness with a nylon clip and screw (M3 x 8).

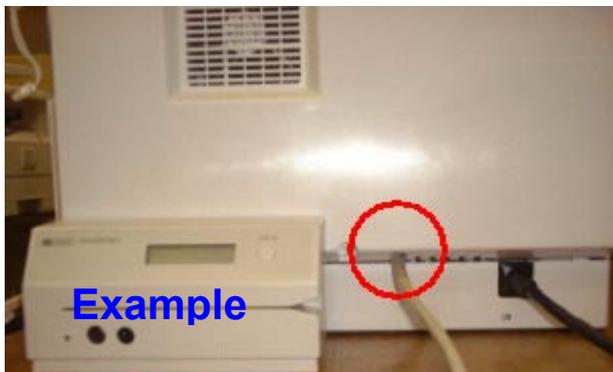
8. Reattach the rear cover.

Important: Route the vendor's harness through the cut-out hole shown in Step 2.

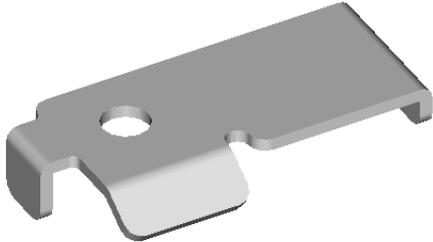
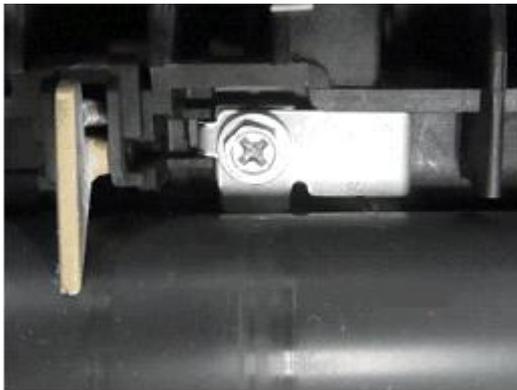
D1274180: Thermistor Cover

In this case, the thermistor may be damaged.

First, instruct the customer not to use a sharp object when removing jammed paper.

Next, if the thermistor and its harness are visible, add the thermistor cover (p/n: D1274180) by the following procedure.

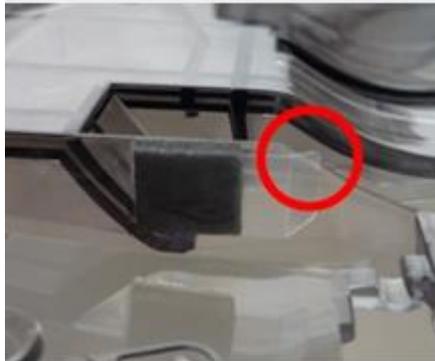
[A] (Symptom)

1. The customer uses an unsupported thin paper type (approx. 0.33gsm or thinner), which causes the ADF feed unit to interfere with the movement of the pick-up roller. As a result, the pick-up roller cannot be lowered to the proper position.

- **If the customer is using an unsupported thin paper type** (approx. 0.33gsm or thinner), replace the ADF feed unit (P/N D6062122; HOLDER:PICKUP ROLLER).
- **In all other cases**, do the **Procedure** on the next page.

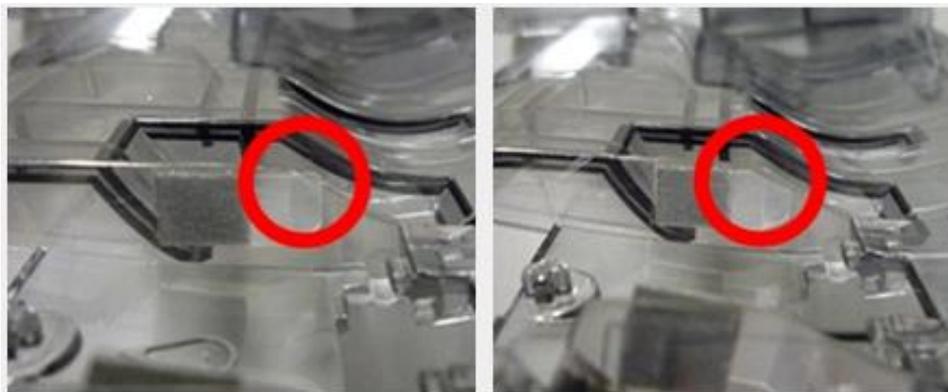
Note: This will not affect the function of the Mylar. This Mylar prevents the separation cushion from peeling off.

4. Replace the separation cushion (with P/N D6063119) **OR**, cut off the portion of the Mylar that is sticking out.

If cutting the Mylar:

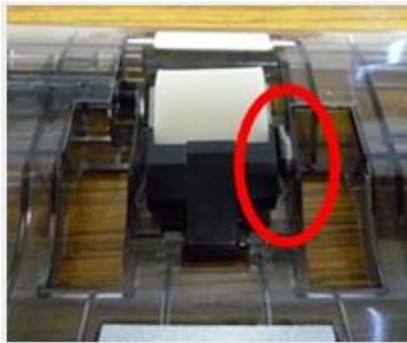
[A] Incorrect

- Make sure the Mylar **does not** slide under the separation pad holder when you attach the holder [B].

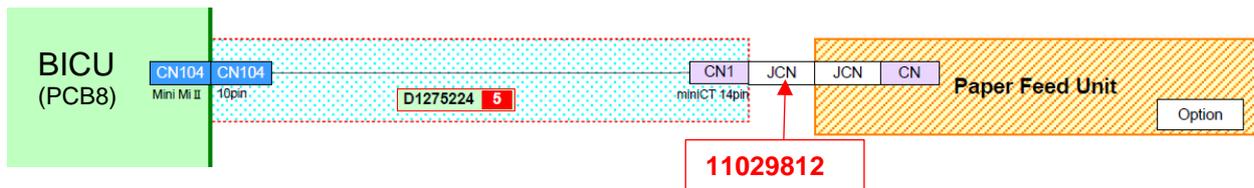
D127/D128 POINT TO POINT DIAGRAM and HARNESS (1/9)

Reason: The parts was missing from the point-to-point diagram.

Part number	Description	Q'ty	Int	Page
11029812	CONNECTOR:1-1612257-4	1	-	1/9
