Model: Lef-C1	Date: 29-Jan-16	No.: RD259006
---------------	-----------------	---------------

Subject: Firmware Release Note: RPCS		Prepared by: Y. Saitoh	
From: 1st Tech Service Sect., MFP/Printer Tech Service Dept.			
Classification:	<input type="checkbox"/> Troubleshooting <input type="checkbox"/> Mechanical <input type="checkbox"/> Paper path <input type="checkbox"/> Product Safety	<input type="checkbox"/> Part information <input type="checkbox"/> Electrical <input type="checkbox"/> Transmit/receive <input checked="" type="checkbox"/> Other (Firmware)	<input type="checkbox"/> Action required <input type="checkbox"/> Service manual revision <input type="checkbox"/> Retrofit information <input checked="" type="checkbox"/> Tier 2

This RTB has been issued to announce the firmware release information for the **RPCS**.

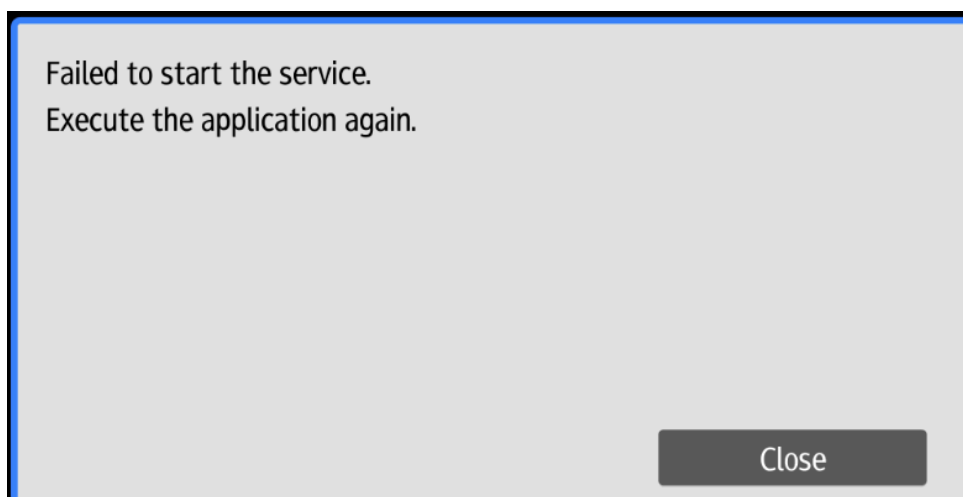
What will happen if the proxy settings in the controller are not configured?: Zoo will fail to start up the service and the following error message will be displayed after tapping the Zoo icon:

Notification to configure Application Site: Proxy settings need to be configured in the controller and Smart Operation Panel in environments that use a proxy server.

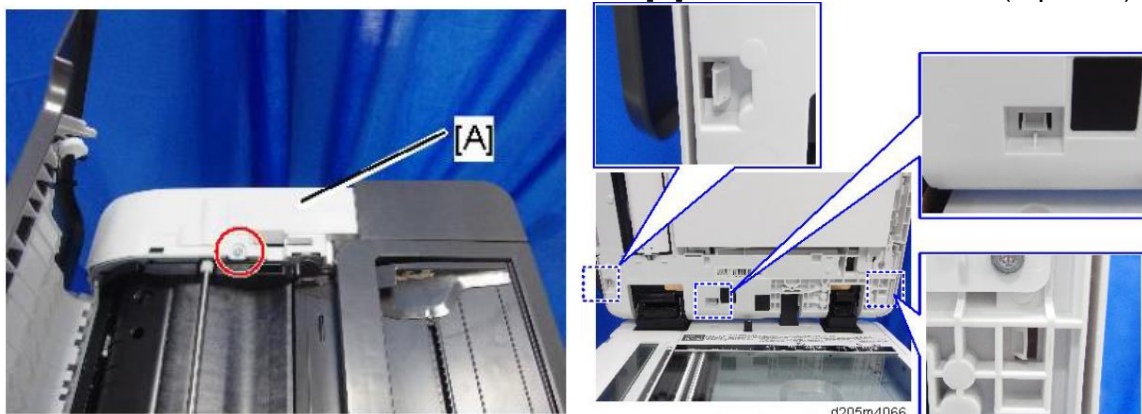
Remove one screw from the ARDF rear cover [A], and release the tabs (3 points).

Several steps were missing from the procedure for adjusting the ADF skew.
Please add the steps in red below.

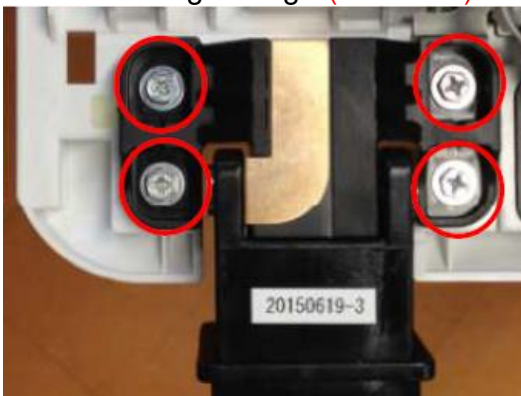
3. Remove the right hinge (screw x4).

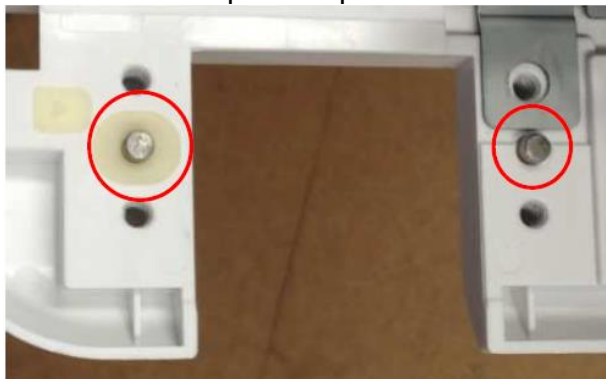
4. Remove the two parallel pins.

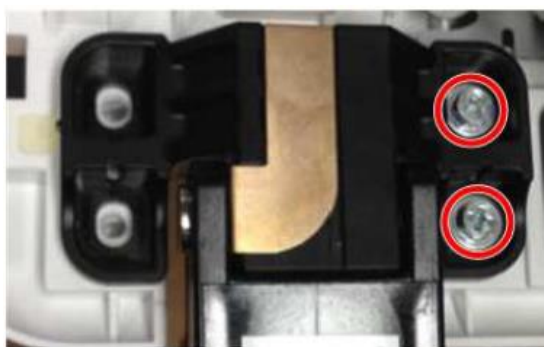
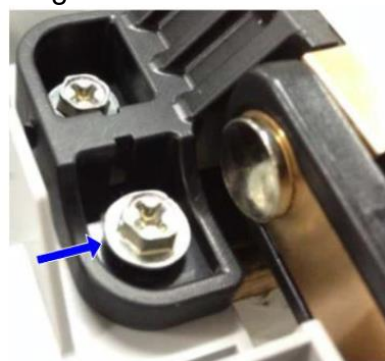
5. Attach the hinge using four screws temporarily with the appropriately spaced along the adjustment slots. Fasten the screws on the right side first.

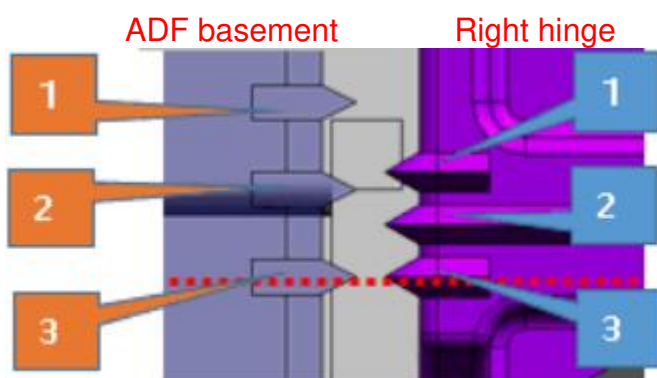
6. Move the hinge for adjustment, and then fasten the screws. Adjustable range is:
ADF basement [1] and Right hinge [1] to ADF basement [3] and Right hinge [3]

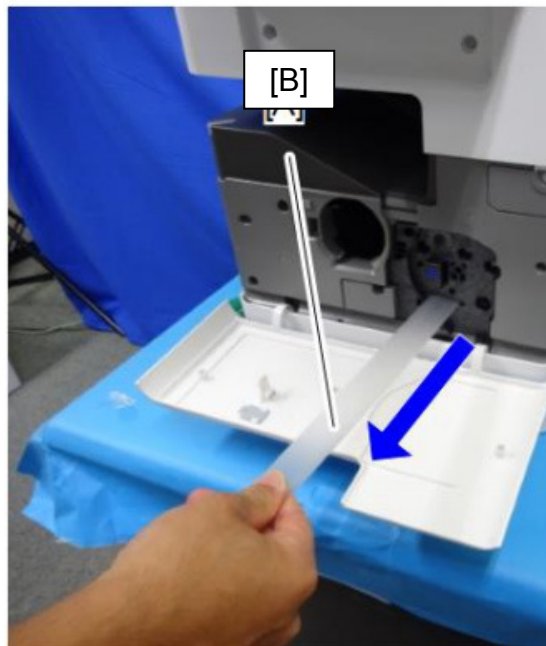
- When you install the machine ***or replace PCDU***, make sure to remove the protective sheet [A] and heat seal [B] from the development unit.
- If you do not ***do this remove protective sheet [A], toner cannot be supplied to development unit and*** toner will coagulate and clog inside the toner pipe ***in Mainframe.***
- If you do not ***do this remove heat seal [B], no image appears.***

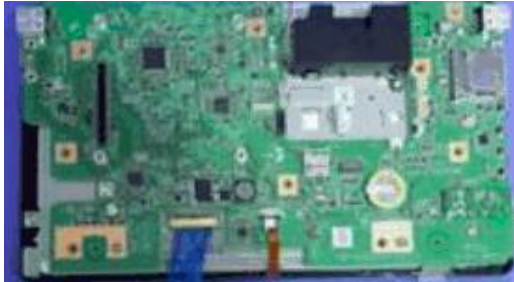
2. Sub board

HW	The Smart Operation Panel can be supplied with electrical power (blue LED lamp), but nothing can be displayed on the LCD.	1. Reconnect the LCD I/F cable. 2. Replace the LCD unit 3. Replace the Sub board. 4. Replace the LCD I/F cable.
3	A splash (blue) screen or "Please wait" message stays on the display.

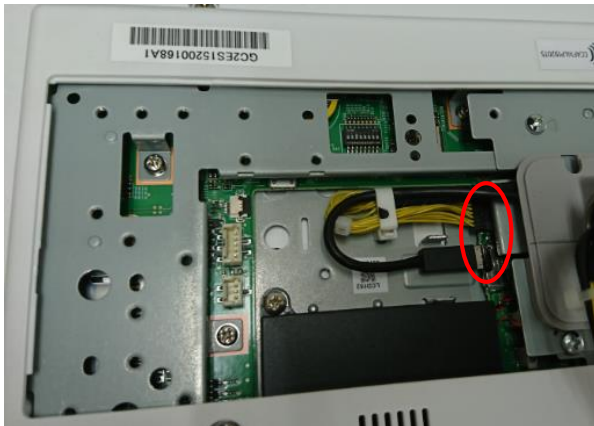
4. Connection between USB cable and harness and main board

HW	The Smart Operation Panel cannot be supplied with electrical power.	1. Reconnect the USB cable and harness between the BiCU and the Smart Operation Panel. 2. Replace the USB cable and harness. 3. Replace the Main board. 4. Replace the Sub board. 5. Replace the BiCU.
2	The Smart Operation Panel does not turn on, but the blue LED on the operation panel turns on.

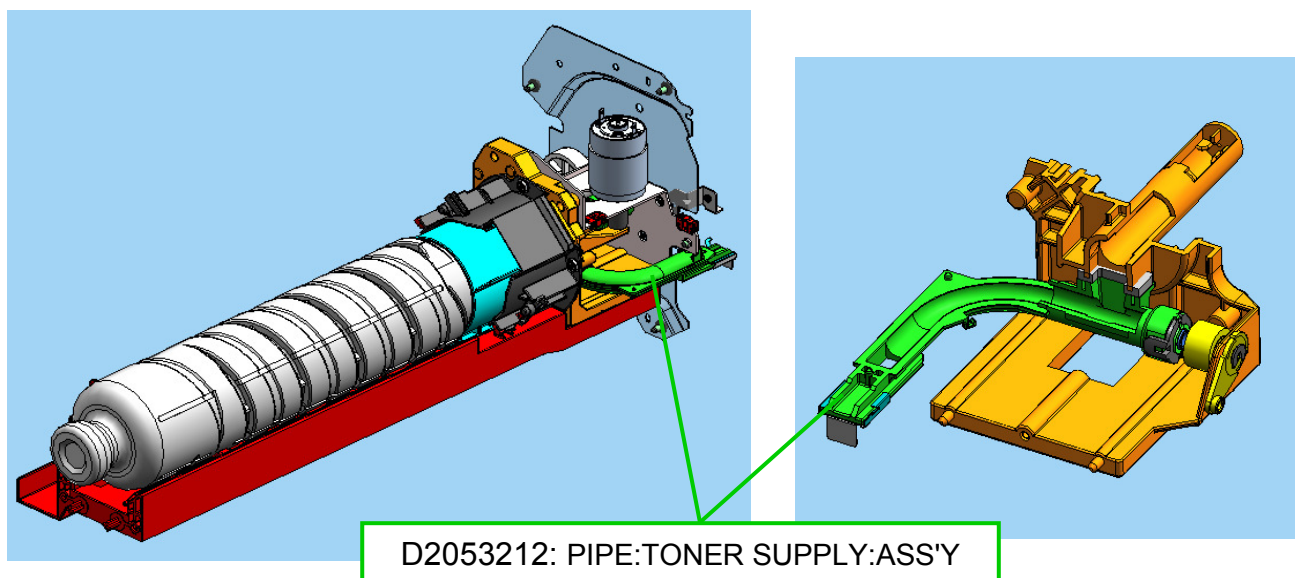
Toner Bottle replacement message does not disappear even the Toner Bottle is not empty.

- **Make sure to remove the protective sheet** at machine installation and whenever you replace the PCDU.
- If the symptom has already occurred, replace the toner supply pipe (P/N: D2053212).
