Model: Model AI-C1	Date: 07-Nov-07	No.: RD009001j
---------------------------	-----------------	----------------

Subject: Firmware Release Note: NetworkDocBox		Prepared by: T. Hirakawa	
From: 2nd Tech Service Sect., MFP/Printer Tech Service Dept.			
Classification:	<input type="checkbox"/> Troubleshooting	<input type="checkbox"/> Part information	<input type="checkbox"/> Action required
	<input type="checkbox"/> Mechanical	<input type="checkbox"/> Electrical	<input type="checkbox"/> Service manual revision
	<input type="checkbox"/> Paper path	<input type="checkbox"/> Transmit/receive	<input type="checkbox"/> Retrofit information
	<input type="checkbox"/> Product Safety	<input checked="" type="checkbox"/> Other ()	<input checked="" type="checkbox"/> Tier 2

This RTB has been issued to announce the firmware release information for the **Network DocBox**.

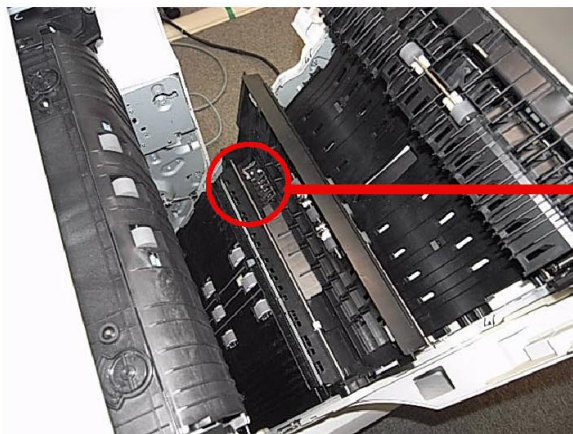
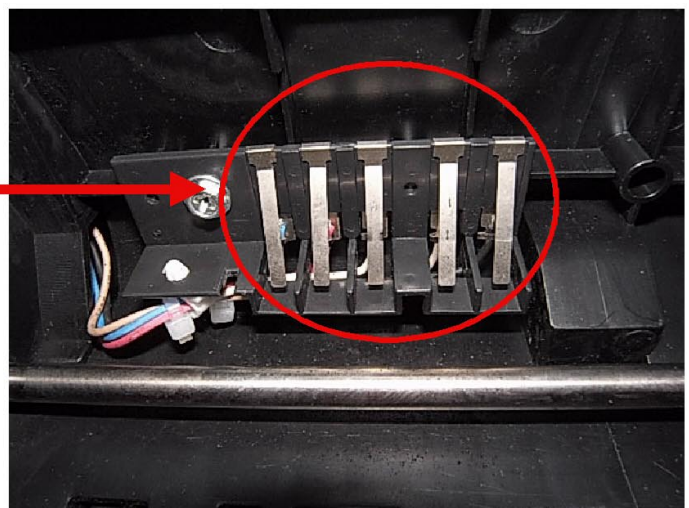
“Waste Toner Almost Full” is displayed, even when the waste toner tank (inside the transfer unit) is not in the near-full condition.

- Clean the entire surface of all five terminals.
- Make sure that the cloth fibers do not stick to the terminals.

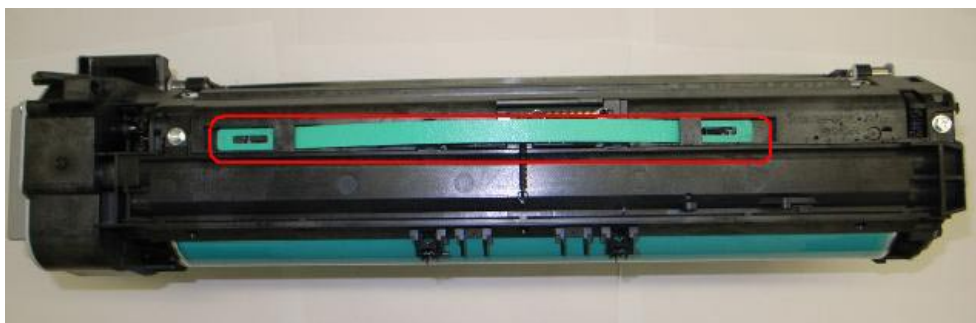
Dirty background image sometimes appears under certain conditions which are mentioned in "Cause" below.

TC becomes high caused by the above factors => Accelerates the "Toner Filming" on the development roller => Toner over toning, dirty background.

These procedures are for cleaning out the recycled toner (location shown in the following photo).

1. Remove the green handle.

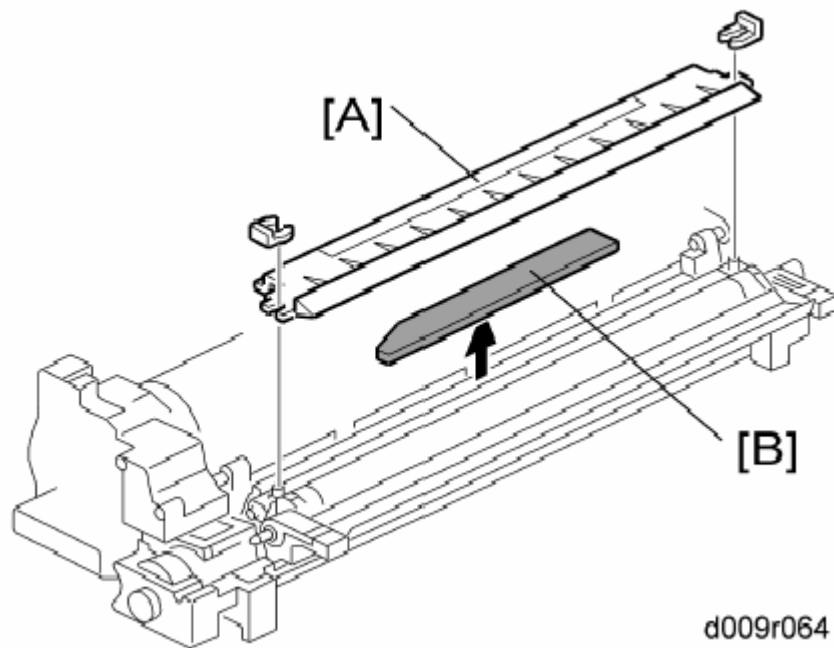
- The paper stack edge is dirty
- The developer leaks

The three development unit caps (P/N D0093102) are not attached to the development unit (P/N D0093010, D0093011), causing developer to leak through the holes.

2. If the caps are not attached to the development unit inside the machine, either install the three caps (P/N D0093102) or replace the development unit with one that already has the caps (D0092301).

Installing the three caps

1. Open the PCDU
2. Remove the development cover [A].
3. Remove the development filter [B].

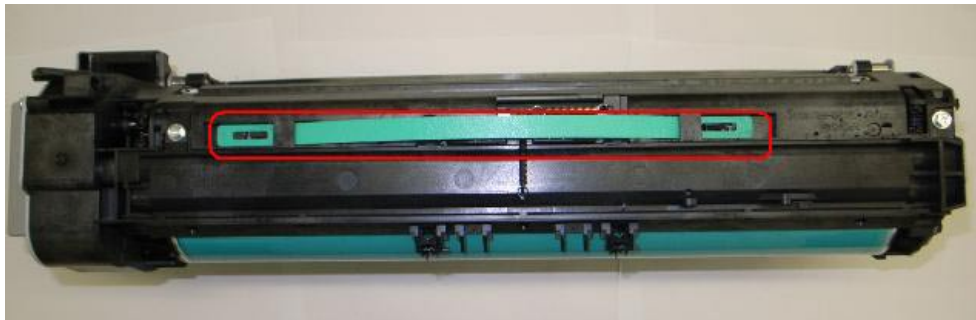
When one of the following conditions is met, the chargeability of the toner is decreased, and the machine responds by increasing the toner concentration (TC). As a result, toner filming on the development roller is accelerated, and poorly-charged toner is easily transferred onto the non-image areas of the OPC surface.

I. Cleaning the pathway for recycled toner inside the PCDU

1. Turn the machine main power OFF.
2. Remove the PCDU.
3. Remove the green handle.

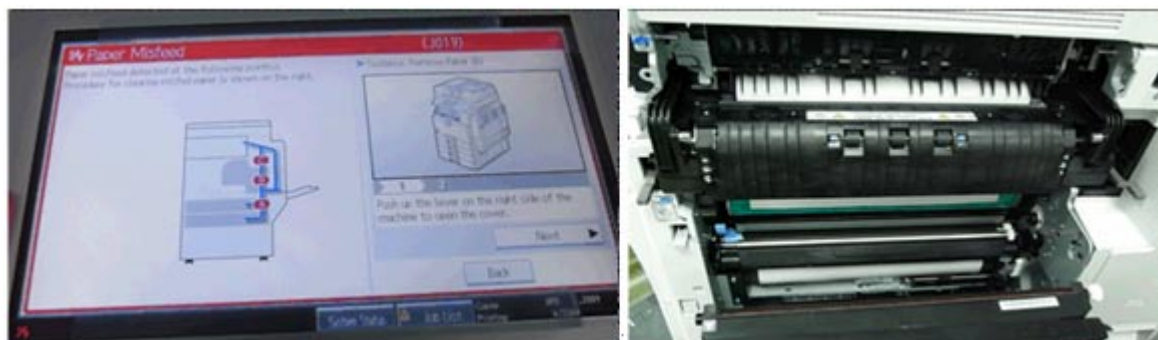
The machine indicates A, B, C Jam all together continually or at two or three paper ejection intervals, but there is no jam (paper is resting inside the machine, but is not jammed).

A specific lot of the Paper Exit Sensor is faulty.

As the result of the above, the sensor detects a "No paper" condition continuously even if there is paper in the paper feed path.

- Replace the Paper Exit Sensor (AW010127) if the following SP input value is not correct.

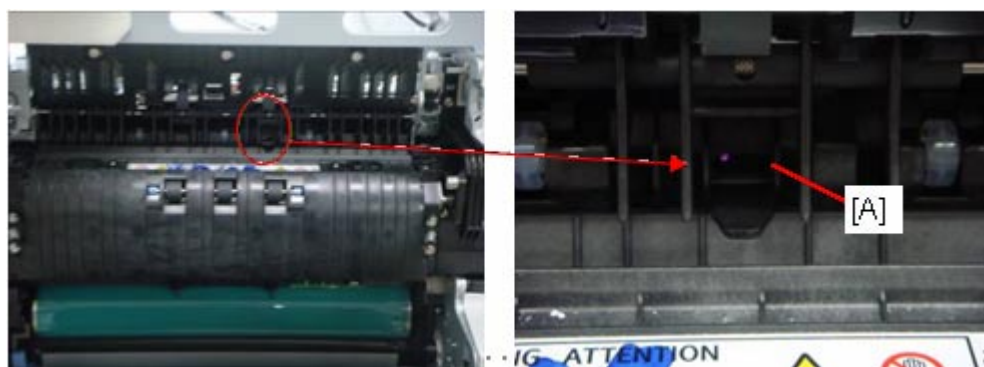
Sensor check condition	SP5803-026 Input Check value	
	Normal Sensor	Faulty Sensor
(a). If the paper exit sensor [A] is covered with paper	00000001	00000000
(b). If the paper exit sensor [A] is not covered with paper	00000000	00000000

3. Check the input value with and without paper.

4. Replace the paper exit sensor if the value is “**00000000**” in condition (a).

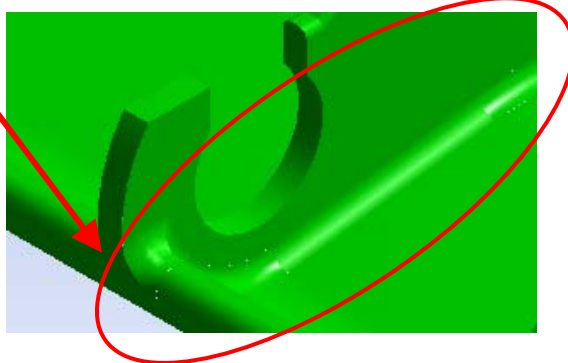
**The thickness of this area
was increased**

Note: When you install the new guide, you do not need to install the M6 spacer.

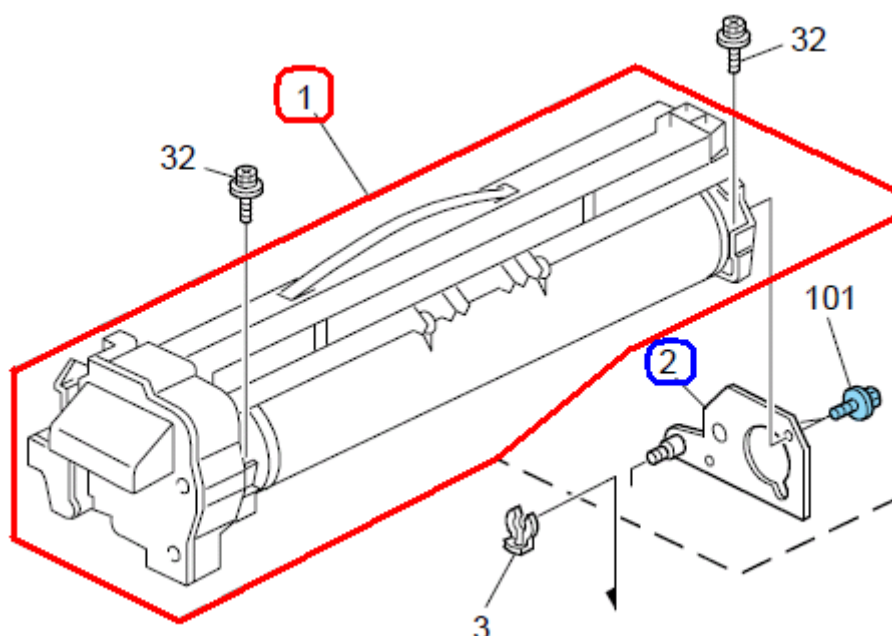
Pg. 62

- The area enclosed by the red box is the correct outline for P/N D0092105 (index #1).
- The rear side plate (index #2) is registered separately as an individual service part.

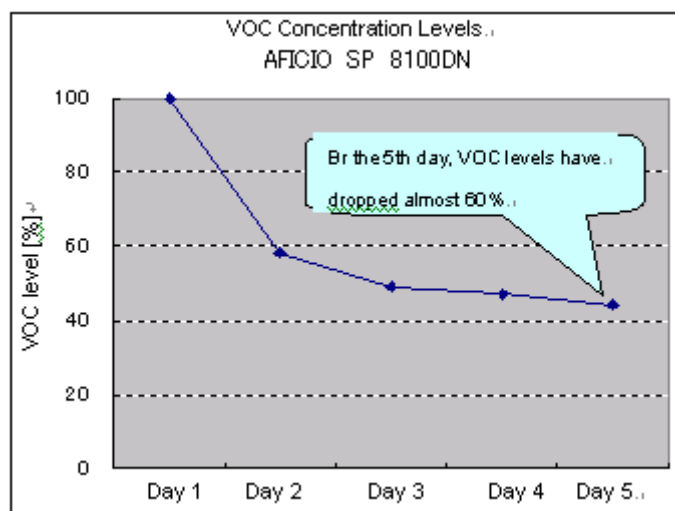
Fig. 1

- However, brand new devices have a particularly strong odor that might worry some customers. This odor is significantly reduced by the end of the **first week of use**, so please ask for the customer's patience. See Figure 1 below for an example using the Aficio SP 8100DN.

- Volatile Organic Compounds (VOC) are particles of the component materials (glues, plastics, chemicals, etc.) that Ricoh devices are built with. VOC are the primary source of the odors produced by Ricoh devices, so tracking VOC levels produced by Ricoh devices is a good indicator of the strength of the odors. Figure 1 shows the VOC levels of a brand new Aficio SP 8100DN during the first 5 days of use. As the graph shows, the amount of VOC has dropped by almost 60%.

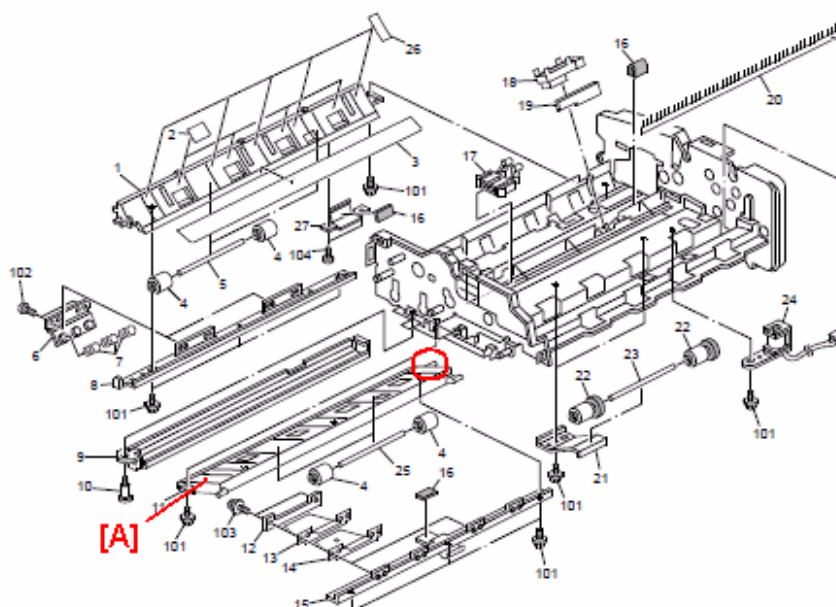
9.Original Transfer 1 (D129/D130)

The frame is damaged by the pin (circled in red below) when P/N B8023553 [A] is replaced.

Install the following hook (See procedure below).

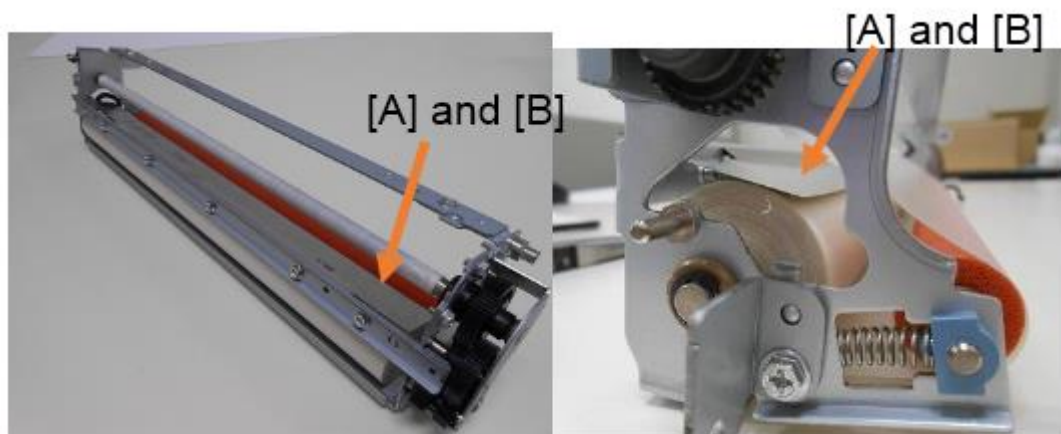
Change/Reason: To prevent the cleaning web coming loose, the following parts are changed and newly added to the fusing unit.

For details of [1], please refer to the following pictures.

[A] and [B] are the variable brake.

Please install a new cleaning unit (p/n: D1294304) when the cleaning web issue occurs, because individual parts are not compatible due to changing of the frame of the fusing unit. After that, individual parts can be replaced.

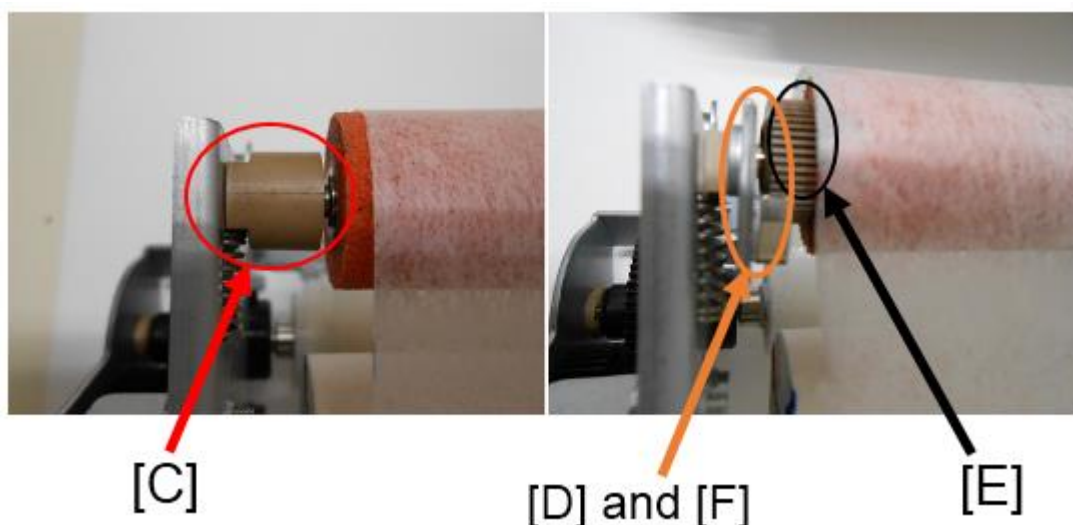
For details of [2], please refer to the following picture.

One-way clutch method was used before. Ratchet method is used after.

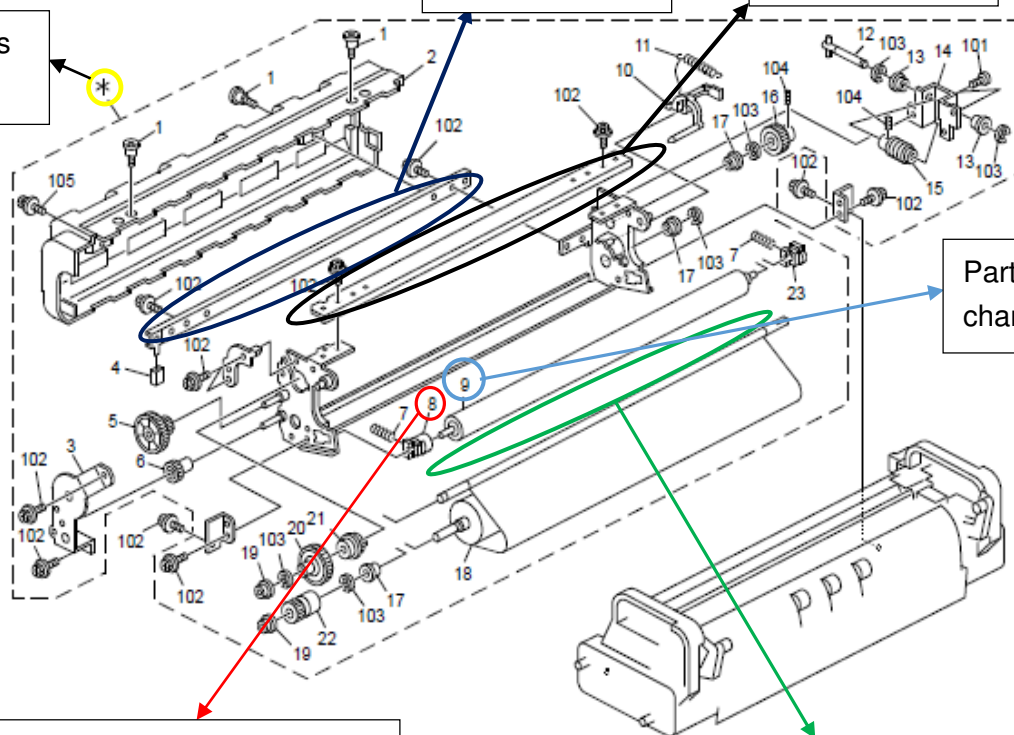
Change/Reason: To prevent the cleaning web from coming loose, the following parts are changed or newly added to the fusing unit.

29** is added.

30** is added.

Part number is changed

This is deleted.
Instead, 26** and 27** and
28** are added for [2].

Please install a new cleaning unit (p/n: D1294304) when a cleaning web issue occurs, because individual parts are not compatible due to modification of a frame on the fusing unit. After that, individual parts can be replaced.
