Model: AI-C2	Date: 19-Dec-11	No.: RD129001h
--------------	-----------------	----------------

Subject: Firmware Release Note: Fax		Prepared by: T.Hirakawa	
From: 2nd Tech Service Sect., MFP/Printer Tech Service Dept.			
Classification:	<input type="checkbox"/> Troubleshooting	<input type="checkbox"/> Part information	<input type="checkbox"/> Action required
	<input type="checkbox"/> Mechanical	<input type="checkbox"/> Electrical	<input type="checkbox"/> Service manual revision
	<input type="checkbox"/> Paper path	<input type="checkbox"/> Transmit/receive	<input type="checkbox"/> Retrofit information
	<input type="checkbox"/> Product Safety	<input checked="" type="checkbox"/> Other (Firmware)	<input checked="" type="checkbox"/> Tier 2

This RTB has been issued to announce the firmware release information for the **Fax**.

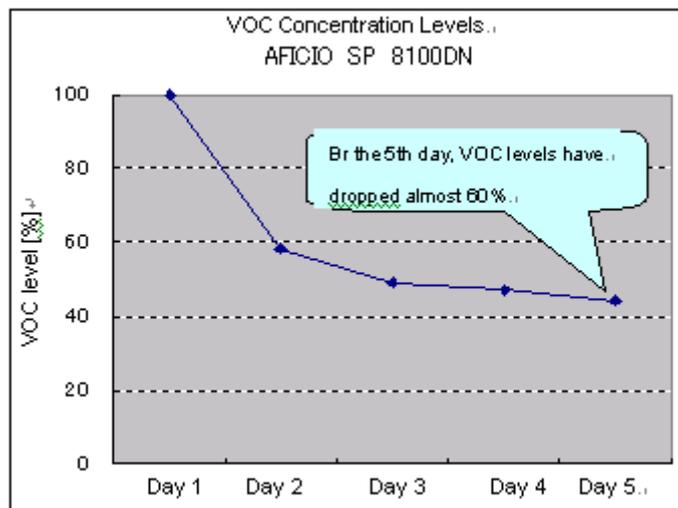
Fig. 1

- However, brand new devices have a particularly strong odor that might worry some customers. This odor is significantly reduced by the end of the **first week of use**, so please ask for the customer's patience. See Figure 1 below for an example using the Aficio SP 8100DN.

- Volatile Organic Compounds (VOC) are particles of the component materials (glues, plastics, chemicals, etc.) that Ricoh devices are built with. VOC are the primary source of the odors produced by Ricoh devices, so tracking VOC levels produced by Ricoh devices is a good indicator of the strength of the odors. Figure 1 shows the VOC levels of a brand new Aficio SP 8100DN during the first 5 days of use. As the graph shows, the amount of VOC has dropped by almost 60%.

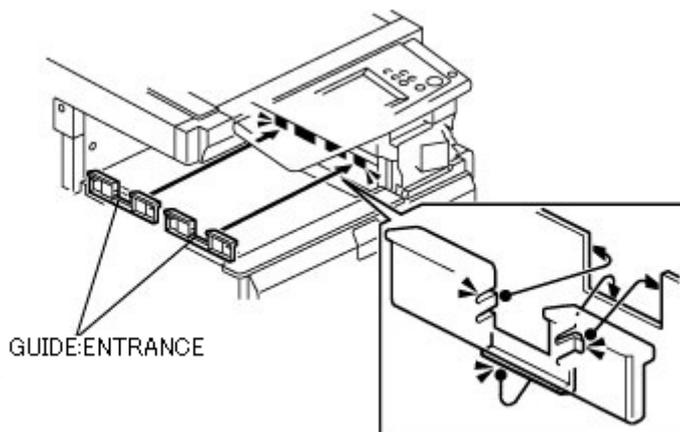
This bridge unit is common with MP C series. However, it is not necessary to attach the GUIDE:ENTRANCE for MPC series. So, please keep the GUIDE:ENTRANCE because it can be used for this model when it was not attached during the bridge unit installation. Otherwise, it may necessary to order this part from your local spare part center.

Attach the entrance guide as shown below during the bridge unit installation.

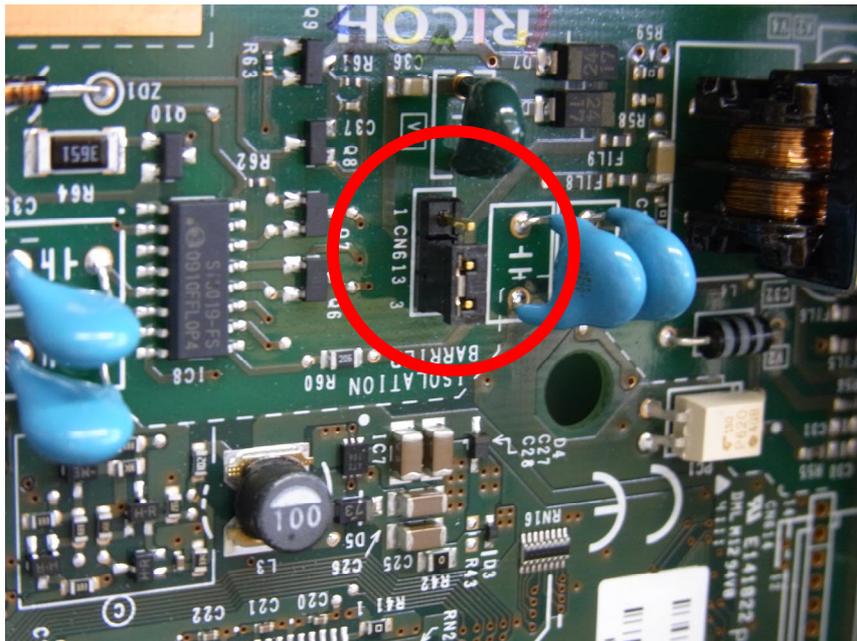
Note: In its default position, the switch covers the middle and "3" pin.

For installation in Brazil, move the jumper switch (CN613) on the fax board so that the edge is anchored at "1" (so that the middle pin and the "1" pin are covered).

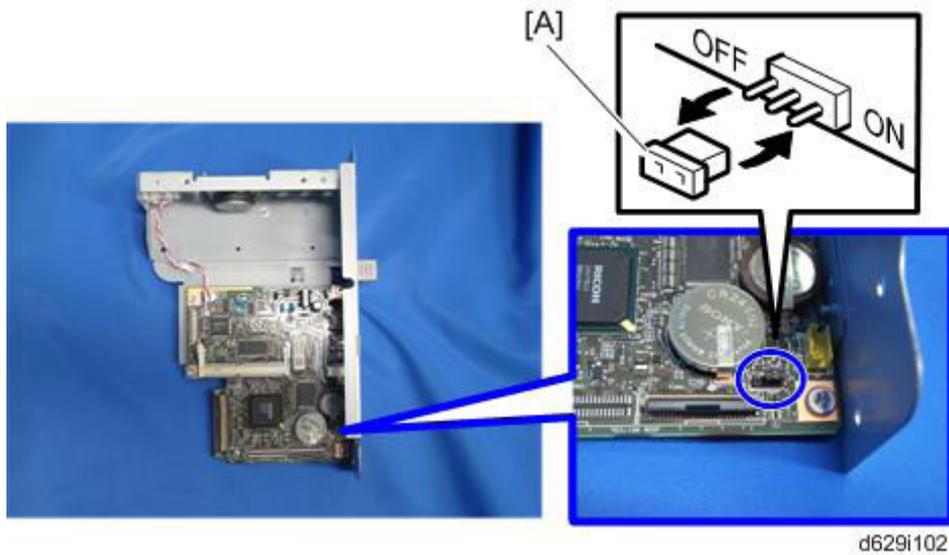
Note: The machine may issue SC819, SC820 if the jumper is not set to "ON" correctly. (Sometimes these SC codes are not issued.)

4.5 Remove the jumper [A] (set to OFF) and set it to ON.

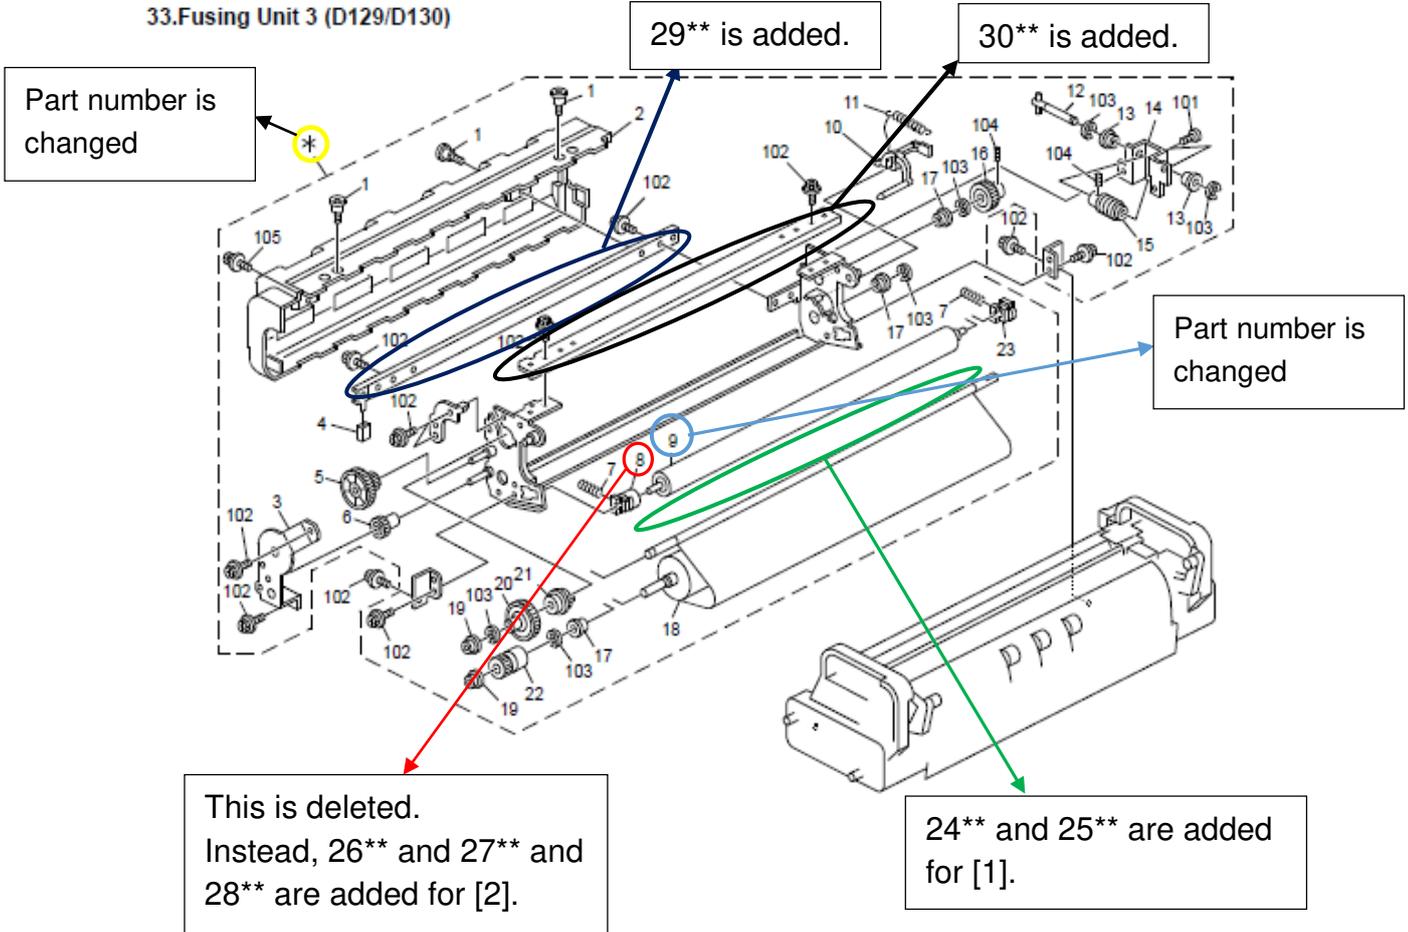
33.Fusing Unit 3 (D129/D130)

Change/Reason: To prevent the cleaning web from coming loose, the following parts are changed or newly added to the fusing unit.

Please install a new cleaning unit (p/n: D1294304) when a cleaning web issue occurs, because individual parts are not compatible due to modification of a frame on the fusing unit. After that, individual parts can be replaced.
