| Model: Gim-MF1a/b | | Date: 23-Feb-15 | No.: RM172001 |
| Subject: Service manual revision | | Prepared by: T.Suzuki | |

| Subject: Troubleshooting - No image printing of received fax | | Prepared by: T.Suzuki | |

| Subject: Dirty reverse side of printing sheets | | Prepared by: J.Kitagawa | |

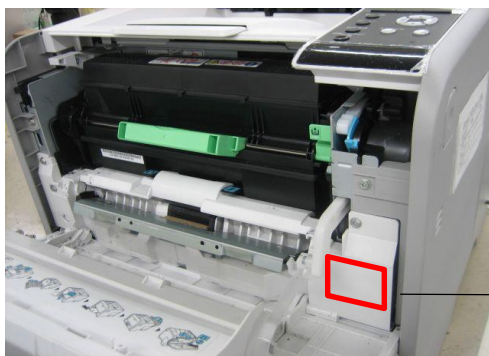
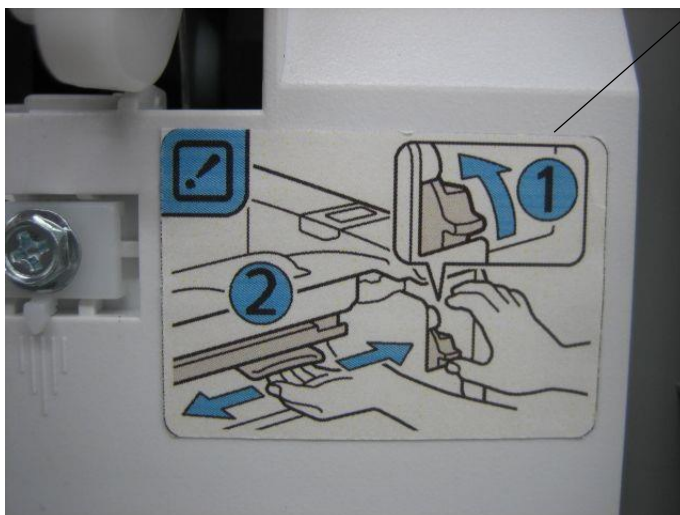
LED Lever Operate Decal

Change: An instructional decal for the LED lever was added.

Reason: To facilitate easier operation of the LED lever.

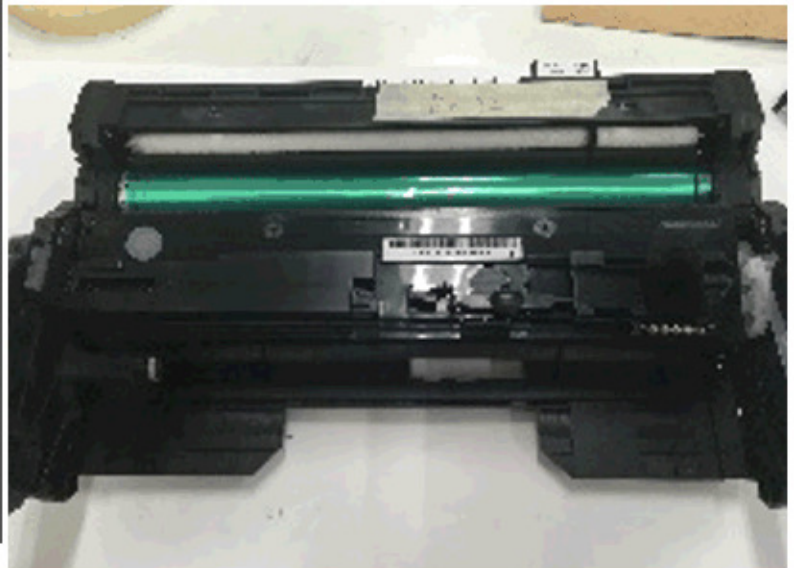
Black line or white line appears on prints in the feeding direction along with unwanted toner on the charge cleaning roller at the line position.
