Important Information about Normal/Smart Panel Firmware Updates

Technical Bulletin

Model: Gim-P1a Dat			te: 23-Feb	-15	No.: RM171002	
Subject: Service manual revision			Prepared by: T.Suzuki			
From: 3rd Tech.	Support Sec. Service Support I	Dept,				
Classification:	 Troubleshooting Mechanical Paper path Product Safety 	Part info Electrica Transmi	al		—	required e manual revision it information

RTB Reissue					
Subject: Dirty reverse side of printing sheets			Prepared by: J.Kitagawa		
From: 1st Tech S	Service Sect., MFP/P Tech Ser	vice Dept.			
Classification:	 Troubleshooting Mechanical Paper path Product Safety 	Part informat Electrical Transmit/rec Other (Action required Service manual revision Retrofit information Tier 2

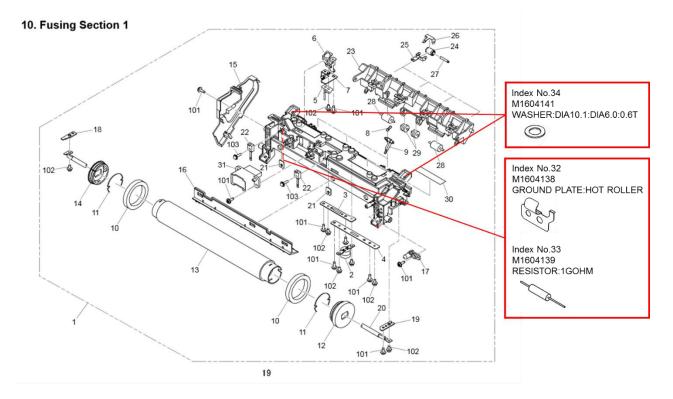
Change: Geometry of these parts has changed.

Incorrect part number	Correct part number	Description	Q'ty	Page	Index	Note
-	M1604138	GROUND PLATE:HOT ROLLER	1	20	32	
-	M1604139	RESISTOR:1GOHM	1	20	33	
-	M1604141	WASHER:DIA10.1:DIA6.0:0.6T	1	20	34

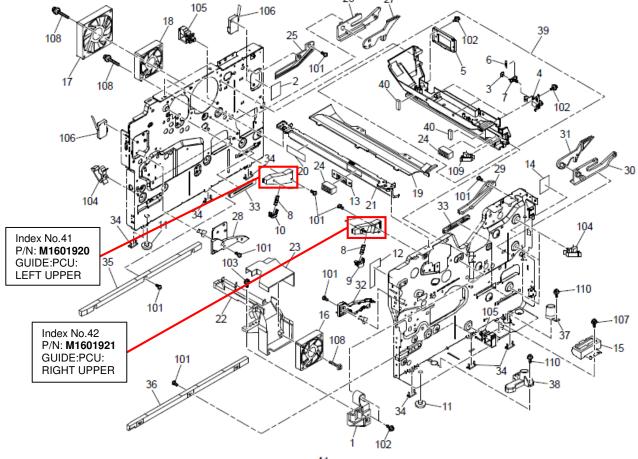
21. Main Frame Section

Old part number	New part number	Description	Q'ty	Page	Index	Note
number	number					
-	M1601920	GUIDE:PCU:LEFT UPPER	1	42	41	
-	M1601921	GUIDE:PCU:RIGHT UPPER	1	42	42

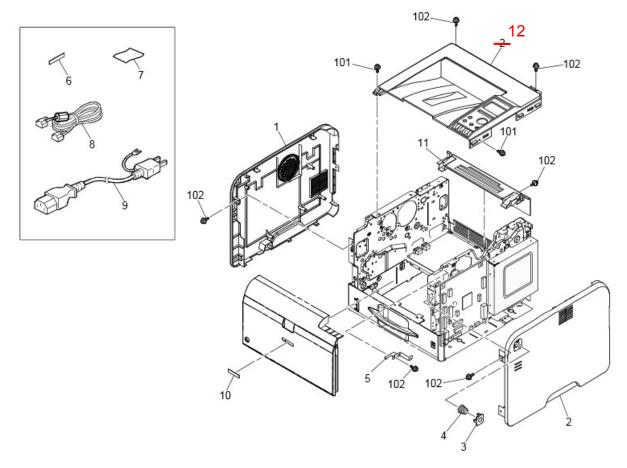
1. Exterior

Part number of the upper cover was missing from the parts catalog and its index number was incorrect. Please make the following correction to your part catalog.

Old part number	New part number	Description	Q'ty	Int	Page	Index	Note
-	M1711231	COVER:UPPER:P1_A	1		1	12

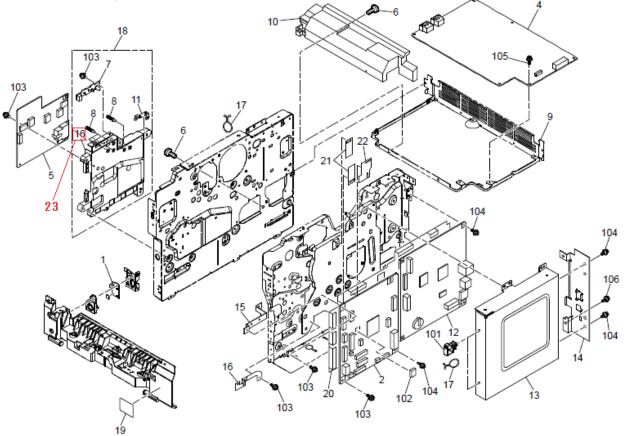
16. Electrical Components Section

Incorrect	Correct	Description	Q'ty	Page	Index	Note
part number	part number					
M1605508	M1715010	PCB:BCU:ASS'Y	1	32	2	
M1715010	-		1	32	3	
M1605506	M1605515	GROUND PLATE: POWER PACK	1	32	11	
-	M1605506	BRACKET: POWER PACK	1	32	23

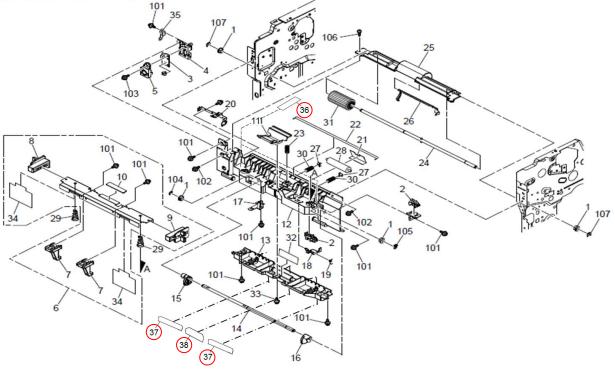
5. Manual Feed Section 2

Old part	New part	Description	Q'ty	Page	Index	Note
number	number					
-	M1602749	SHEET:GUIDE:MPT:LOWER	2	13	37	
-	M1602751	SHEET:ENTRANCE:MIDDLE:ROLLER	1	13	38	
-	M1602756	INSULATING SHEET:ENTRANCE:MF	2	13	36
