Model: Gim-P1c/Gim-P1d Date: 21-		Nov-14	No.: RM158003		
Subject: Firmware	Release Note: NetworkDock	Зох		Prepared	by: Y. Gaman
From: 3rd Tech Se	rvice Sect., MFP/Printer Tech	Service Dept.			
Classification:	☐ Troubleshooting	☐ Part informati	on	☐ Action re	equired
	☐ Mechanical	Electrical		Service ı	manual revision
	☐ Paper path	☐ Transmit/rece	eive	☐ Retrofit i	nformation
	☐ Product Safety	Other (Firmwa	are)	□ Tier 2

Technical Bulletin

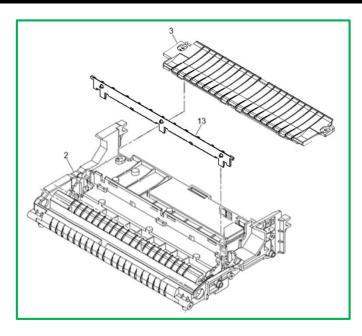
Reason: To further minimize staining on the printed paper.

Important: These three parts need to be installed **together as a set.**

Incorrect part number	Correct part number	Description	Q'ty	Int	Page	Index	Note
M1603861	M1603865	COVER:ELECTRODE PLATE:SEPARATION:2	1 - 1	X/X	22	13	X/O as a
M1603851	M1603866	GUIDE:EXIT:STAY:TRANSFER:2	1 - 1	X/X	22	3	set
M1603850	M1603870	STAY:TRANSFER	1 - 1	X/X	22	2

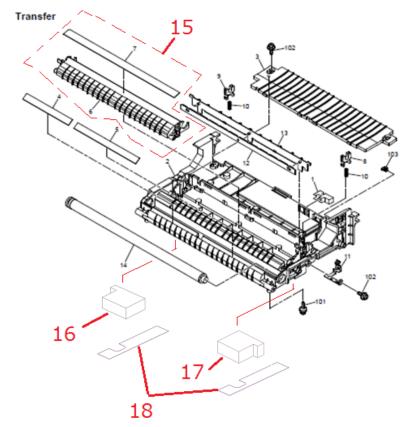
This RTB(RM160030) explains the replacement to avoid black band stains caused by dropped toner on the front paper guide of the transfer roller, however this toner dropping occurs after reaching to the PCU life.

Old part	New part	Description		Int	Index
number	number		У		
M1603850	M1603870	STAY:TRANSFER	1	X/X	2
	M1603877	SPONGE:TRANSFER/	1	X/X	16
		SEPARATION UNIT:LEFT			
	M1603878	SPONGE:TRANSFER/SEPARATION UNIT:RIGHT	1	X/X	17
	M1603879	SHEET:TRANSFER UNIT: TONER CATCHPAN	2	X/X	18
M1603881	M1603880	GUIDE:TRANSFER ROLLER: CLICK:ASS'Y	1	X/X	15
M1603854	M1603874	GUIDE:TRANSFER ROLLER: CLICK	1	X/X	6
M1603855	M1603875	SHEET:GUIDE:TRANSFER ROLLER:CLICK	1	X/X	7

We don't recommend replacing parts of transfer section.

Because it is so difficult and time consuming to replace these parts in the field, and the risk of the machine being broken is very high during the process.

we recommend to replace the PCU when the PCU reaches its life.

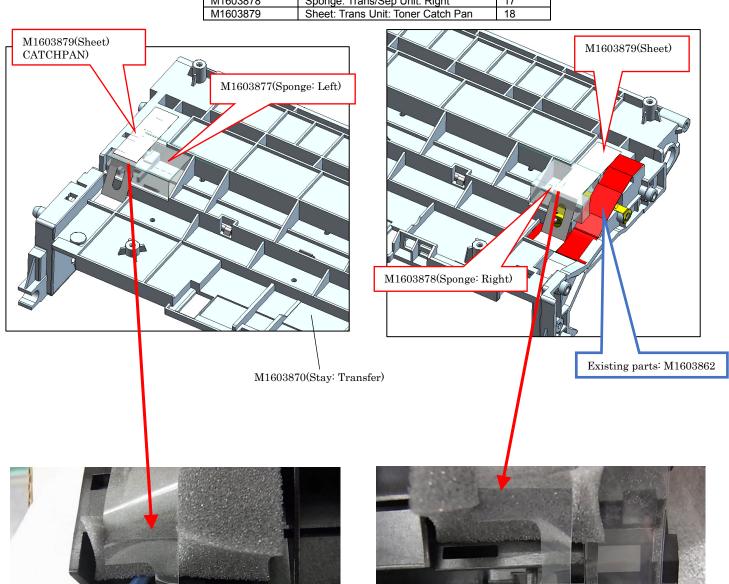
Pasting Position of Sponge and Sheet

Part Number	Description	#index
M1603870	Stay: Transfer	2
M1603877	Sponge: Trans/Sep Unit: Left	16
M1603878	Sponge: Trans/Sep Unit: Right	17
M1603879	Sheet: Trans Unit: Toner Catch Pan	18

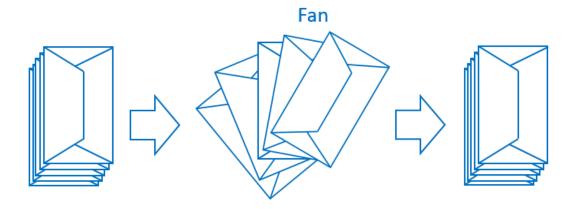
3 Fan Envelopes

Fan envelopes to separate them because they may stick together with glue on their flaps.

Note:

If the envelopes still stick together, then load them one by one.

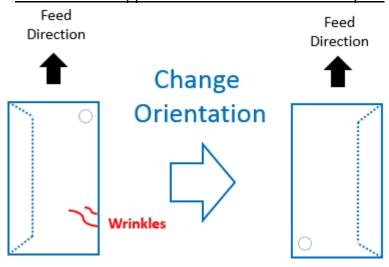
➤ If the wrinkles appear on the SIDE of the envelopes:

Before loading onto the standard tray or bypass tray, check the wrinkles location and change the orientation accordingly.

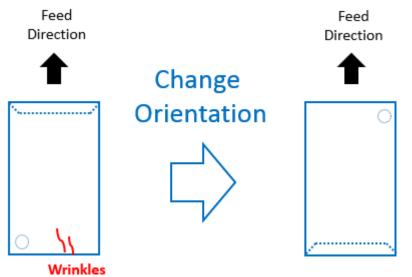
If the wrinkles appear on the BOTTOM of the envelopes:

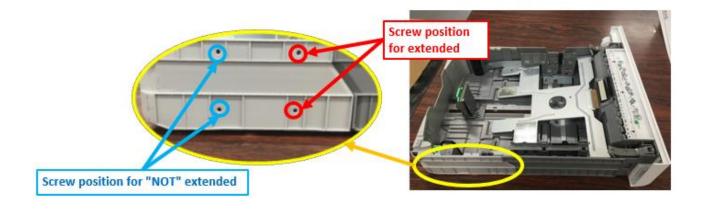
For cause (B)

Advise the user to lock the catches and **NOT** to extend the tray when loading A4-SEF or smaller paper sizes (as mentioned in the Operator's Instructions). If the user uses only A4SEF or smaller paper sizes, then the catches can be fixed in place (both sides) using the following screws:

P/N	Description	Necessary Q'ty
04583010N	HEXAGON HEAD TAPPING SCREW:3X10	4
