Model: Brz-MF1	Date: 23-May-16	No.: RD255002b
----------------	-----------------	----------------

Subject: Firmware Release Note: Engine		Prepared by: T. Tachibana	
From: 2nd Tech Service Sect., MFP/Printer Tech Service Dept.			
Classification:	<input type="checkbox"/> Troubleshooting <input type="checkbox"/> Mechanical <input type="checkbox"/> Paper path <input type="checkbox"/> Product Safety	<input type="checkbox"/> Part information <input type="checkbox"/> Electrical <input type="checkbox"/> Transmit/receive <input checked="" type="checkbox"/> Other (Firmware)	<input type="checkbox"/> Action required <input type="checkbox"/> Service manual revision <input type="checkbox"/> Retrofit information <input checked="" type="checkbox"/> Tier 2

This RTB has been issued to announce the firmware release information for the **Engine**.

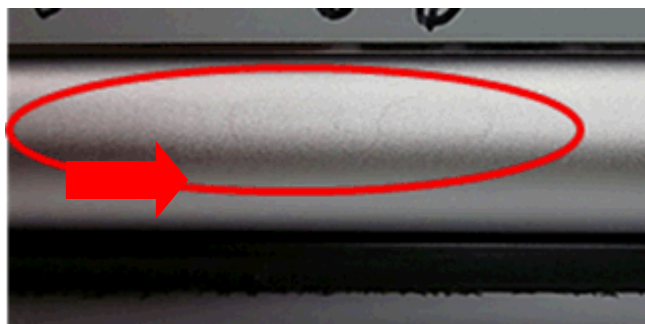
CAUSE

The plastic bag wrapped around the MFP was not sealed properly. As a result, condensation formed on the surface of the development roller before the development unit was filled with toner. Marks remain on the roller surface after the water evaporated.

The plastic bag used to cover the machine is sealed securely, so as to prevent moisture from forming inside.

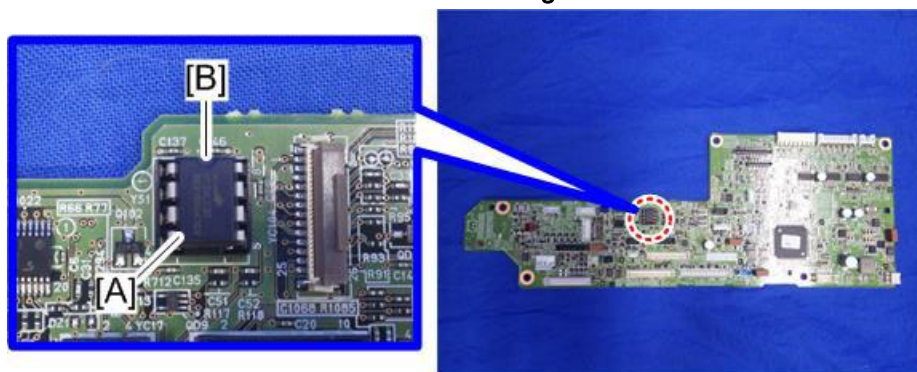
d255a1303

Incorrect installation of the NVRAM will damage both the IOB and NVRAM.

• Install a NVRAM [A] so that the indentation [B] on the NVRAM corresponds with the mark on the IOB.

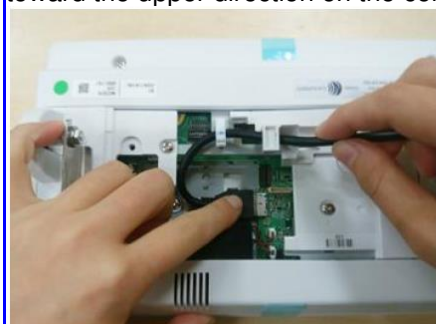
When connecting the cable, hold the molded part of the cable as shown below so as not to apply excessive force on the connector part. Applying excessive force toward the upper direction on the connector may cause connection failure.

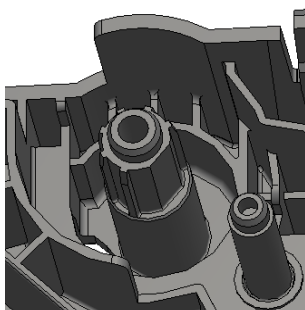
Old:

The shafts circled in red have been modified because they may turn white or break. If the shafts are broken, SC501-01(Paper Feed Tray Lift Motor Error (Tray 1)) appears.

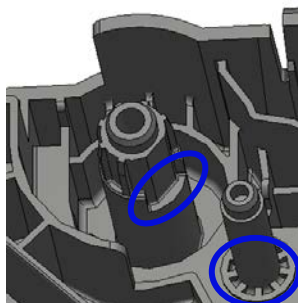
New: The shape of the parts circled in blue have been modified.

The modified parts are provided as a service parts.

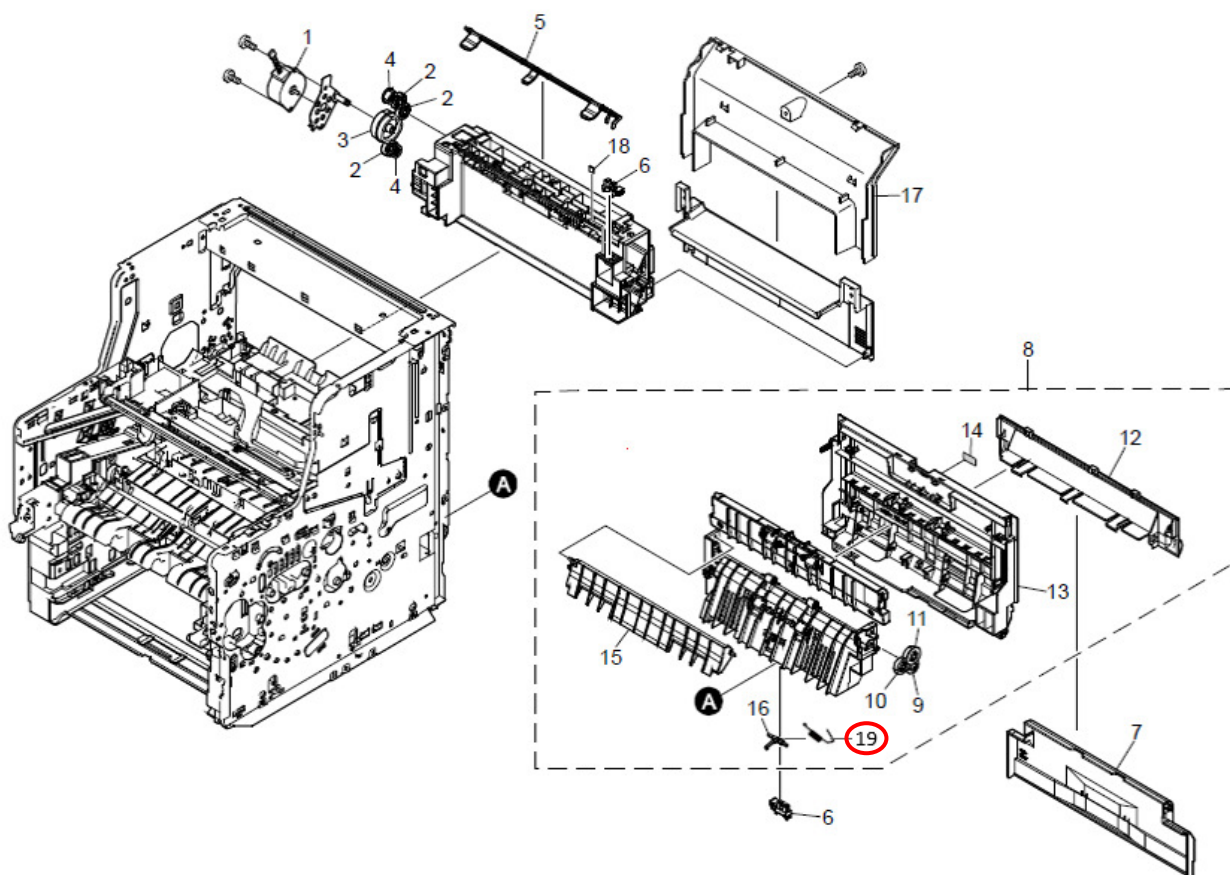
8. Exit Section

Reason: To make it possible to replace the spring individually when a duplex jam occurs (Jam code: 86).

Part number	Description	Q'ty	Int	Page	Index	Note
M2814458	SPRING ACTUATOR DU	1		18	19

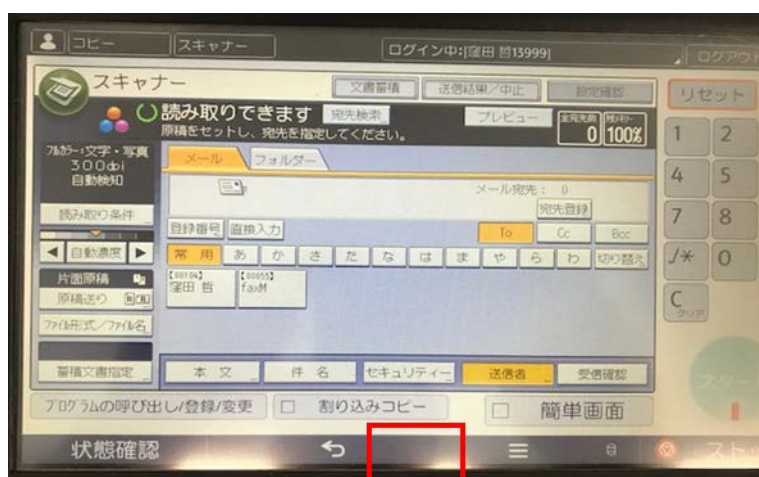
With firmware combination **#3** below, the Home button is not displayed, making it impossible to switch between applications.

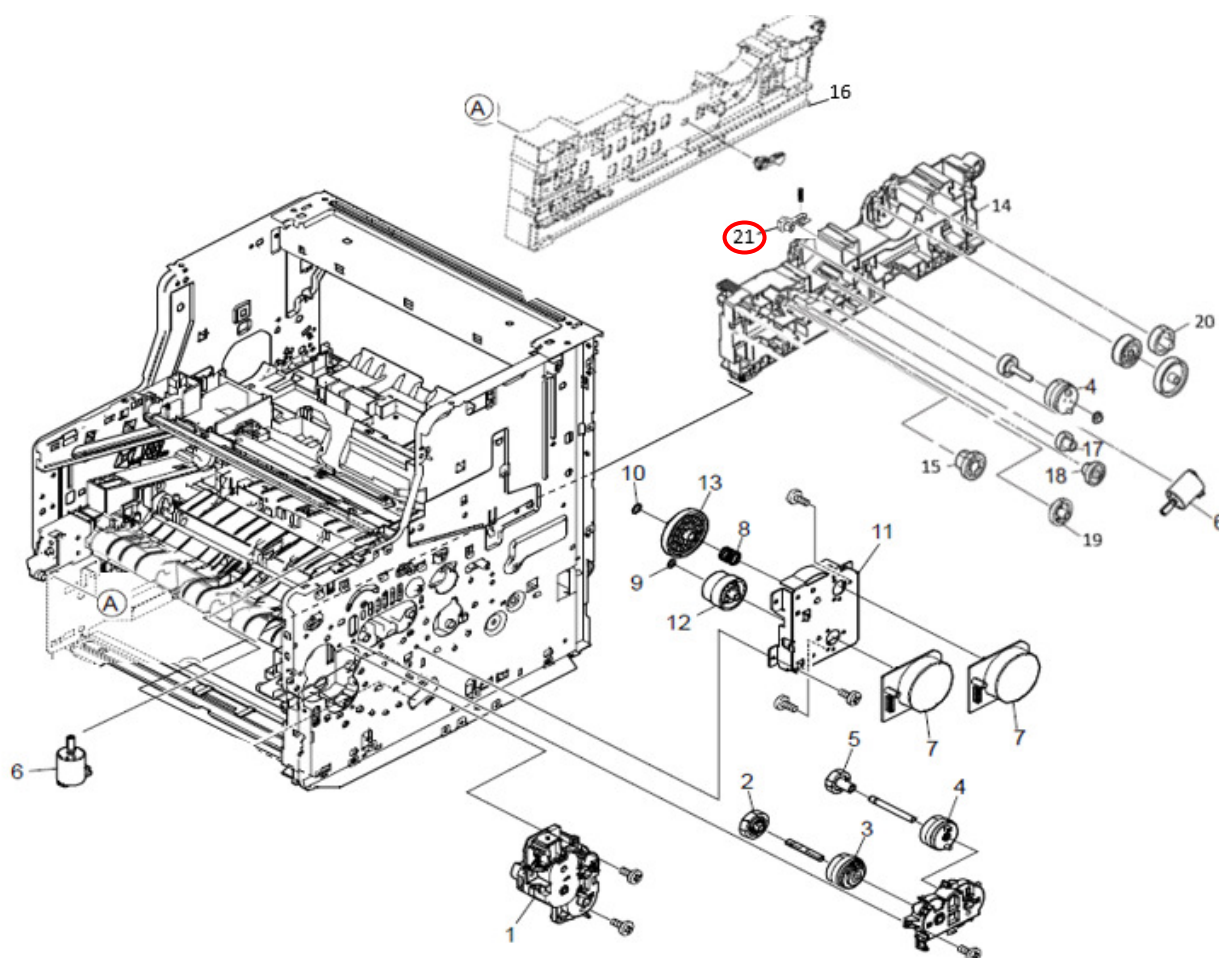
10. Drive Section

Part number	Description	Q'ty	Int	Page	Index	Note
M2817506	LEVER LOCK CASSETTE L	1		22	21

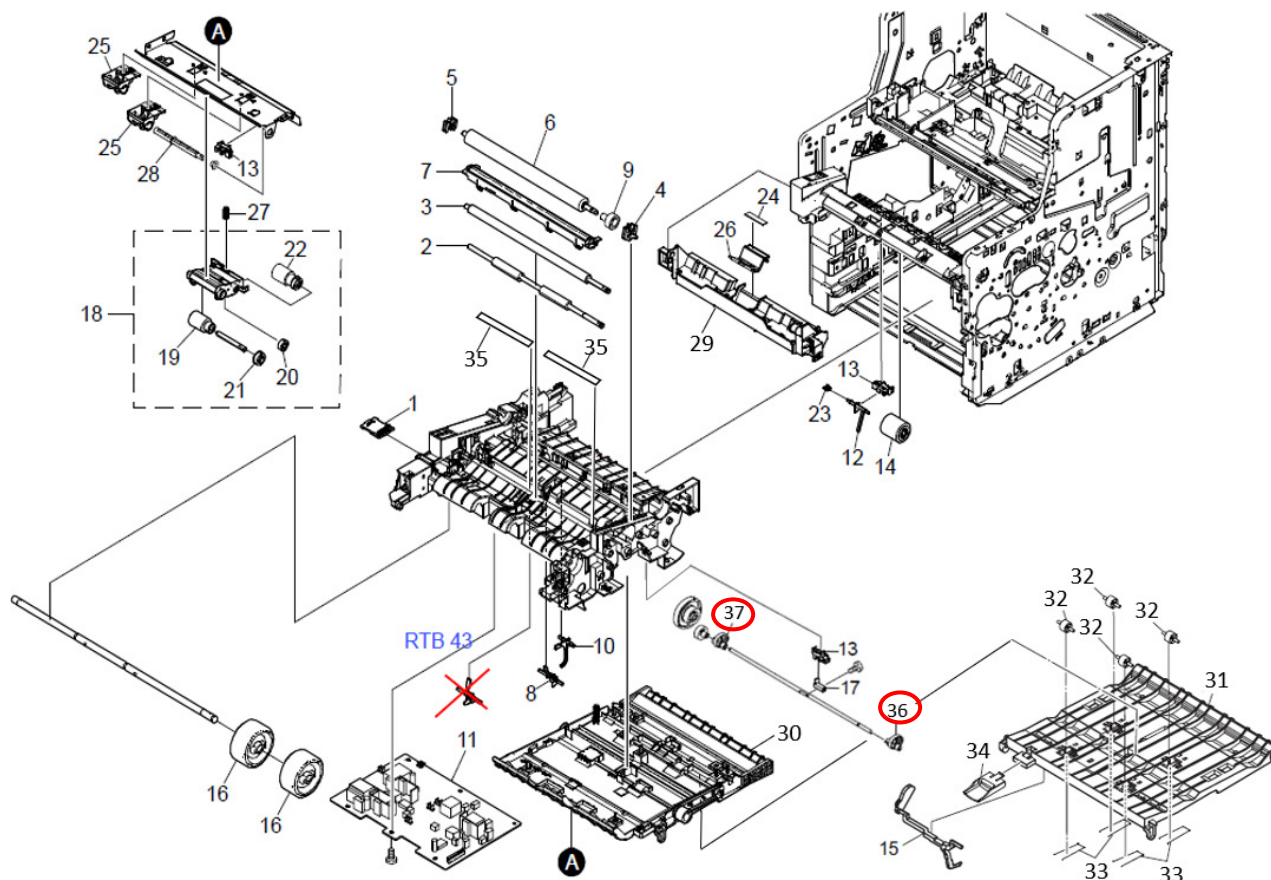
4. Paper Feed Section

Change: *The bold italic parts* are newly added.

Part number	Description	Q'ty	Int	Page	Index	Note
D2552851	GUIDE TURN MPF A	1		10	29	
M2812852	BASE_DU	1		10	30	
M2817502	GUIDE DU	1		10	31	
M2817503	PULLEY PA	4		10	32	
M2817504	SPRING DU	4		10	33	
M2816684	LEVER_DU_RELEASE	1		10	34	
M2817505	SHEET REGIST	2		10	35	
<i>M2812859</i>	<i>LOCK ENVELOPE R</i>	<i>1</i>		<i>10</i>	<i>36</i>	
<i>M2812855</i>	<i>LOCK ENVELOPE L</i>	<i>1</i>		<i>10</i>	<i>37</i>

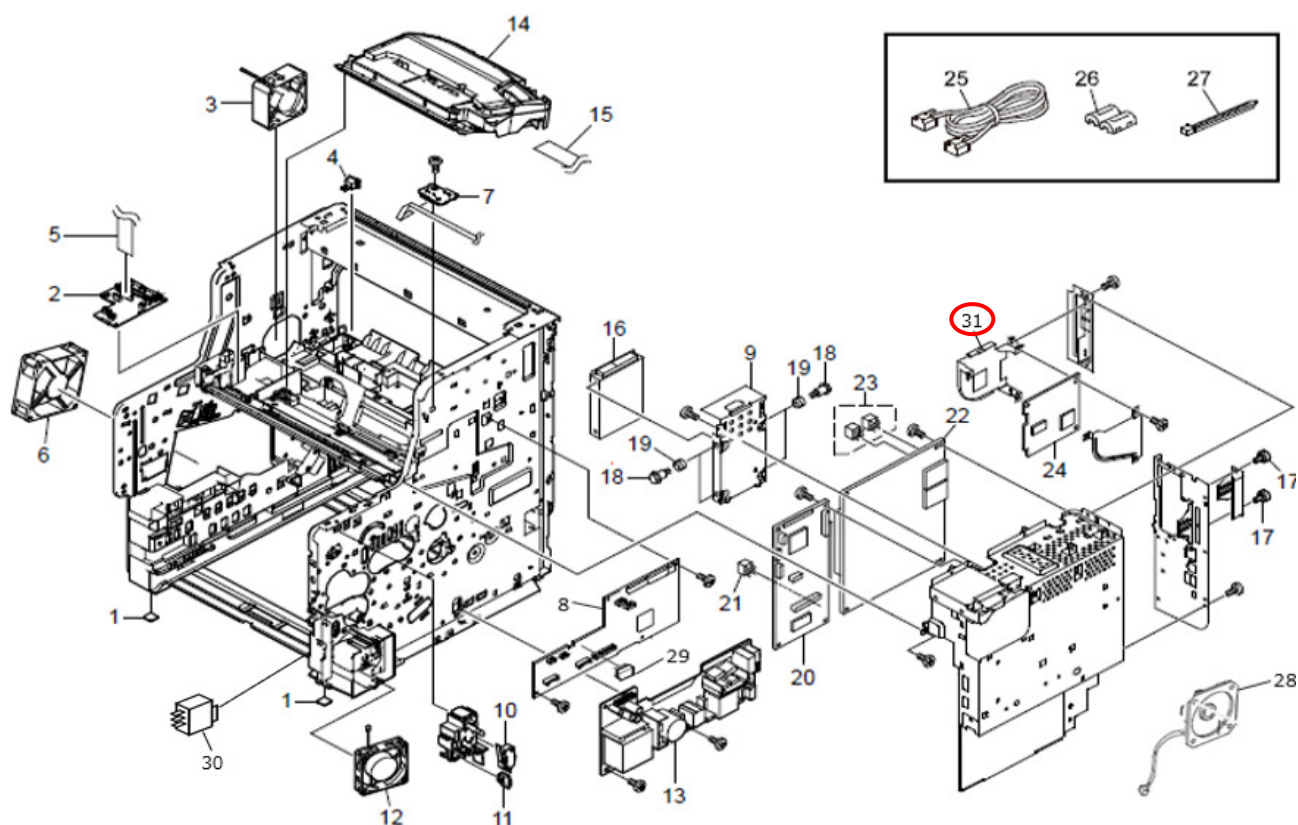
2. Frames

Change: *The bold italic part* is newly added.

Part number	Description	Q'ty	Int	Page	Index	Note
D2551058	SPEAKER	1		6	28	
D2555321	PARTS_IC_EEPROM	1		6	29	
M2812860	SW.PUSH	1		6	30	
<i>D2555557</i>	<i>PLATE FAX B</i>	<i>1</i>		<i>6</i>	<i>31</i>

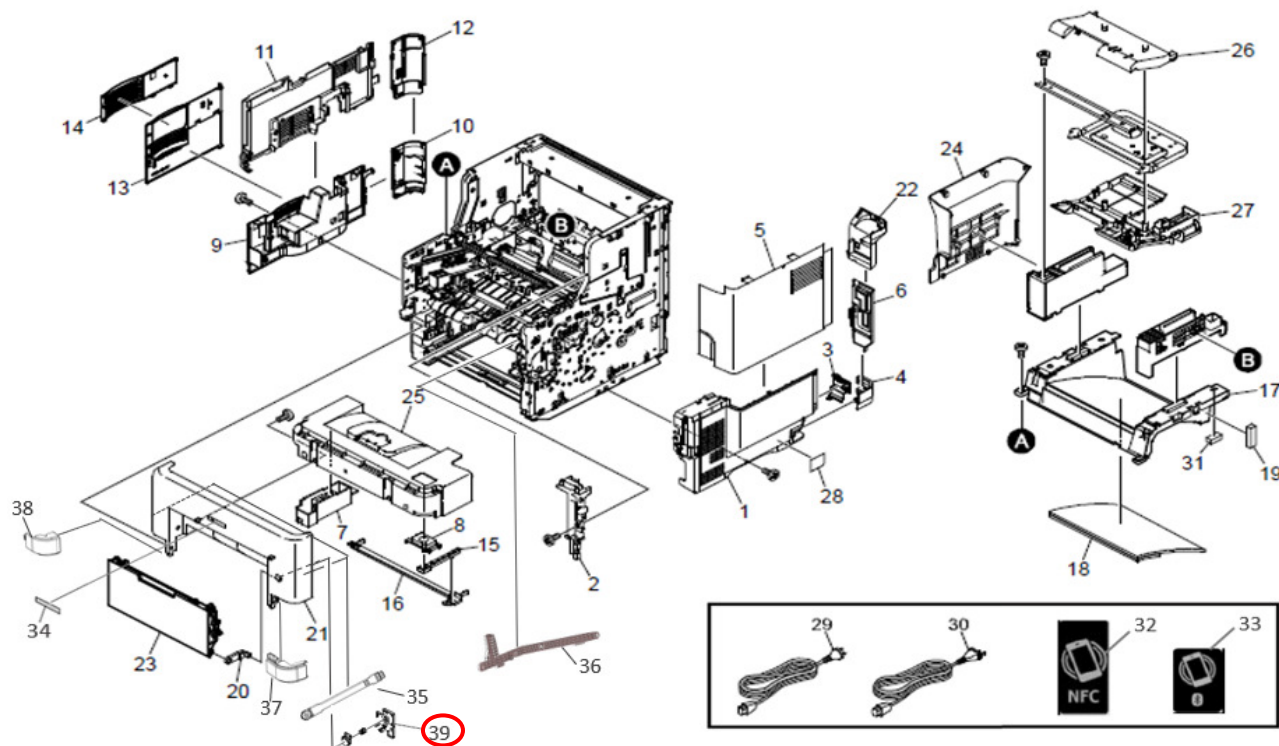
1.Covers

Change: *The bold italic part* is newly added.

Part number	Description	Q'ty	Int	Page	Index	Note
D1961485	IC:NFC_TAG:MN63Y3212NB	1		4	32	
D2557798	DECAL:BLUETOOTH:CHEETAH-G2	1		4	33	
M1011301	PLATE:LOGO:RIC	1		4	34	
D1201561	SHEET:LOGO:SAV	1		4	34	
AA001531	PLATE:LOGO:LAN	1		4	34	
D2551252	STRAP COVER FRONT	2		4	35	
M2811139	ARM COUPLING	1		4	36	
D2551250	COVER FRONT RIGHT	1		4	37	
D2551249	COVER FRONT LEFT	1		4	38	
<i>D0BT1071</i>	<i>HOLDER KEY SW</i>	<i>1</i>		<i>4</i>	<i>39</i>

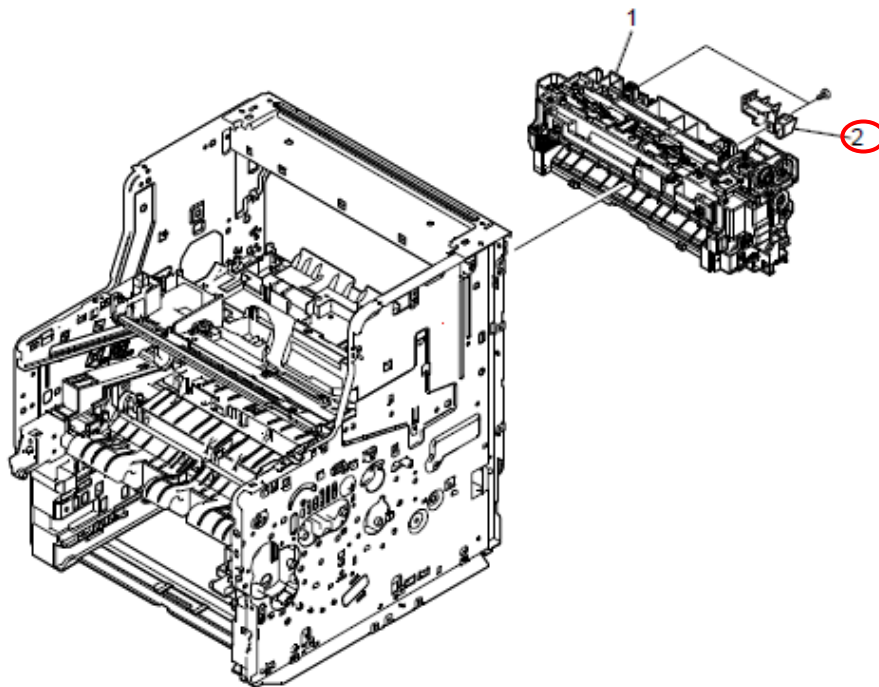
7. Fusing Section

Change: This part is newly added.

Part number	Description	Q'ty	Int	Page	Index	Note
M2811087	COVER SENSOR	1		16	2

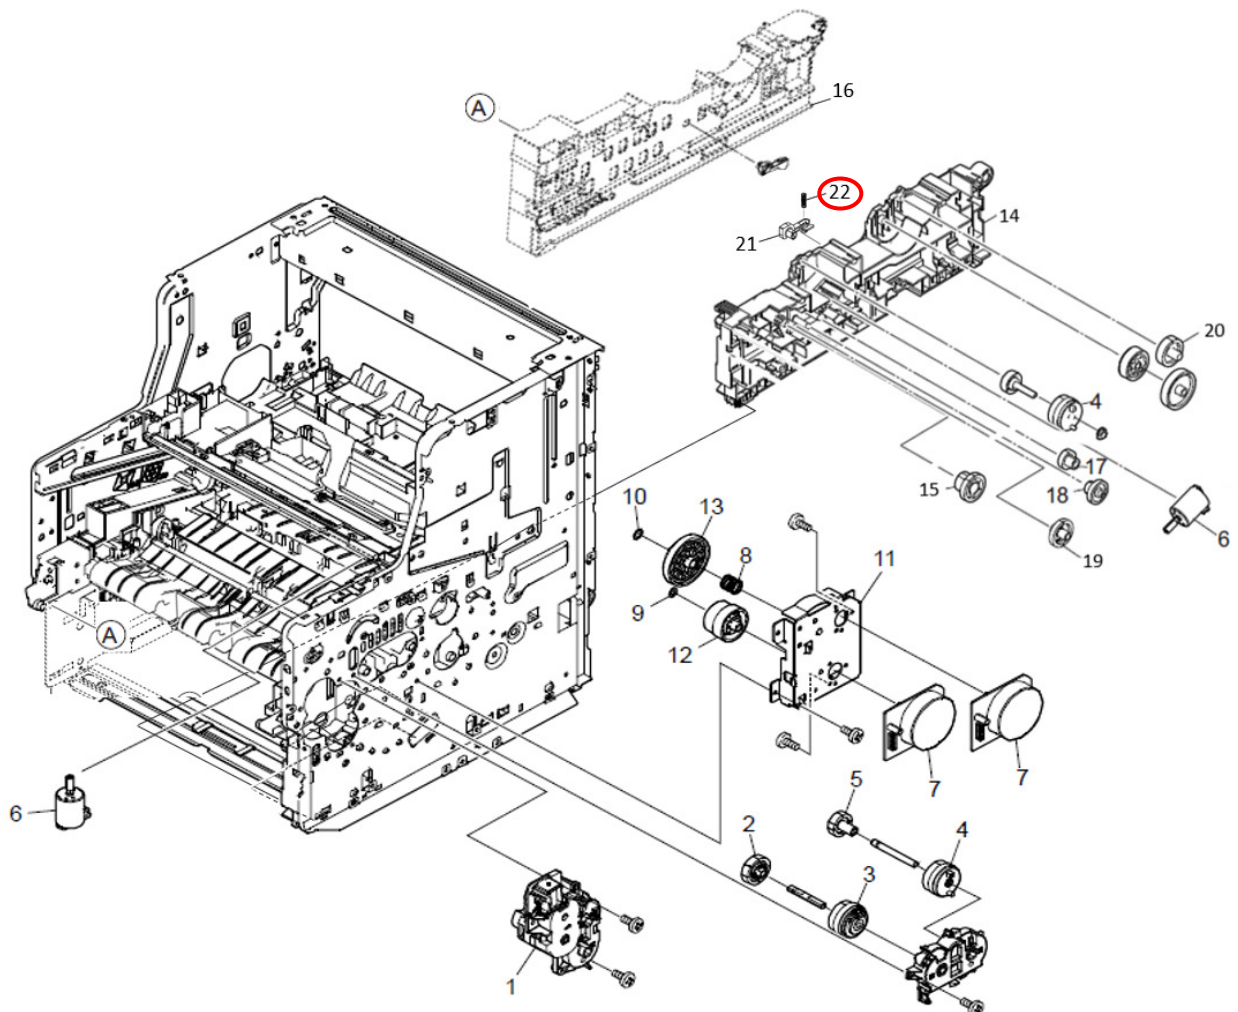
10. Drive Section

Change: *The bold italic part* is newly added.

Part number	Description	Q'ty	Int	Page	Index	Note
M2811182	GUIDE CASSETTE R	1		22	14	
M2811130	GEAR Z35S-Z13S B	1		22	15	
M2811183	GUIDE CASSETTE L	1		22	16	
M2812543	GEAR Z36L-Z20S	1		22	17	
M2812542	GEAR Z46S-Z13S	1		22	18	
M2812541	GEAR Z34S-Z13S	1		22	19	
M2817501	GEAR Z34S INPUT	1		22	20	
M2817506	LEVER LOCK CASSETTE L	1		22	21	
<i>M2811246</i>	<i>SPRING LOCK CASSETTE</i>	<i>1</i>		<i>22</i>	<i>22</i>
