Model: Brz-P1

Technical Bulletin

No.: RM281002c

<i>lics</i> ha	IVe
Subject: Firmware Heekasenslootaplenginta		been corrected or	adeeepared by: T. Tachibana
From: 2nd Tech S	ervice Sect., MFP/Printer Tec	ch Service Dept.	
Classification:	 Troubleshooting Mechanical 	Part information	 Action required Service manual revision
	Paper path	Transmit/receive	Retrofit information
	Product Safety	🛛 Other (Firmware)	🖾 Tier 2

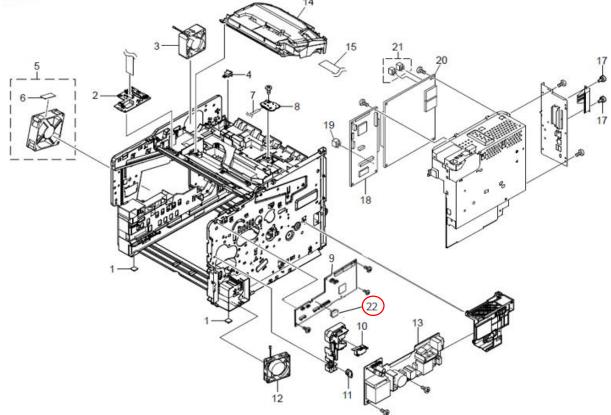
2. Frames

Reason: The parts was missing from the parts catalog.

Part number	Description	Q'ty	Int	Page	Index	Note
D2555321	PARTS_IC_EEPROM	1		6	22

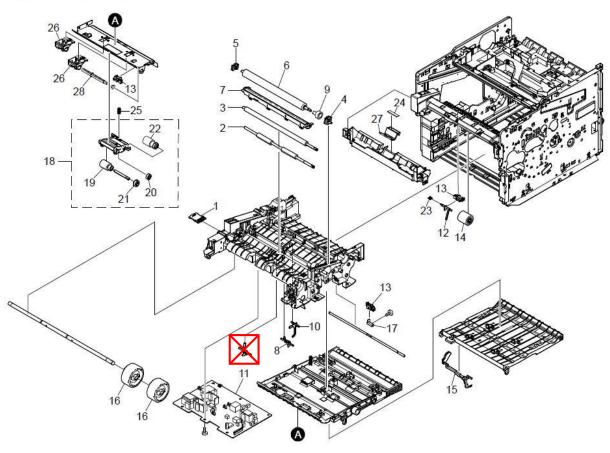
4. Paper Feed Section

Change: The illustration of the actuator outlined in red was deleted.

Reason: Brz-P1 does not have this actuator.

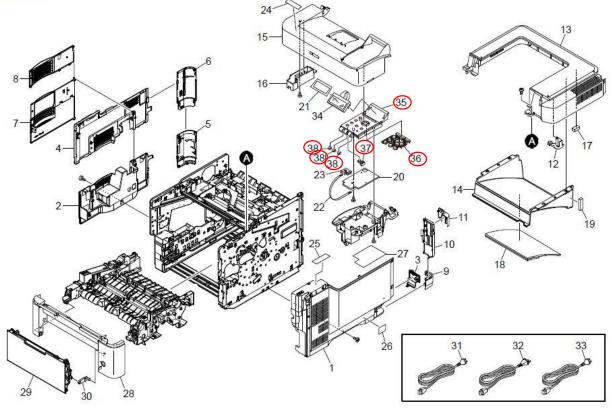
1.Covers

Change: These parts are newly added.

Reason: To meet requests received from the field.

Part number	Description	Q'ty	Int	Page	Index	Note
M2811420	LID OPERATION	1		4	35	
M2811424	KEY A	1		4	36	
M2811425	KEY PAUSE	1		4	37	
M2811427	LENS LED	3		4	38

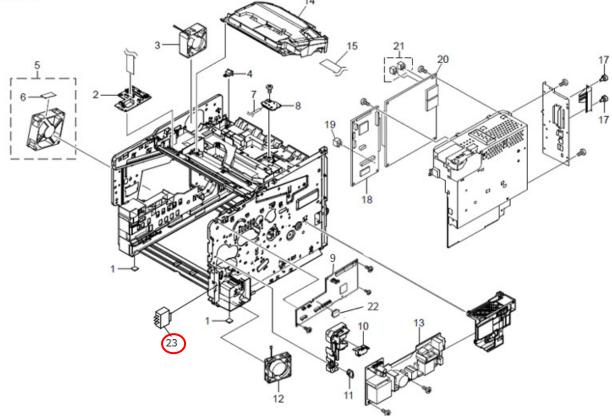
2. Frames

Change: These parts are newly added.

Reason: To meet requests received from the field.

Part number	Description	Q'ty	Int	Page	Index	Note
M2812860	SW.PUSH	1		6	23

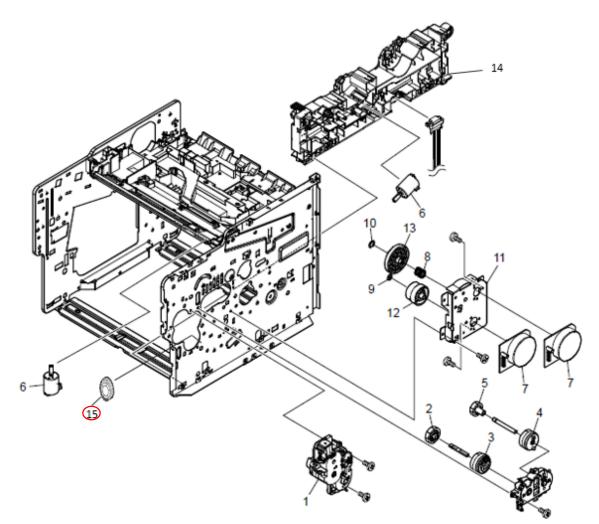
9. Drive Section

Change: This parts is newly added.

Reason: To meet requests received from the field.

Old part number	New part number	Description	Q'ty	Int	Page	Index	Note
	M2811130	GEAR Z35S-Z13S B	0-1	-	20	15

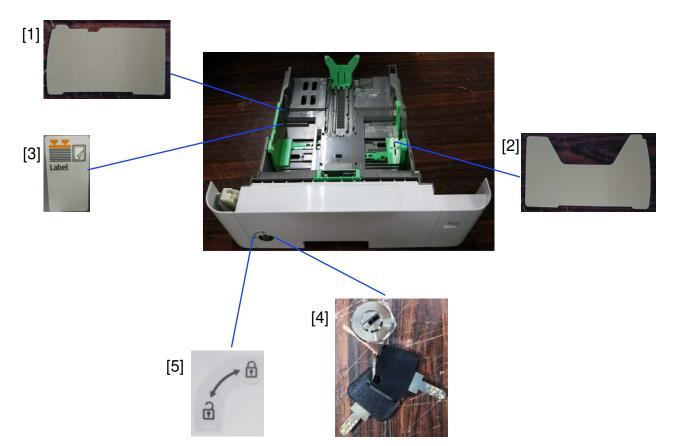
Parts Catalog Revision for HC model:

Index No.	Part No.	Description	Q'ty	Note 1 (Destination)	Note 2 (Machine Code)
1	D3DC2841	SHEET:SIDE FENCE:LEFT	1	NA / EU	D255-17/ D255-27/
2	D3DC2842	SHEET:SIDE FENCE:RIGHT	1	NA / EU	M281-17/ M281-27/
3	D3DC2843	DECAL:SIDE FENCE	1	NA / EU	D3C2-01
4	D3DC2891	KEY:SN-711-8-D:SPECIAL ORDER	1	NA	D255-17/ M281-17/
5	D3DC2894	DECAL:KEY	1	NA	D3C2-01

Note: The key (p/n: D3DC2891) comes with two spare keys.

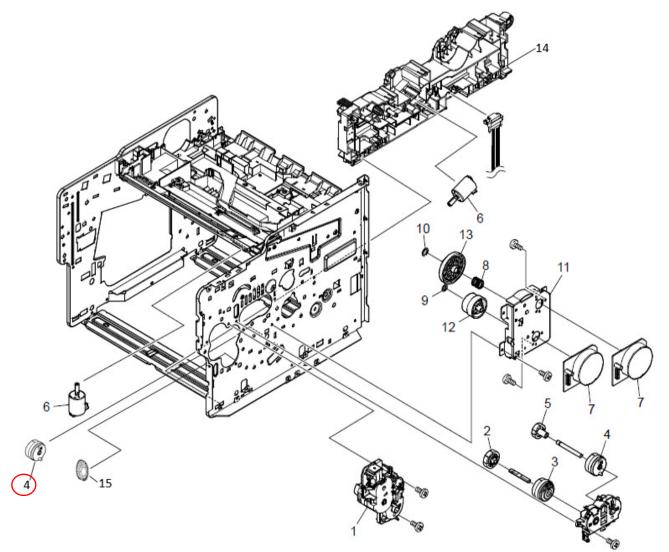
9. Drive Section

Reason: This part was missing from the parts catalog.

Part number	Description	Q'ty	Int	Page	Index	Note
M2811127	PARTS CLUTCH 20-2W Z35R	1-2	-	20	4
