Model: <b>Martini-C4</b>	Date: 30-Apr-09	No.: RD062001
--------------------------	-----------------	---------------

Subject: Printer SP Bit Switch #5-7		Prepared by: Koji KY Yamamoto	
From: 2nd Tech. Support Sec. Service Support Dept.			
Classification:	<input type="checkbox"/> Troubleshooting	<input type="checkbox"/> Part information	<input type="checkbox"/> Action required
	<input type="checkbox"/> Mechanical	<input type="checkbox"/> Electrical	<input checked="" type="checkbox"/> Service manual revision
	<input type="checkbox"/> Paper path	<input type="checkbox"/> Transmit/receive	<input type="checkbox"/> Retrofit information
	<input type="checkbox"/> Product Safety	<input type="checkbox"/> Other ( )	<input type="checkbox"/> Tier 2

Model: MT-C4	Date: 28-May-09	No.: RD062002c
--------------	-----------------	----------------

Subject: Firmware Release Note: Web Support		Prepared by: K. Yamamoto	
From: 1st Overseas Tech Support Sec., 1st PQM Dept.			
Classification:	<input type="checkbox"/> Troubleshooting	<input type="checkbox"/> Part information	<input type="checkbox"/> Action required
	<input type="checkbox"/> Mechanical	<input type="checkbox"/> Electrical	<input type="checkbo

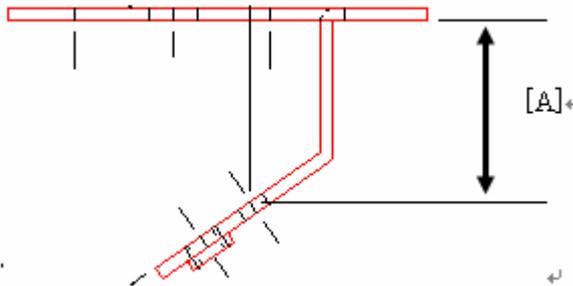
**B1404196/7: 14.8mm**

**D0624196/7: 15.3mm**

1. Clean the middle and rear thermistors.
2. If the SC still occurs even after cleaning the thermistors, replace the thermistor brackets with the new parts in the table below.

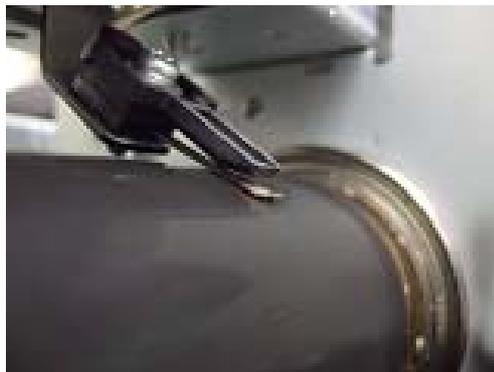
New

Correct position of the thermistor

3. Replace the middle and rear thermistors.

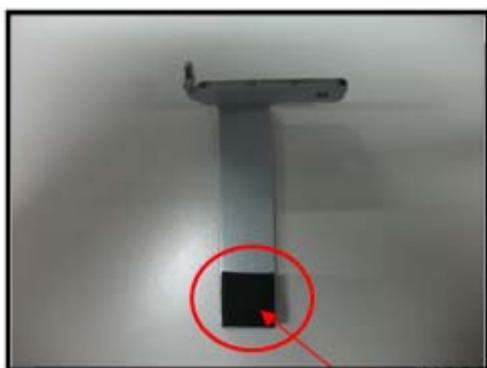
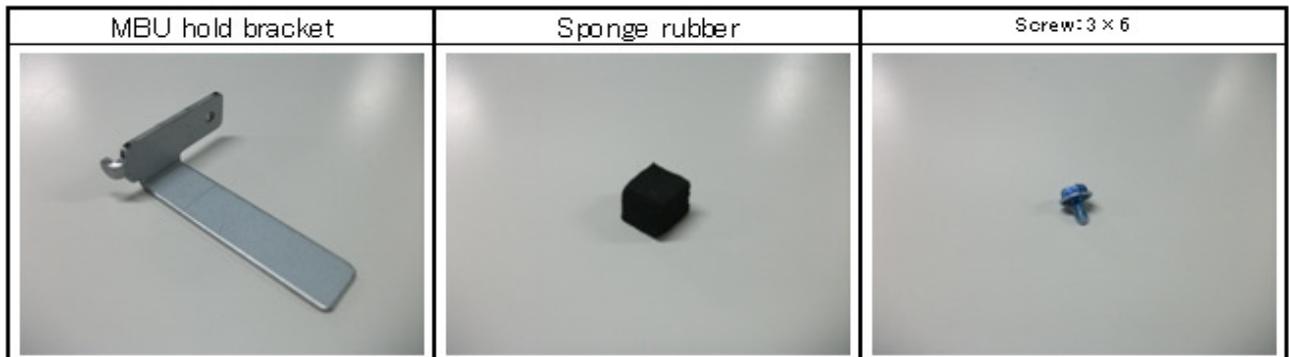
Sponge rubber

## CAUSE

The fax unit bracket bends, which causes the MBU connector to detach from the fax unit.

Attach the following bracket and related parts (D0629451: MBU kit).

**See the attachment procedure below**

**Note:** The MBU kit includes the following parts.

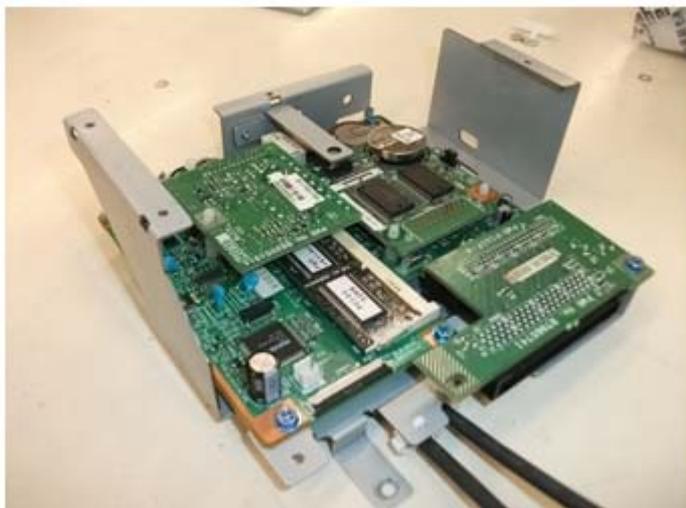
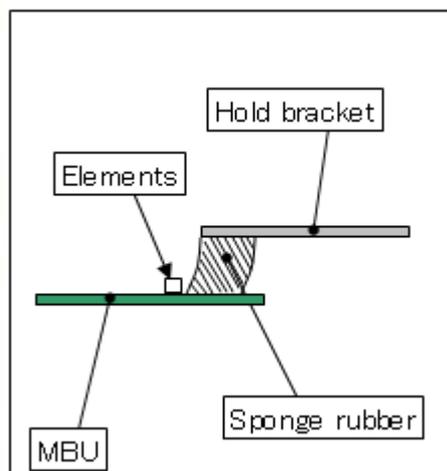
**Important:** The sponge rubber should not touch any of the elements of the MPU board.

5. Make sure that the bracket is attached to the fax unit correctly.

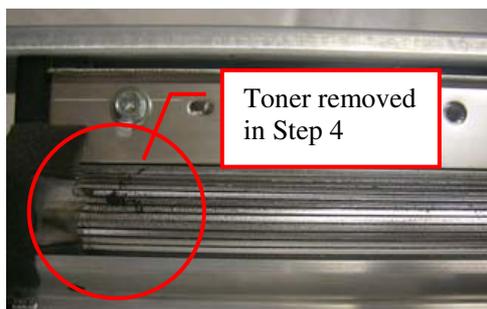
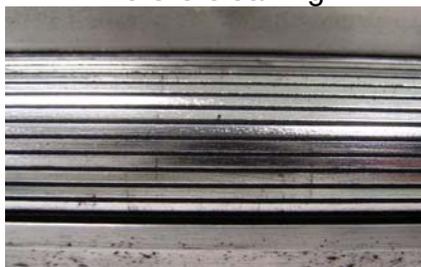
Before cleaning

- 4. Wipe the toner off the sleeve.  
Important: This is necessary in order to remove the toner that is still stuck to the sleeve.

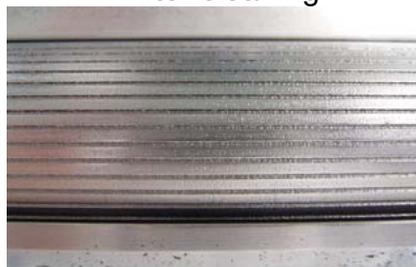
After cleaning

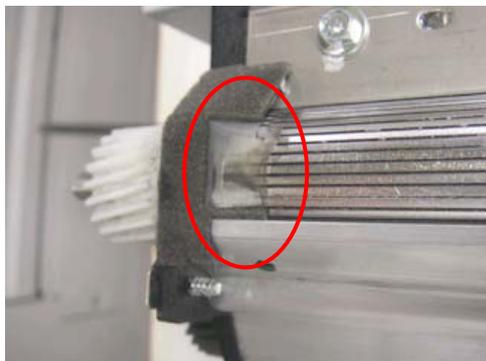
**CORRECT:**

5. Make sure that the sponge and both entrance Mylars are attached correctly.

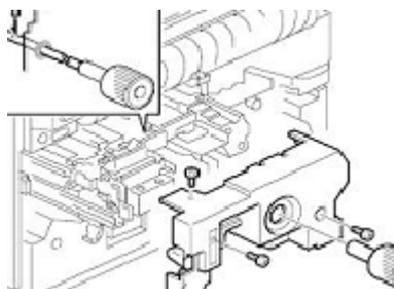
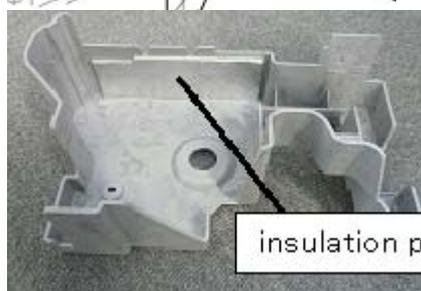
Note: This will prevent heat from being transferred from the fusing unit to the toner bottle.

3. Attach the extra insulation pad (B0654255).

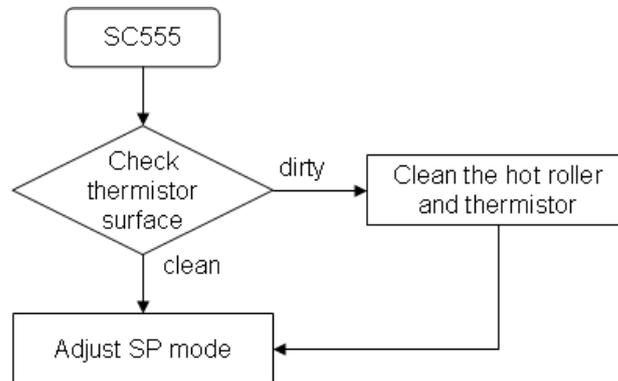
Workflow in the field

The fusing lamps have a tolerance in the temperature distribution. Because of the variation in the parts on this characteristic and some other conditions described below, the fusing temperature could not reach the target level within the programmed time.

1. Check whether the thermistors are clean or dirty.
2. If the thermistors are clean, move to #3.
  - If the thermistors and/or hot roller are expected to reach PM yield before the next service visit (or have already reached yield), **replace them**.
  - If yield will not be reached before the next visit, but the surface of the thermistors and/or hot roller is dirty, clean the toner/dust off the surface.
  - If the surface of the thermistors and/or hot roller often become dirty before reaching yield, replace the cleaning web with the new type.

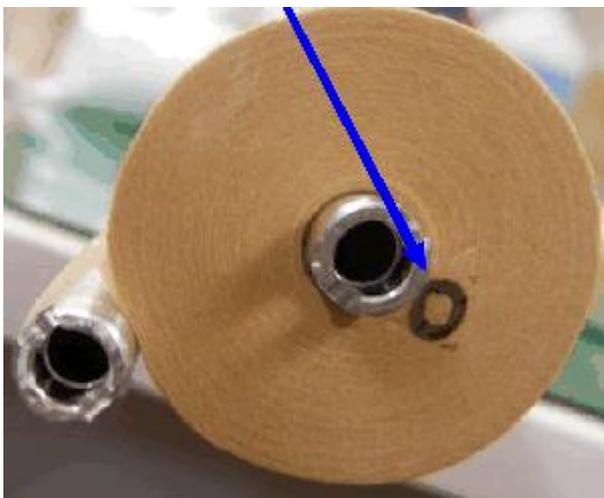
No.: RD131033a

The **new web** (AE045069) is marked with a circle as shown below.

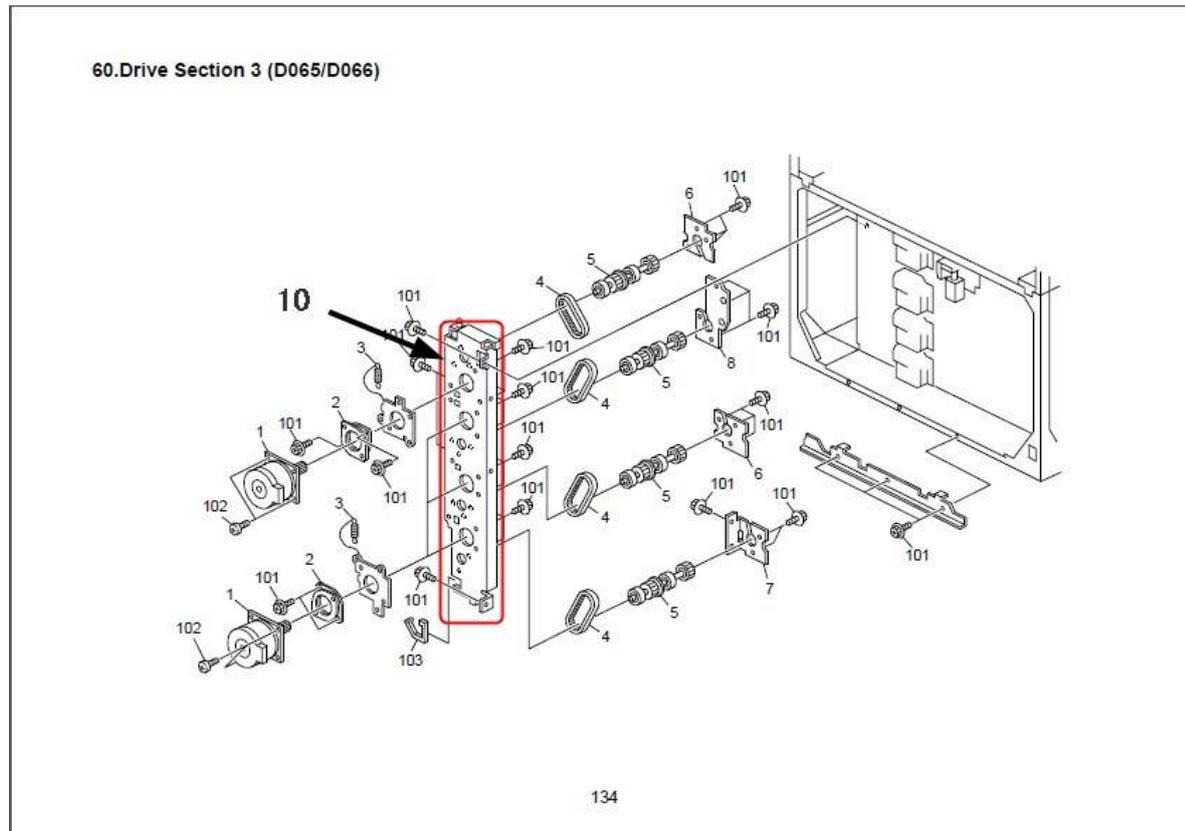
**Change/Reason:** The following was missing from the Parts Catalog.

New part number	Description	Q'ty	Int	Page	Index	Note
D0666753	BRACKET:PAPER FEED:DC STEPPER MOTOR:THREE WAY:ASS'Y	1		135	10*

**\*New Index**

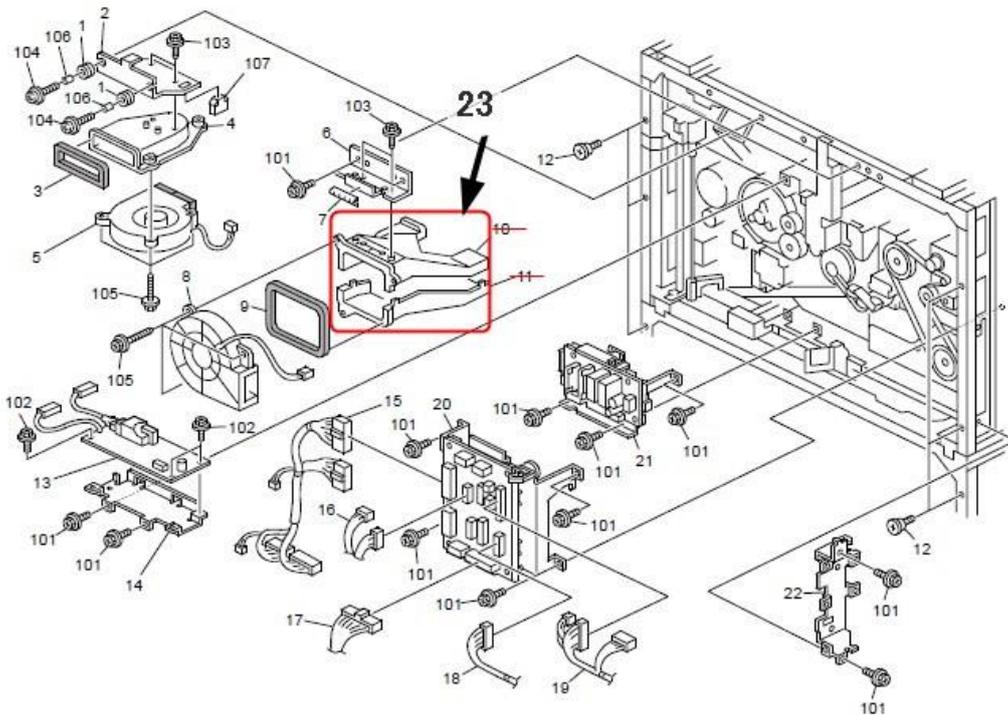
62.Electrical Section 2 (D062/D063/D065/D066)

**Reason:** To further ensure the proper performance of the exhaust system.

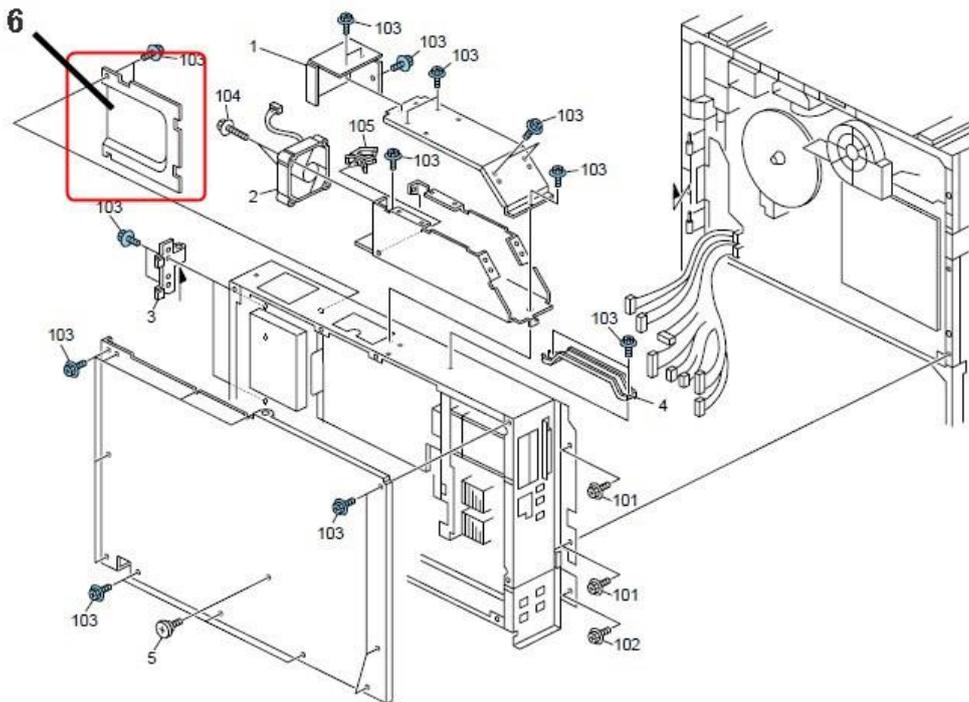
67.Electrical Section 7 (D062/D063/D065/D066)

**Change/Reason:** The following part was missing from the Parts Catalog.

**\*New Index**

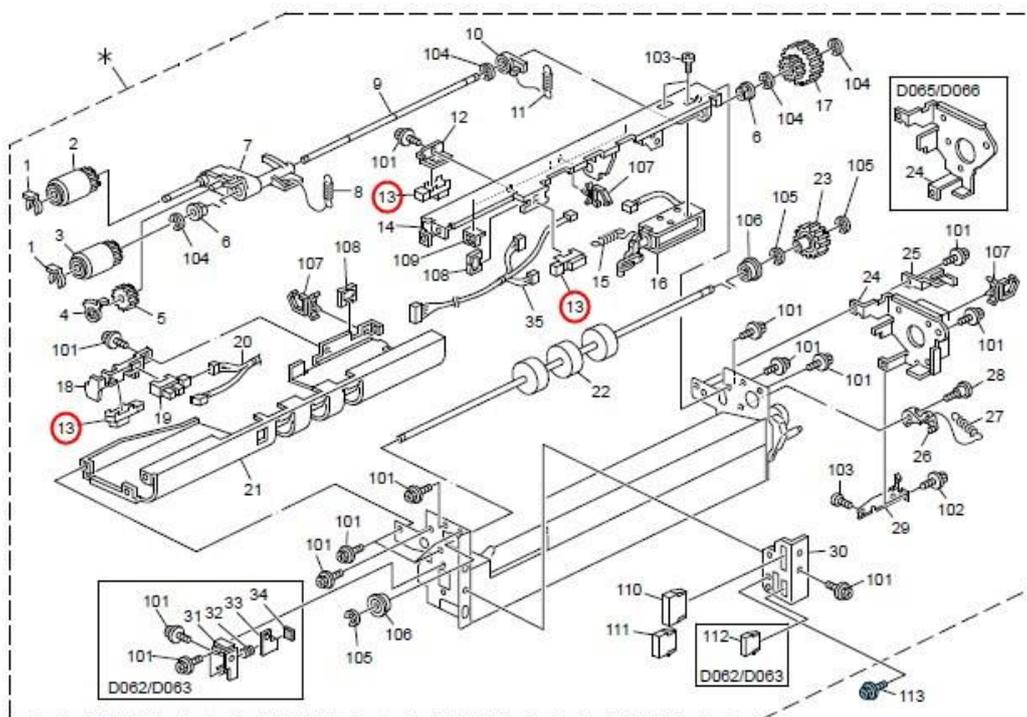
27.Paper Feed Unit 1 (D062/D063/D065/D066)

part number	Description	Page	Index	Note
AW010107	PAPER FEED SENSOR	68	13	
AW010149

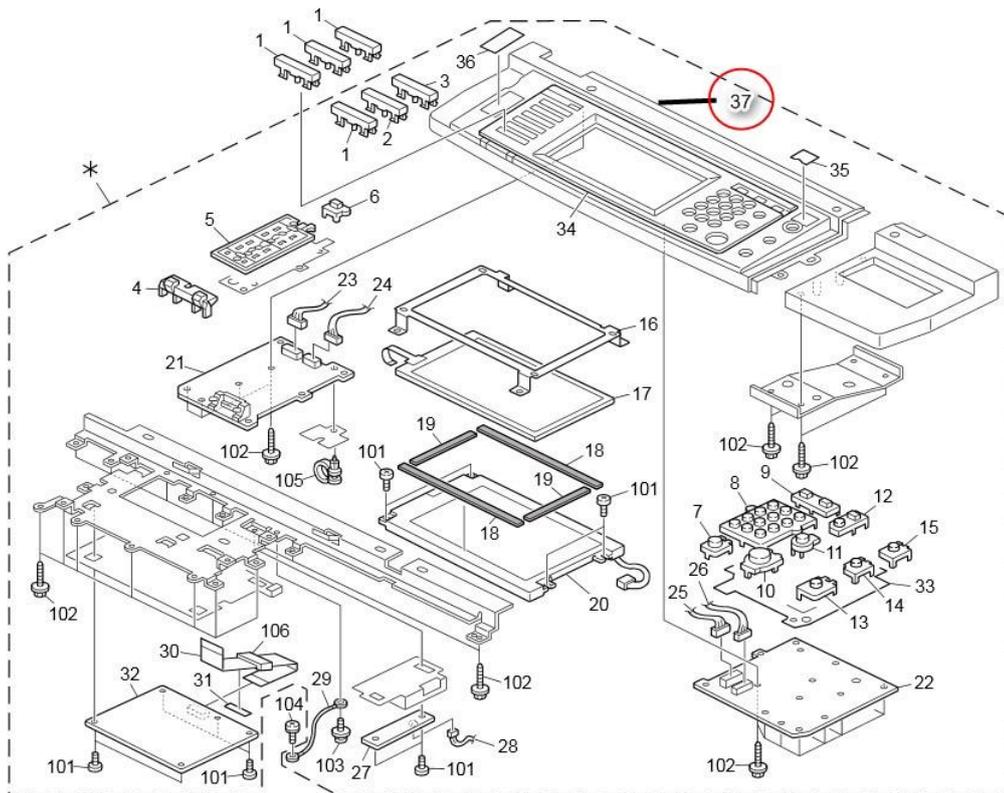
**5.Operation Panel (D062/D063/D065/D066)**

**Change/Reason:** The following part was missing from the Parts Catalog.

**\*New Index**

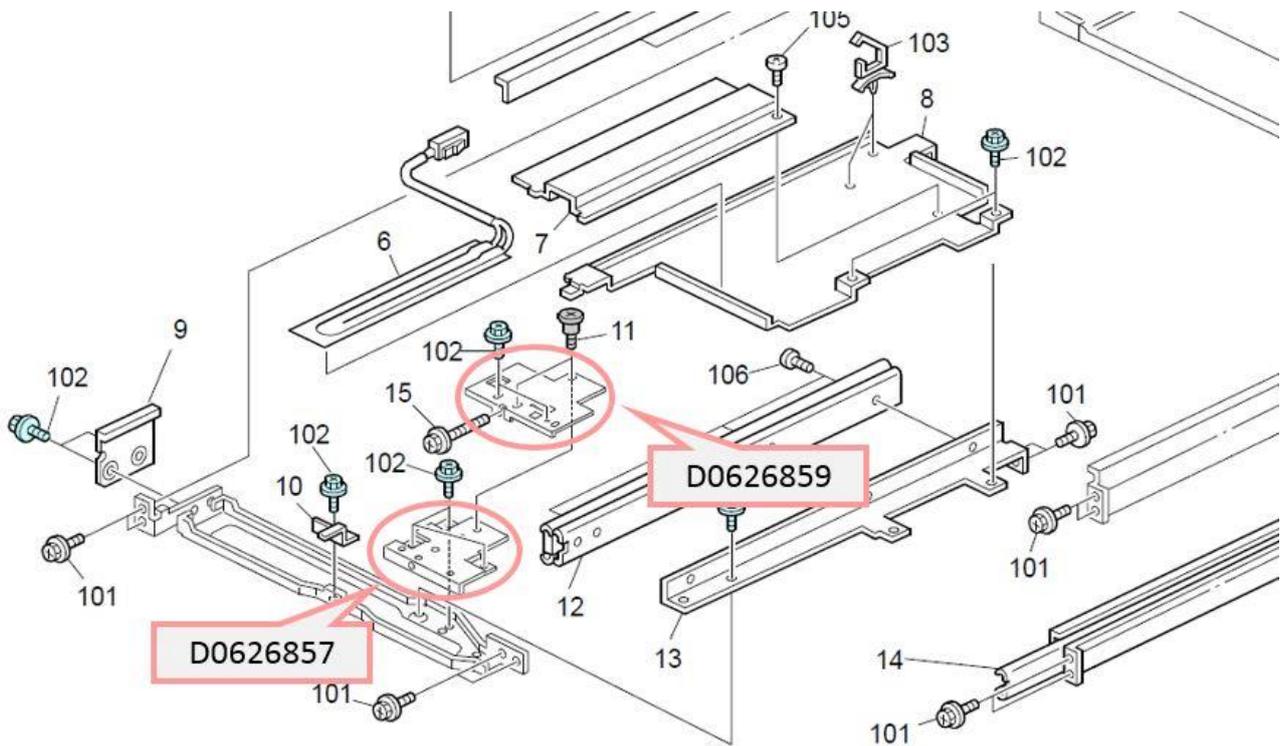
Part number	Description	Q'ty	Int	Page	Index	Note
D0626857	BRACKET:HOLDER:STOPPER: TANDEM LCT	1	-	162	-	-
D0626859	HOLDER:STOPPER:TANDEM LCT	1	-	162	-	-

The following parts were missing from the Parts Catalog.

The holder (p/n: D0626859) needs to be adjusted when performing side-to-side registration. See "Tandem Tray Side Registration" in the FSM for details.
