Model: MT-C5	Date: 17-May -12	No.: RD131001a
--------------	------------------	----------------

Subject: Firmware Release Note: RPCS		Prepared by: M. Yoneda	
From: 2nd Tech Service Sect., MFP/Printer Tech Service Dept.			
Classification:	<input type="checkbox"/> Troubleshooting <input type="checkbox"/> Mechanical <input type="checkbox"/> Paper path <input type="checkbox"/> Product Safety	<input type="checkbox"/> Part information <input type="checkbox"/> Electrical <input type="checkbox"/> Transmit/receive <input checked="" type="checkbox"/> Other (Firmware)	<input type="checkbox"/> Action required <input type="checkbox"/> Service manual revision <input type="checkbox"/> Retrofit information <input checked="" type="checkbox"/> Tier 2

This RTB has been issued to announce the firmware release information for the **RPCS**.

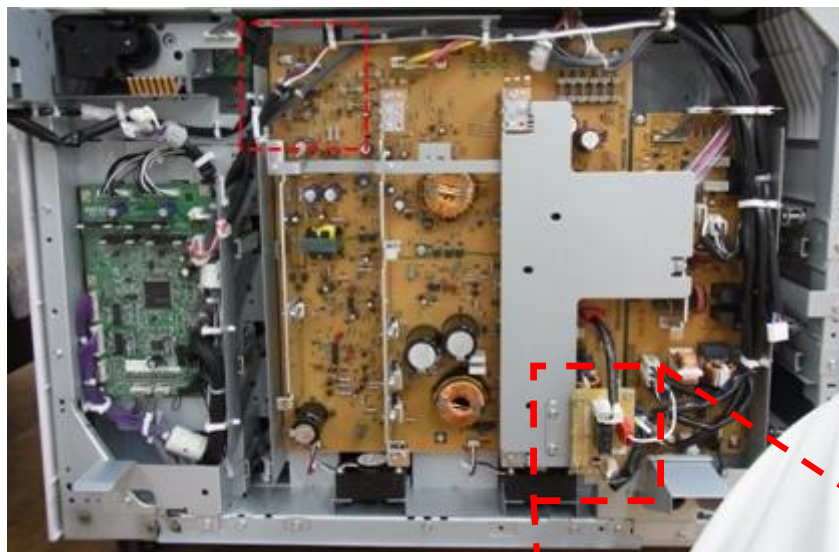
Newly added relay board (with bracket)

- Cut-in S/N information for this modification is unavailable. If the machine is installed with the new relay board (RYB, p/n: D1315240), it is of the modified type.
- **Installing the new RYB in a machine manufactured prior to this modification will not reduce power consumption during Sleep Mode. Refer to this bulletin only when any of the above parts need to be replaced.**
- Old harnesses (p/n: D0625561, p/n: D0625517) do not have to be replaced with new ones (p/n: D1315562, p/n: D1315518) on machines manufactured prior to this modification. Old harnesses will continue to be supplied.

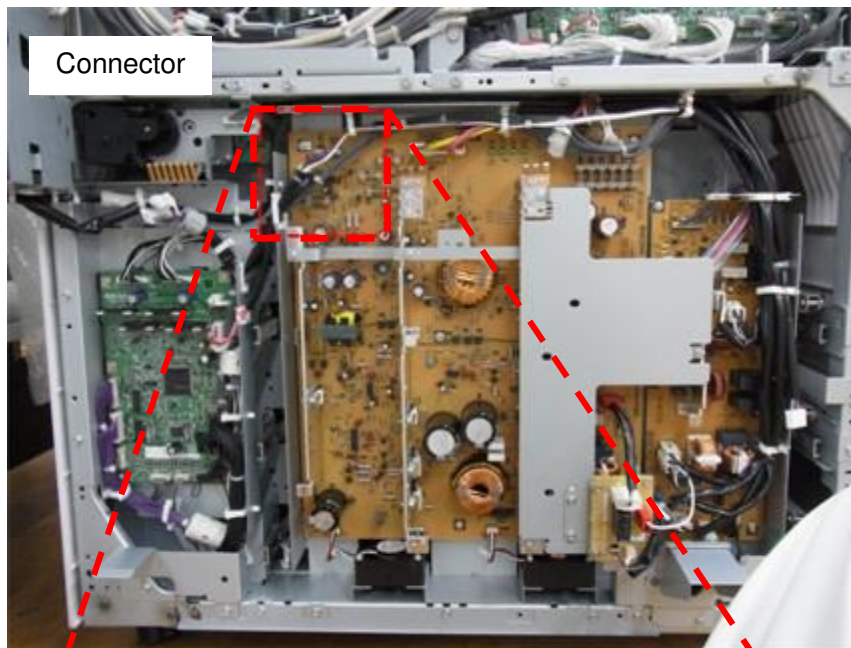
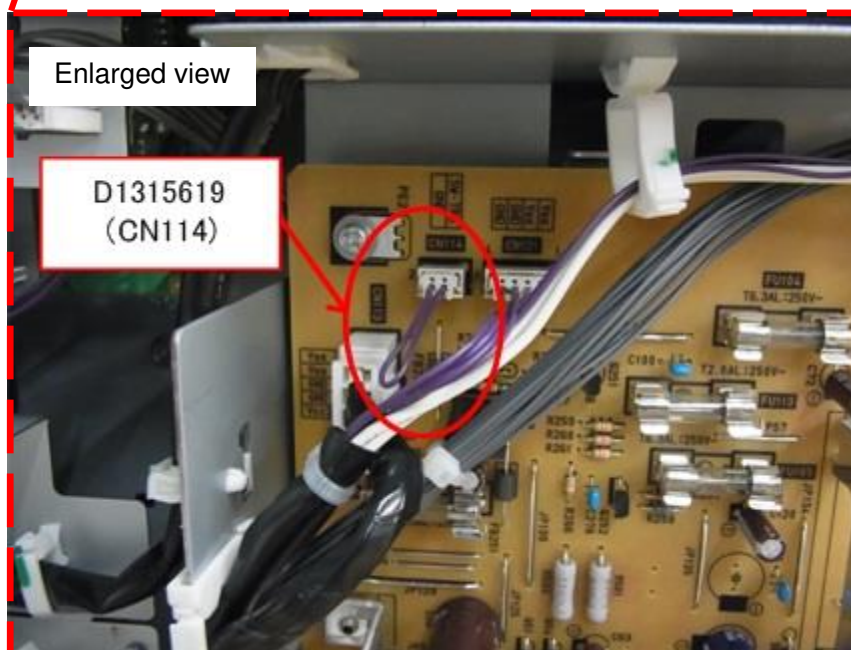
Newly added harness (p/n: D1315619)

Connection to CN114 is shorted with the new harness (p/n: D1315619).
