Model: Cor-C1 / Cor-C1_SOP	Date: 05-Sep-14	No.: RD197002d
-----------------------------------	-----------------	----------------

Subject: Firmware Release Note: browser		Prepared by: H. Morishima	
From: 2nd Tech Service Sect., MFP/Printer Tech Service Dept.			
Classification:	<input type="checkbox"/> Troubleshooting <input type="checkbox"/> Mechanical <input type="checkbox"/> Paper path <input type="checkbox"/> Product Safety	<input type="checkbox"/> Part information <input type="checkbox"/> Electrical <input type="checkbox"/> Transmit/receive <input checked="" type="checkbox"/> Other (Firmware)	<input type="checkbox"/> Action required <input type="checkbox"/> Service manual revision <input type="checkbox"/> Retrofit information <input checked="" type="checkbox"/> Tier 2

This RTB has been issued to announce the firmware release information for the **browser**.

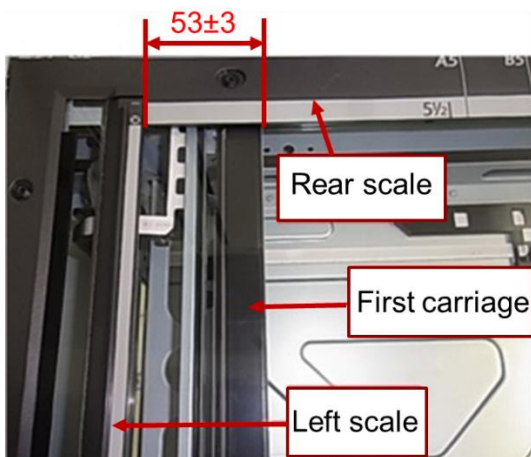
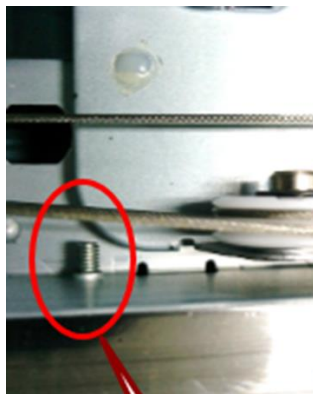
- This ensures that the second carriage stays firmly fixed in place. When the first carriage is in this position, the second carriage is supported by the screw (circled in red).
- See Cut-in Serial Numbers below.

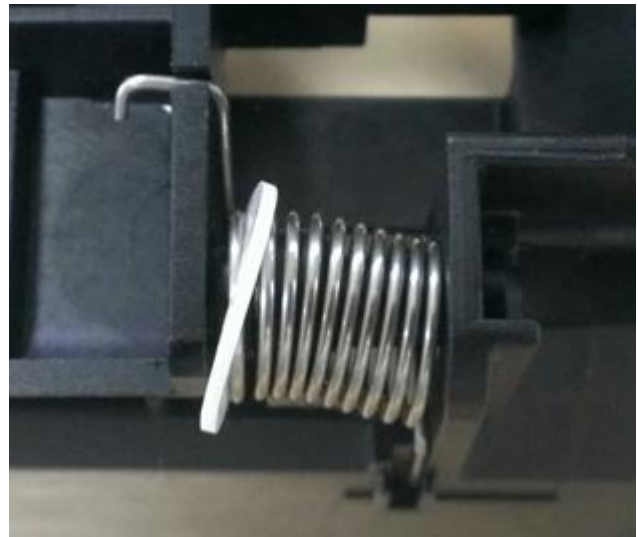
**Incorrect:**

Attach the retaining ring on the **left side of the spring**, as shown.

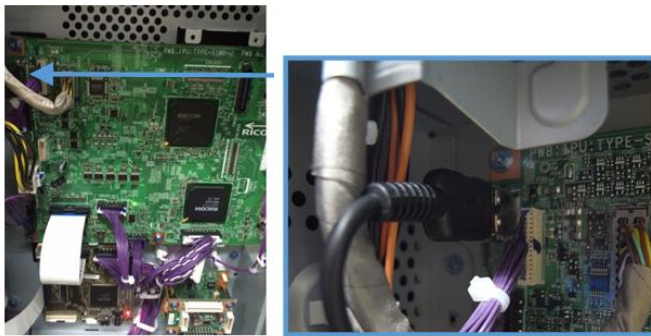
Figure 2: USB connector (IPU)

1. Turn the machine power OFF/ON.
2. Check the power saving system firmware version.
 - If this firmware is older than ver. F.23 update it to **ver. F.23 or newer**.
3. Re-connect the USB cable between IPU board and operation panel.

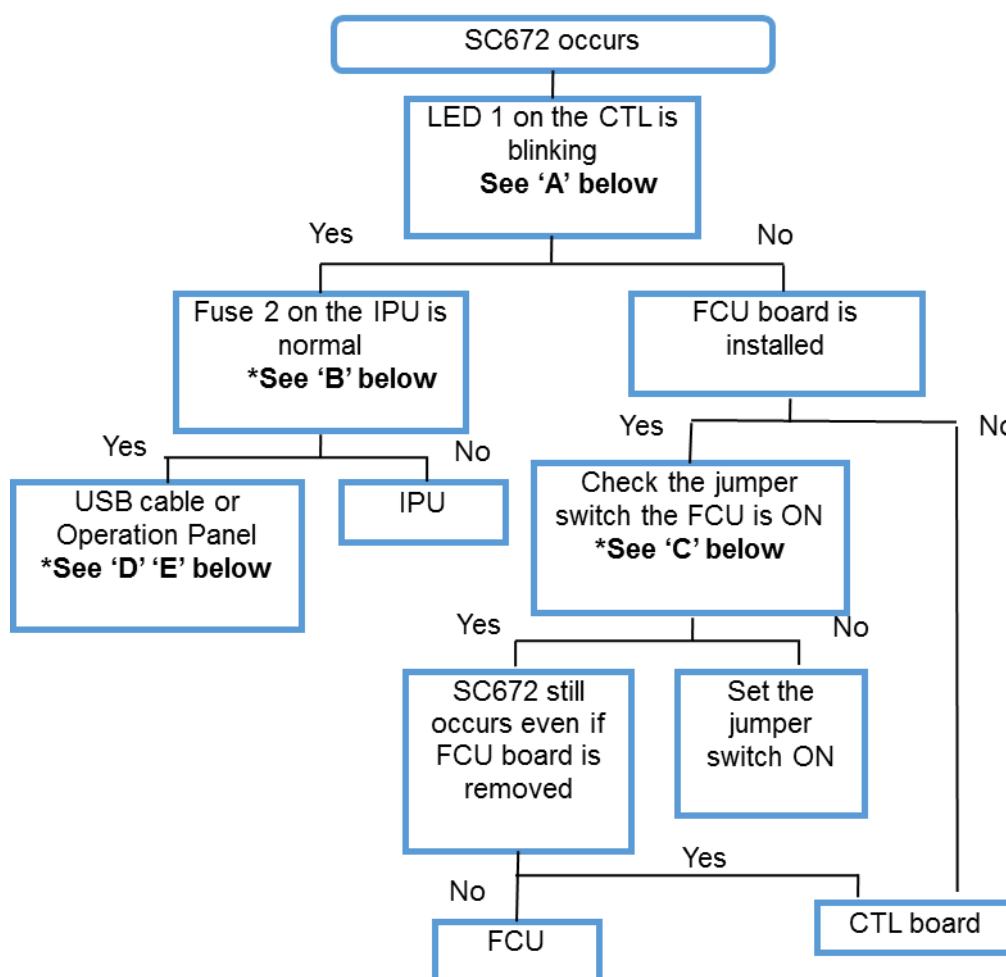
Flowchart to determine the replacement parts

- If SC819 (cache error) appears in the SC history, replace the controller board.
- If SC991 (SCS: scs time count level c') appears in the SC history, replace the controller board and the USB cable.

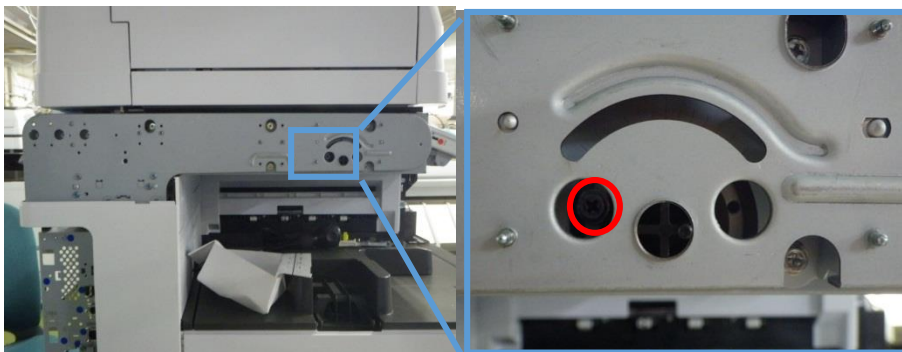
Never loosen or remove the following screw when you remove or re-attach the unit. This is because this screw fixes the scanner cam in place. If the position of the scanner cam changes, the scanner will be misaligned. This will result in image skew and other image alignment issues.

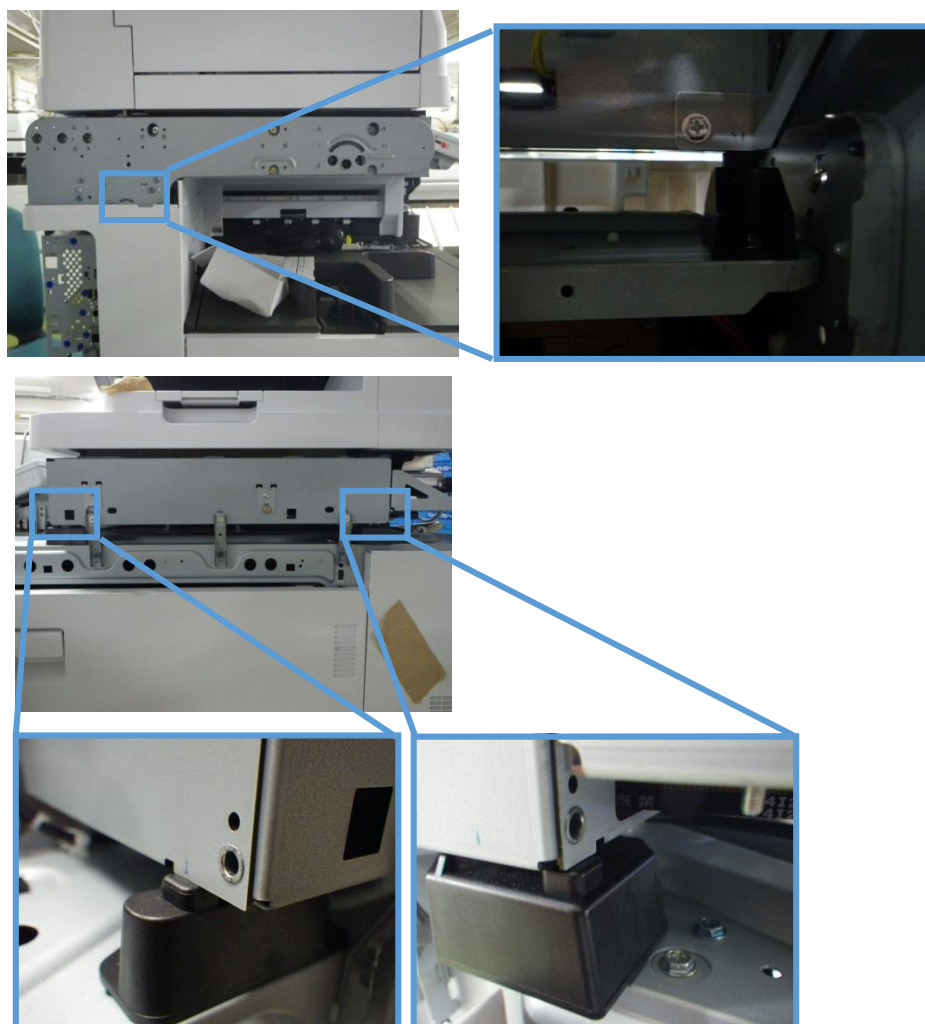
Make sure that there is no space between the machine frame and the following three areas of the scanner unit when you re-attach the scanner unit.

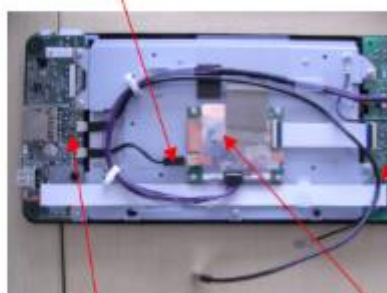
Do the following procedure step-by-step if the USB cable replacement does not solve the problem.

1. Reconnect **[a]** (Cable:LCDC:USB) and **[b]** (Cable:USB).
2. Replace **[a]** (Cable:LCDC:USB) and **[b]** (Cable:USB).
3. Replace **[c]** (PCB:OP-L:USB:ass'y).
4. Replace **[d]** (PCB:LCDC).

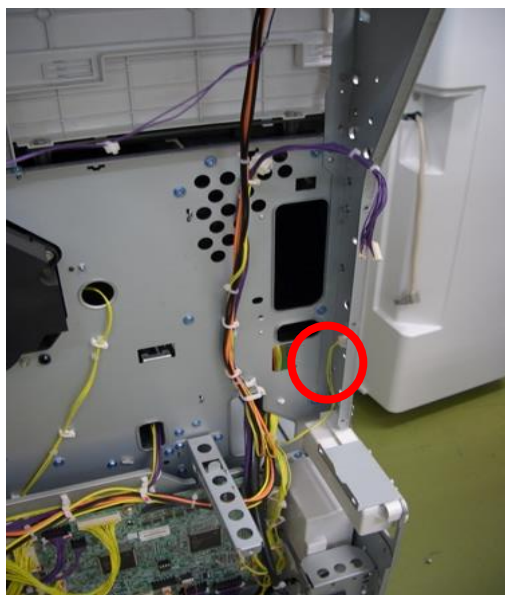
8. Check whether or not the relay harness (circled in red) is caught between the air duct and frame.

5. Disconnect the connector for the relay harness (circled in red) and then replace the harness.

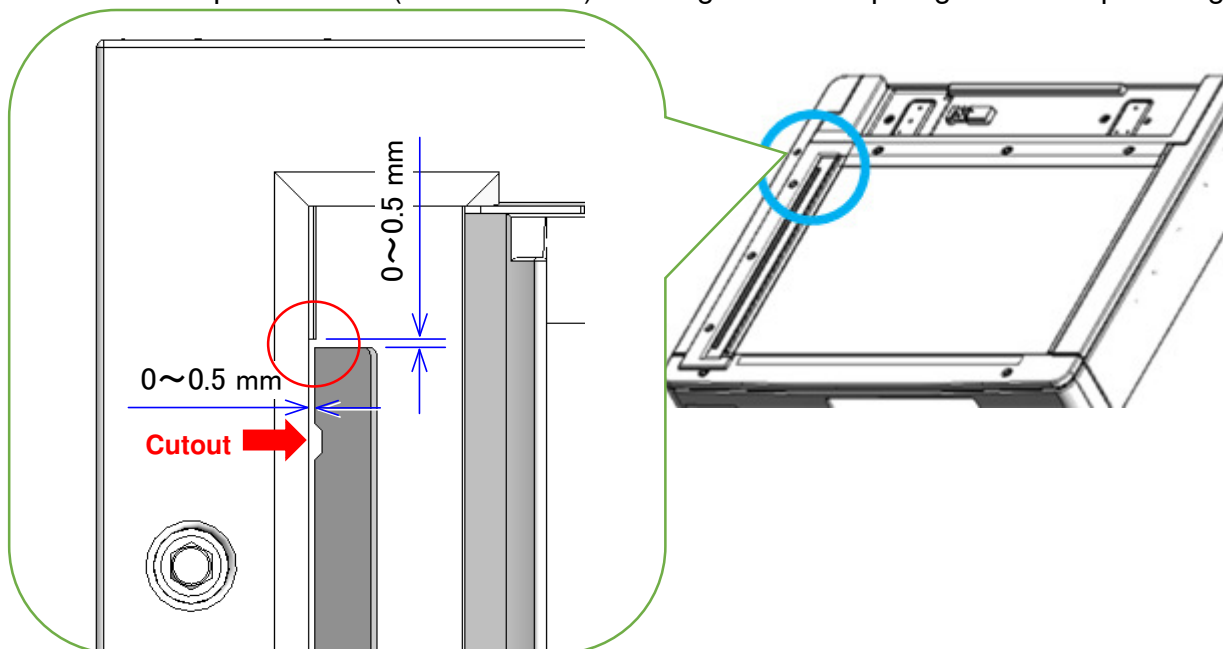
When installing the Document Feeder (DF3090), replace the mylar originally attached to its exposure glass with the new mylar included as an accessory to the Document Feeder. Scan quality, especially at the trailing edge of the original, is better with the new mylar.

- If the mylar could not be attached properly, remove it and attach a new one at your next visit.
- Without the new mylar, feeding thick paper for more than 90K pages may cause jitter.

1. Remove the mylar originally attached from the document feeder exposure glass.
2. Wipe the document feeder exposure glass with cloth.
3. Attach the new mylar.
 - The cutout on the mylar faces to the left.
 - Set the top left corner (circled in red) flush against the top edge of the exposure glass.

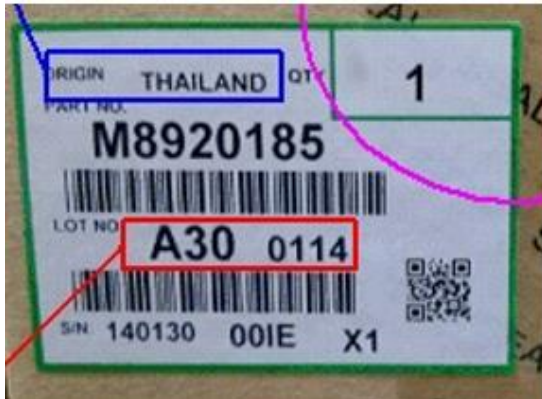
- Check the production date by looking at the lot number on the packaging.
 - The lot number is circled in red in the photo below.
 - The right 4 digits show the production date (example: production month: 01, production year: 14)

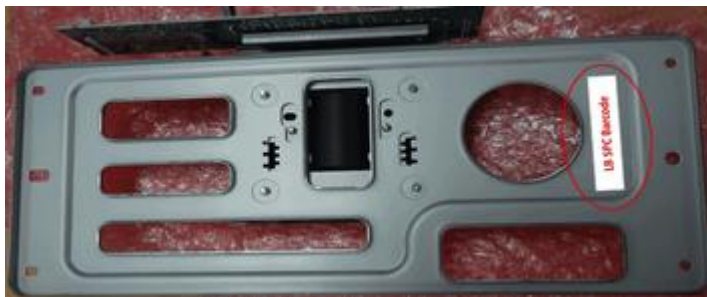
- Check the serial number on the lens holder frame.
 - If the serial number is attached to the frame, the focusing and positioning adjustments have already been completed.

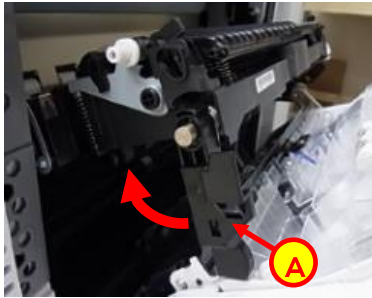
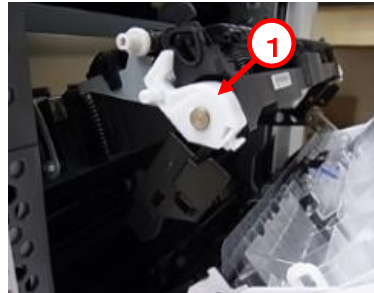
The front lever is broken when the duplex unit is opened and closed.

5. Move [A] in the direction of the red arrow and attach the new lever.

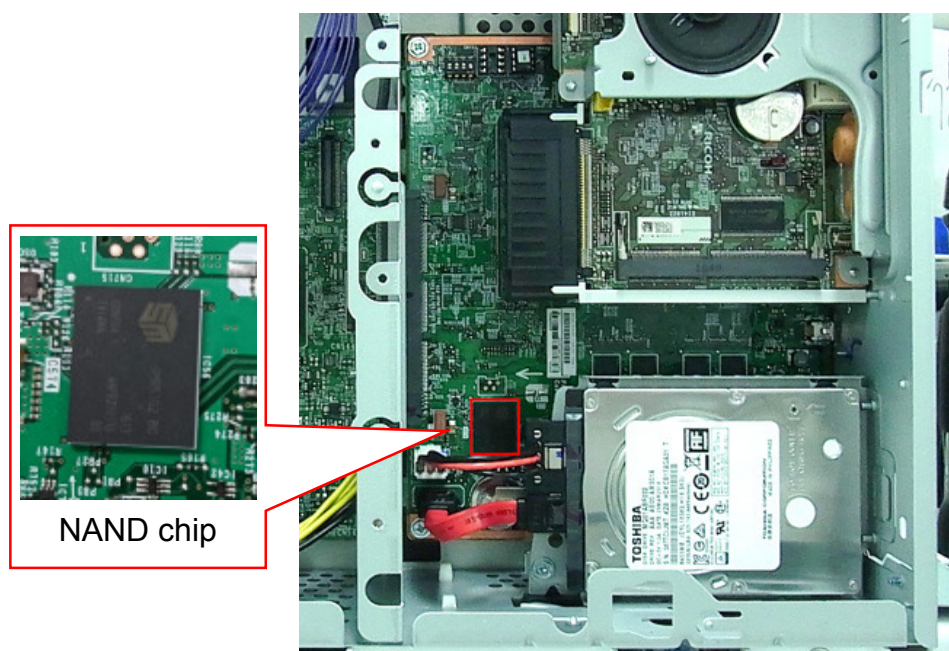
Defective NAND chips are used on controller boards produced between Aug 2016 to April 2017 (see **Affected Models** below). A software bug is in the NAND chip. As a result of this bug, the chip cannot perform a restore after the System Reset, which triggers the SC.
