Model: Model PG-C1	Date: 12-May-06	No.: RB229001b
--------------------	-----------------	----------------

Subject: Firmware Release History (System)		Prepared by: A.Ishiyama	
From: 1st Tech. Support Sec. Service Support Dept.			
Classification:	<input type="checkbox"/> Troubleshooting <input type="checkbox"/> Mechanical <input type="checkbox"/> Paper path <input checked="" type="checkbox"/> Other (      )	<input type="checkbox"/> Part information <input type="checkbox"/> Electrical <input type="checkbox"/> Transmit/receive	<input type="checkbox"/> Action required <input type="checkbox"/> Service manual revision <input type="checkbox"/> Retrofit information

This RTB has been issued to announce the firmware release information for System.

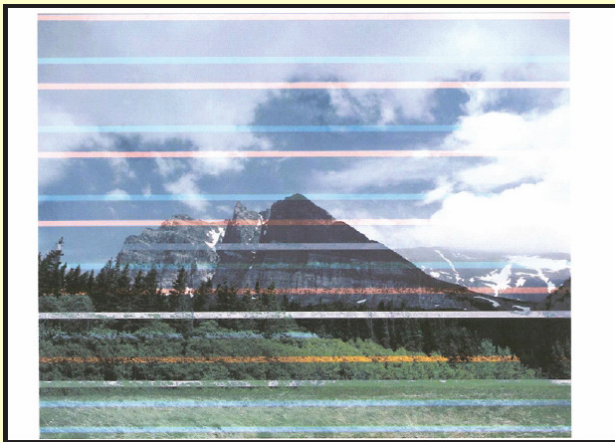
Output Image of white lines and color drift

When white lines appear on the paper or color drift occurs, adjust followings:

Clean Print-heads

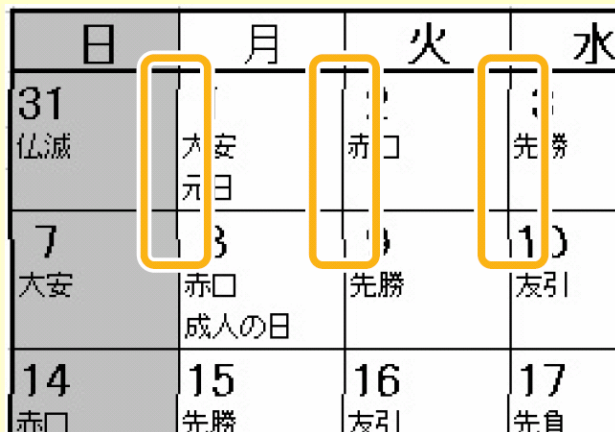
Output Image of misaligned vertical lines

When the color of output image blurs or vertical lines are misaligned, adjust followings:

Clean Print-heads
