Technical Bulletin

Model: Diana-C1	L		Dat	e: 27-Nov-	-08	No.: RD037001
Subject: PictBridge option (Camera Direct Print Card Type E)				Prepared	d by: к. м	Noriizumi
From: 1st Tech. S	Support Sec. Service Support D)ept.				
Classification:	☑ Troubleshooting	Part info	ormat	tion	Action	n required
	Mechanical	Electric	al		Servic	e manual revision
	Paper path	Transm	it/rec	eive	Retrof	fit information
	Product Safety	Other ()	🛛 Tier 2

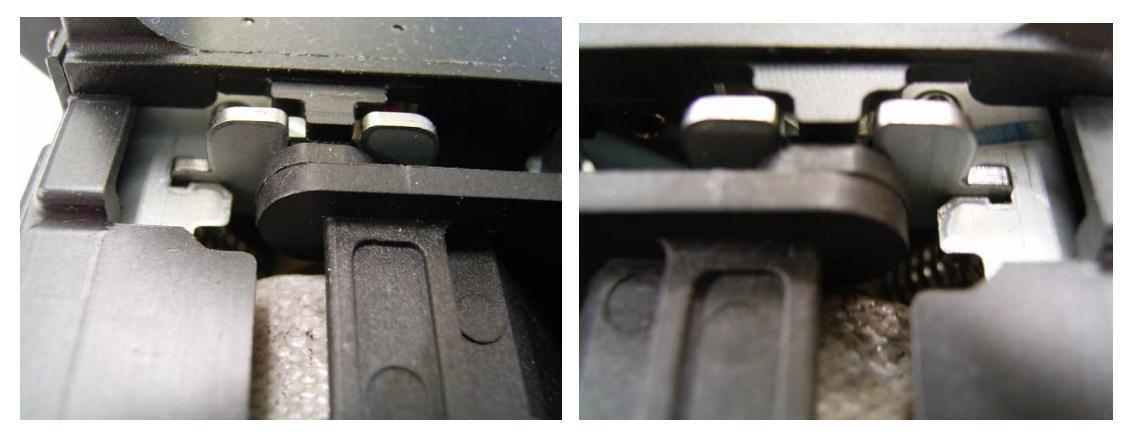
OK:

If there is a gap between the metal plates shown in the photo below, this means the pressure roller stay has been bent, so replace the pressure roller stay (P/N D0394183).

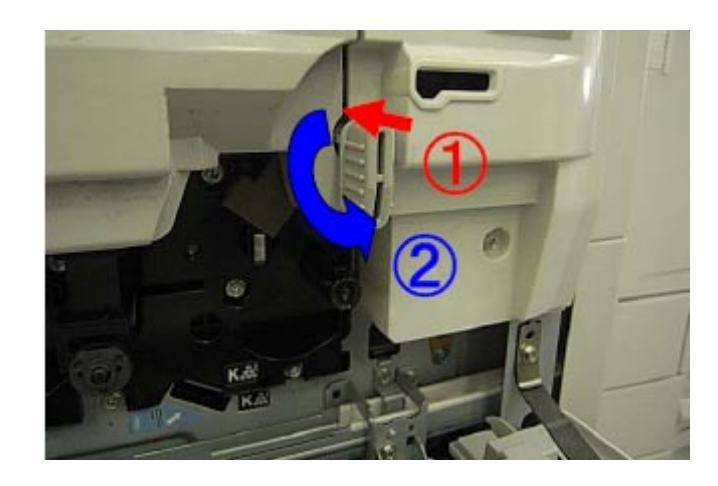
Important: As described in the Service Manual, whenever you lock the ITB lock lever, make sure to **push the lever in** first (1), and then rotate it downward (2). If you do not, the lever can break or SC492 and/or an image problem may occur.

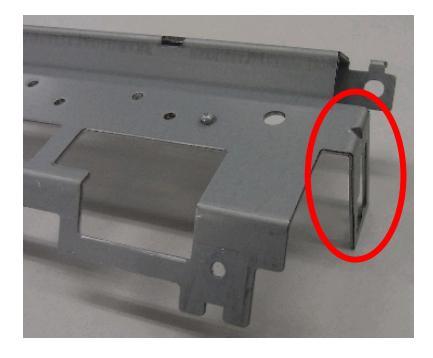
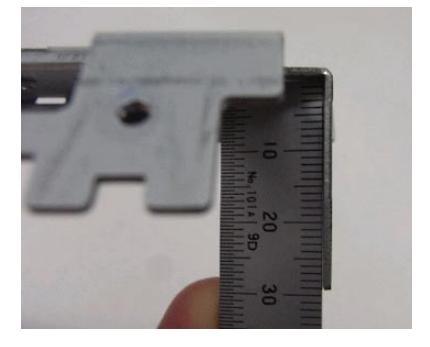
OK:

- Do the following whenever you replace any components of the fusing unit. This is to make sure that the fusing stay is not bent or deformed.
- If the fusing stay is bent or deformed as shown below, the fusing roller may be in the wrong position. As a result, the thermistor or surface of the fusing belt can be damaged, which will cause SC543 and/or mechanical noise.

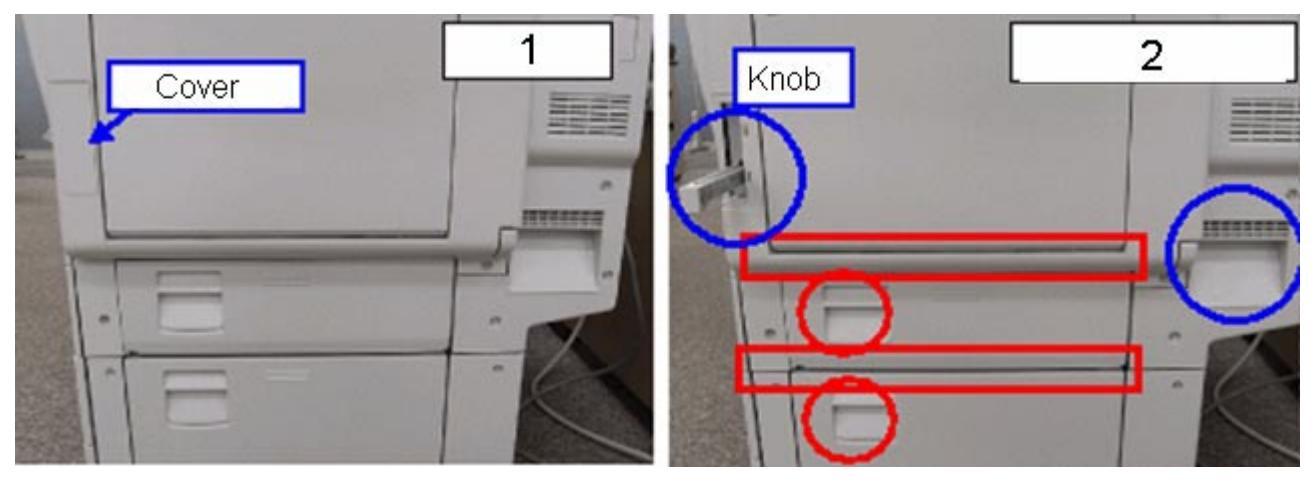
When moving the machine, open the cover on the rear side of the machine (see Photo 1) and pull out the knob. Hold the machine by this knob and the area circled in blue (see Photo 2). Never hold the machine by the edges circled in red or any other areas. If you do, you may damage the machine.

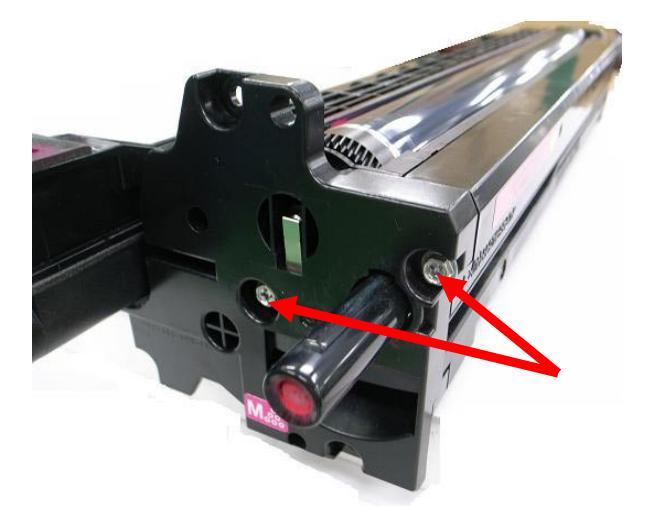
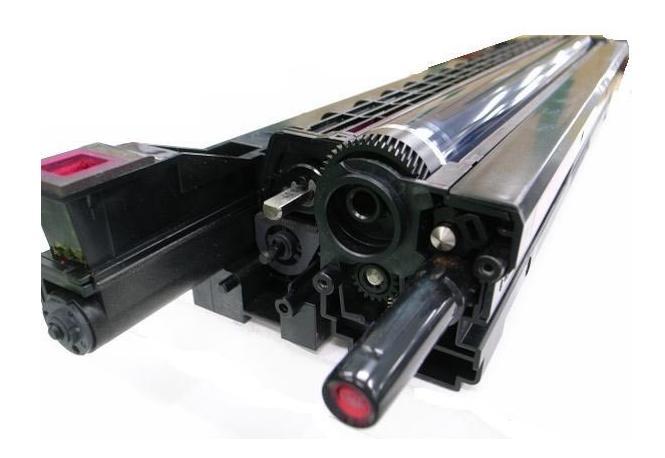
A loud squeaking noise can be heard when any of the following conditions is met:

Under the conditions described above, the cleaning brush becomes unable to supply enough lubricant to the surface of the drum.

If this problem is reported, replace the compression spring with the modified part (P/N AA063690).

1. Remove the front bracket from the PCDU (screws x 2).

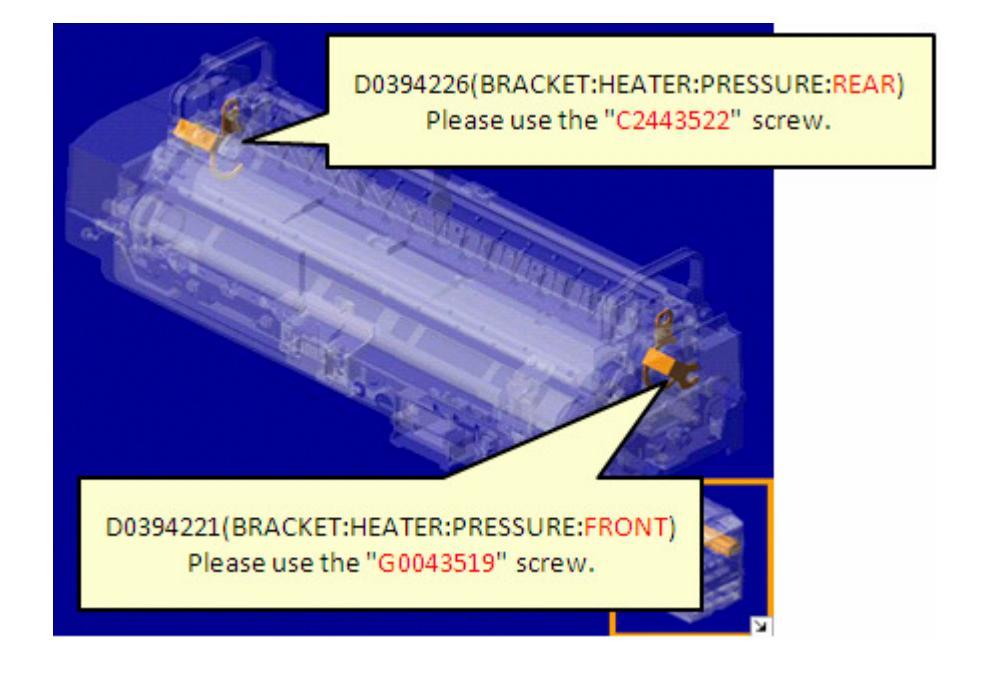
- The shape of the rear bracket for the pressure heater was changed.
- The screw for the bracket was changed to a different type.
- **Reason:** To optimize the clearance between the base of the pressure heater and the inner wall of the pressure roller.

Important: If the old **rear** bracket needs to be replaced, make sure to install the two new parts shown above (bracket and screw) **together as a set.** Note that the old screw (G0043519) can still be used for the front bracket.

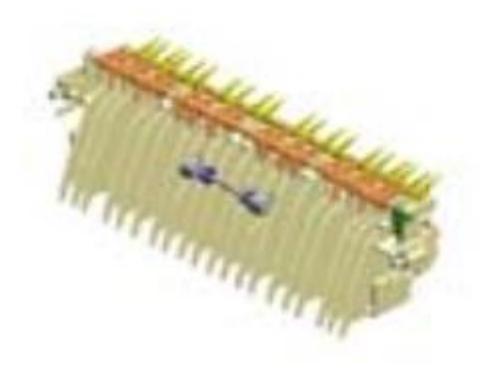
D0394506 GUIDE PLATE:EXIT:DUPLEX: ASS'Y

Reason Modified for hook breaking
