Model: Di-C1/C1L	Date: 09-Dec-08	No.: RD038001d
------------------	-----------------	----------------

Subject: Firmware Release Note: Engine		Prepared by: M. Saiki	
From: 2nd Overseas Tech Support Sec., 2nd PQM Dept.			
Classification:	<input type="checkbox"/> Troubleshooting	<input type="checkbox"/> Part information	<input type="checkbox"/> Action required
	<input type="checkbox"/> Mechanical	<input type="checkbox"/> Electrical	<input type="checkbox"/> Service manual revision
	<input type="checkbox"/> Paper path	<input type="checkbox"/> Transmit/receive	<input type="checkbox"/> Retrofit information
	<input checked="" type="checkbox"/> Other (      )

This RTB has been issued to announce the firmware release information for the **Engine of the Model Di-C1 and Di-C1L**.

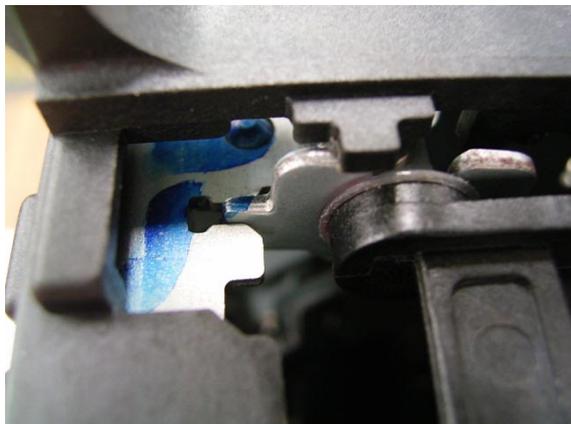
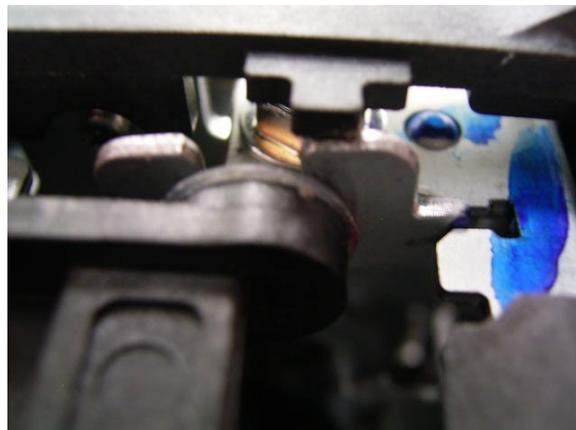
If there is a gap between the metal plates shown in the photo below, this means the pressure roller stay has been bent, so replace the pressure roller stay (P/N D0394183).

**NG** (the pressure roller stay has been bent): Notice the gap between the metal plates.

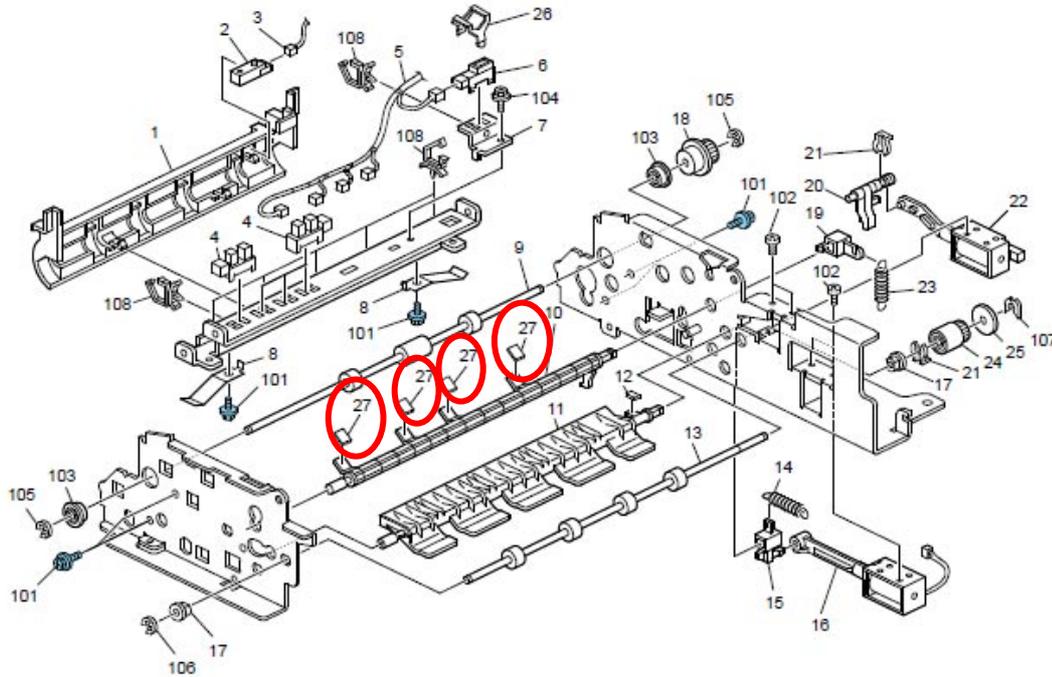
## 5.Original Exit (D366)

A 'P' Jam' occurs when the leading edge of the original hits and hooks up on the upper edge of the original stopper pads and bends inside. As a result, the original will be stuck and cause a 'P Jam'. This happens because the scale of the stay (***Stay: Separation (B7891161)***) is incorrect, and it cannot be lowered enough. Pads on the stopper, which are positioned at about the same height as the center of the leading edge of the incoming original, then interfere with the paper feed path.

**Permanent Countermeasure****Production Line:****The size of the original stopper pad was changed.**

**In the field:****If the symptom is reported, replace the stopper pad with the modified one (D3662416).****Important:**

- **In order to replace the stopper pad, you must first remove the original feed unit and original feed-in guide in the ARDF. See the Service Manual for the procedure.**
- **Be sure to attach the pads in the correct position (see the photo below).**

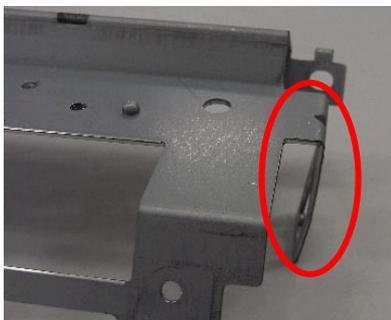
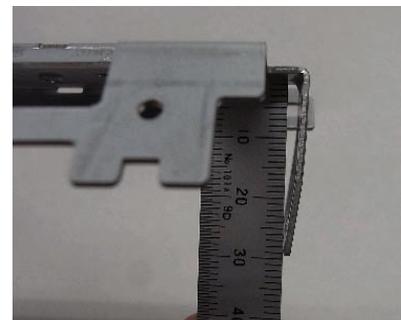
**NG:**

- Do the following whenever you replace any components of the fusing unit. This is to make sure that the fusing stay is not bent or deformed.
- If the fusing stay is bent or deformed as shown below, the fusing roller may be in the wrong position. As a result, the thermistor or surface of the fusing belt can be damaged, which will cause SC543 and/or mechanical noise.

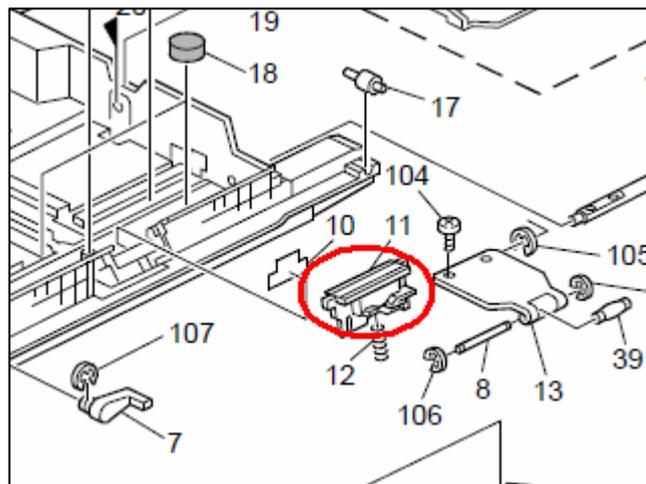
A growling noise (rattling caused by vibration) can be heard coming from the PB3030 Paper Feed Unit when the unit is installed on the Di-C1.

If this symptom is reported, replace the friction pad with the following:

**P/N D4252831 FRICTION PAD:GUAM-C:ADHESION**

See the diagram below to check the position of the pad. The pad is numbered 11 and encircled in red.

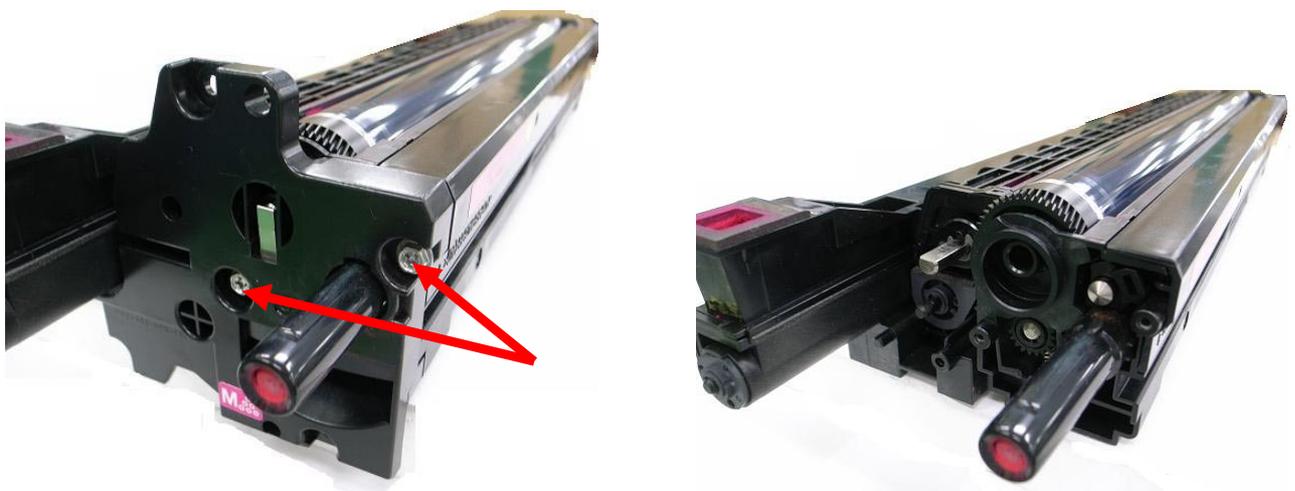
**SYMPTOM**

Under the conditions described above, the cleaning brush becomes unable to supply enough lubricant to the surface of the drum.

If this problem is reported, replace the compression spring with the modified part (P/N AA063690).

1. Remove the front bracket from the PCDU (screws x 2).

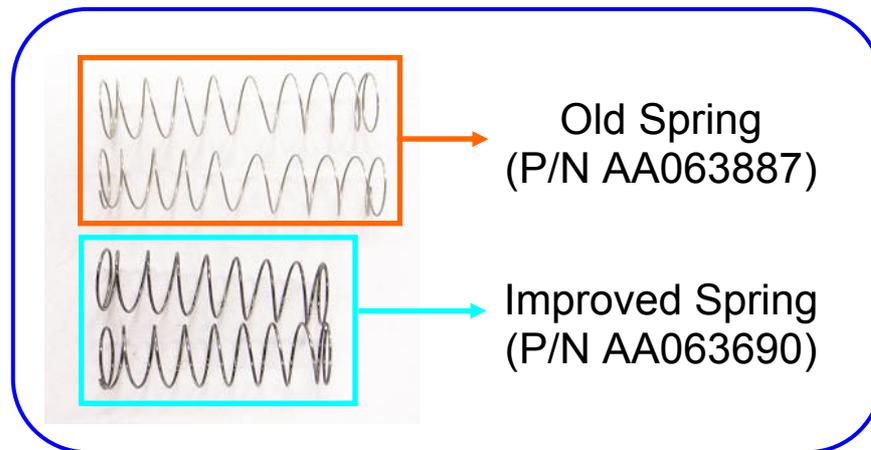
**Note:** The modified spring is black, and about 3mm shorter than the old spring.

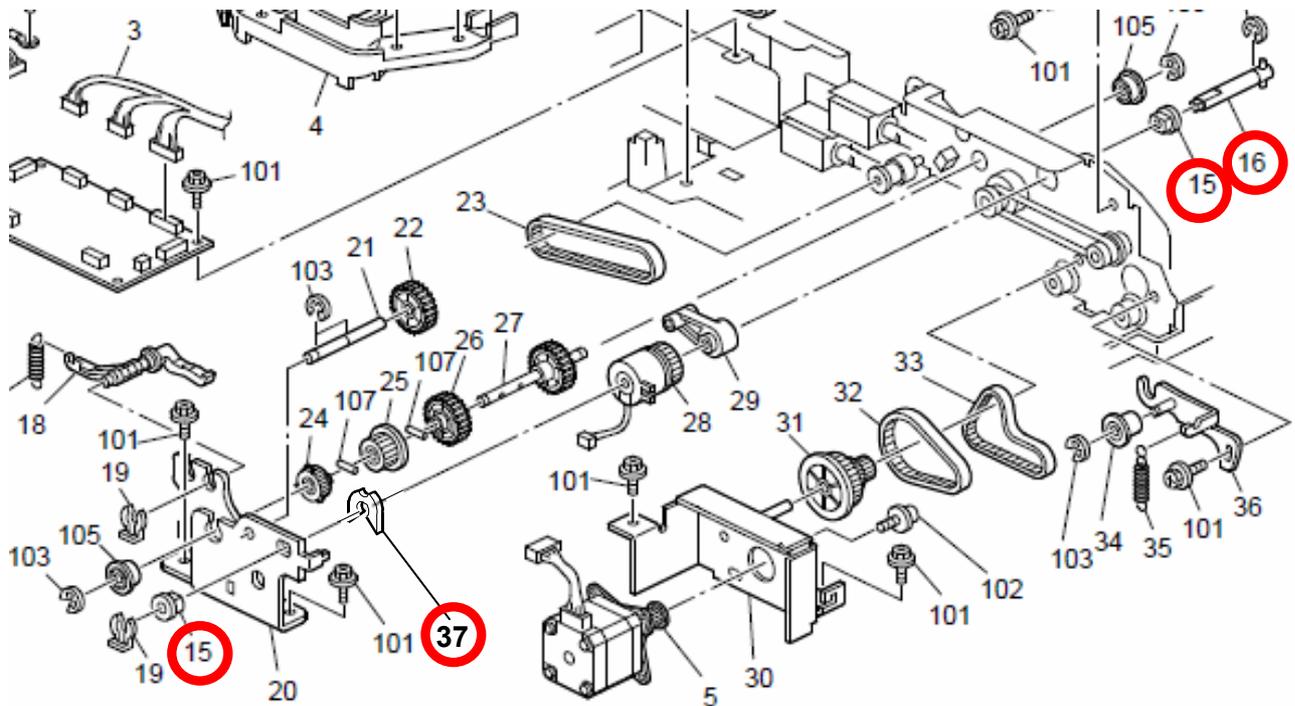
**Reason:** Parts standardization with other model

**Important:** If you replace the old shaft in the field, make sure to install the new bushing and retaining ring **together as a set**.

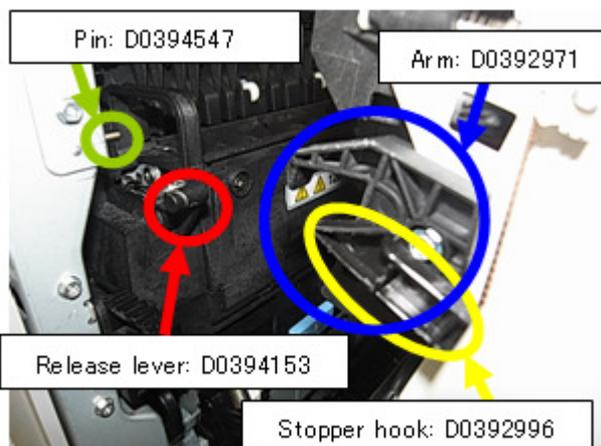
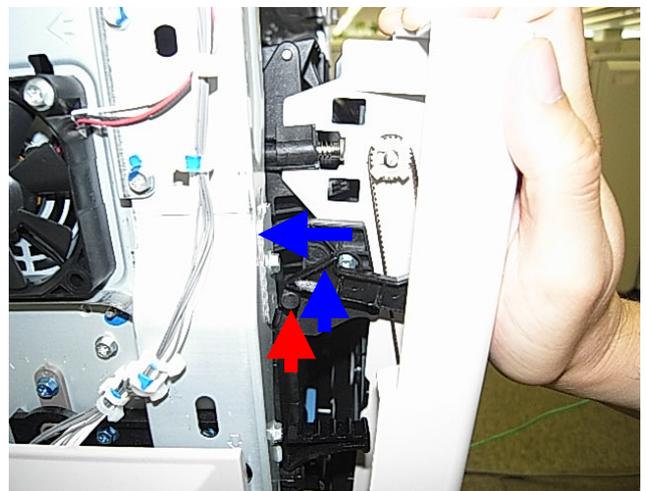
- Side-to-side play in the front pressure release lever
- The user does not push the center of the duplex unit cover when closing the cover. As a result, the cover is angled when closed, sometimes causing the arm to catch on the lever.

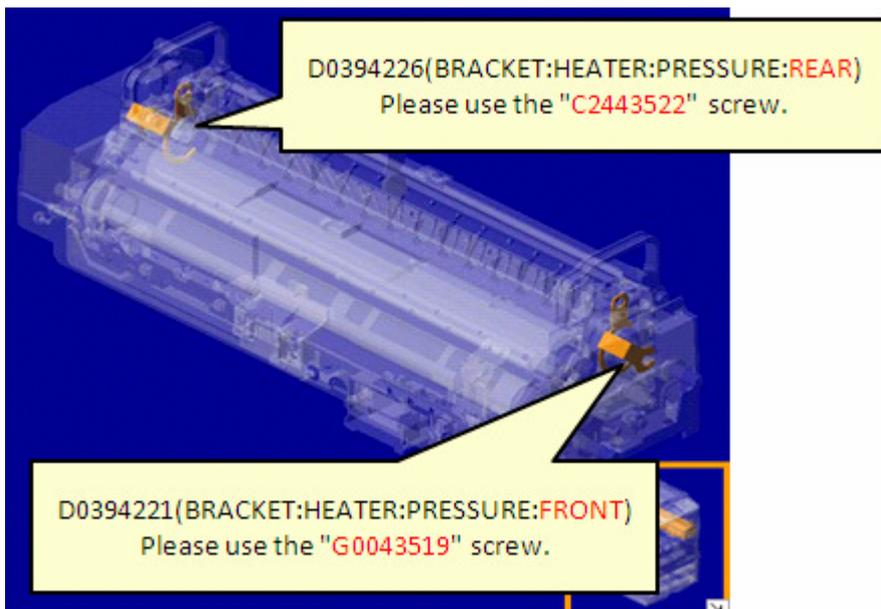
**Reason:** To optimize the clearance between the base of the pressure heater and inner wall of the pressure roller.

**Important:** If the old **rear** bracket needs to be replaced, make sure to install the two new parts shown above (bracket and screw) **together as a set**. Note that the old screw (G0043519) can still be used for the front bracket.

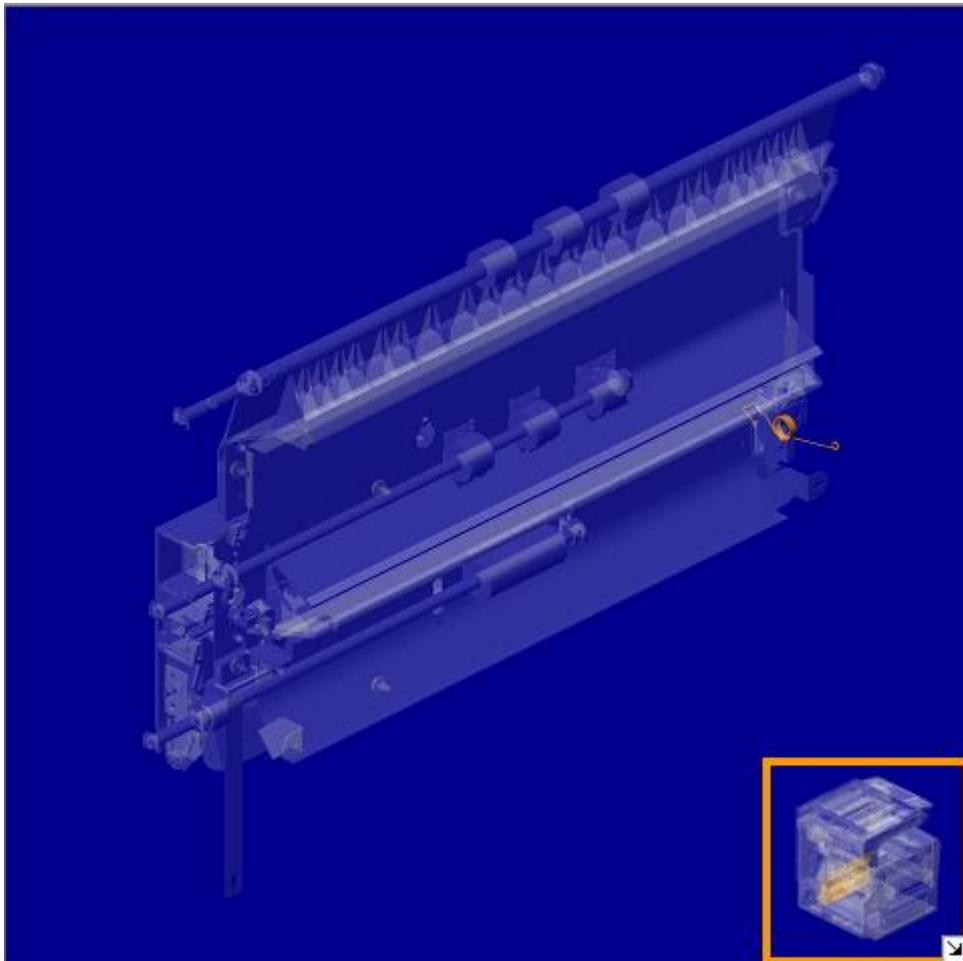
**Reason:** To prevent damage to the duplex unit guide plate.

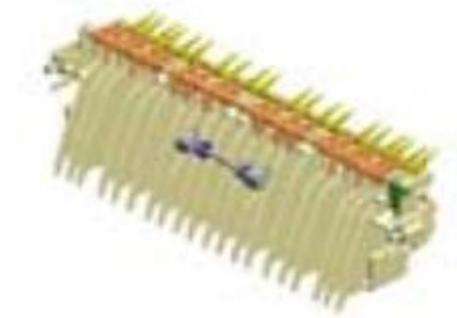
**D0394506**  
GUIDE PLATE:EXIT:DUPLEX:  
ASS'Y

Reason  
Modified for hook breaking

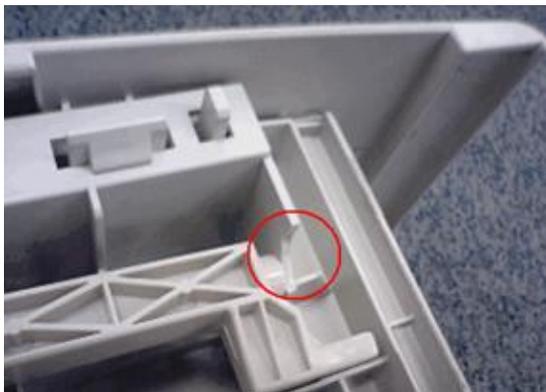
The boss on Tray 1 or Tray 2 breaks if the tray is pulled out before the internal tray lock fully disengages.

Under these conditions, stress is concentrated on the root of the boss (circled above), forming a crack and then damaging the part as shown in the photo.

If the root of the boss is cracked, remove the boss with nippers before you begin this procedure.

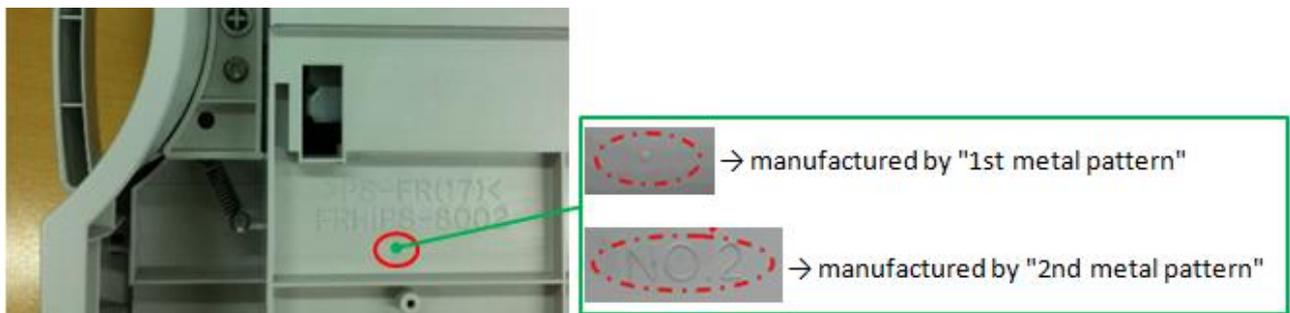
**Note:** The part number was not changed, but you can identify the modified paper tray by the engraved marking on the rear of the machine. Trays that have either of these two markings shown in the photo below have been modified:
