Model: DI-C1.5	Date: 15-Dec-10	No.: RD104001d
----------------	-----------------	----------------

Subject: Firmware Release Note: Engine		Prepared by: R. Takemura	
From: 1st Tech Service Sect., MFP/Printer Tech Service Dept.			
Classification:	<input type="checkbox"/> Troubleshooting <input type="checkbox"/> Mechanical <input type="checkbox"/> Paper path <input type="checkbox"/> Product Safety	<input type="checkbox"/> Part information <input type="checkbox"/> Electrical <input type="checkbox"/> Transmit/receive <input checked="" type="checkbox"/> Other (Firmware)	<input type="checkbox"/> Action required <input type="checkbox"/> Service manual revision <input type="checkbox"/> Retrofit information <input checked="" type="checkbox"/> Tier 2

This RTB has been issued to announce the firmware release information for the **Engine**.

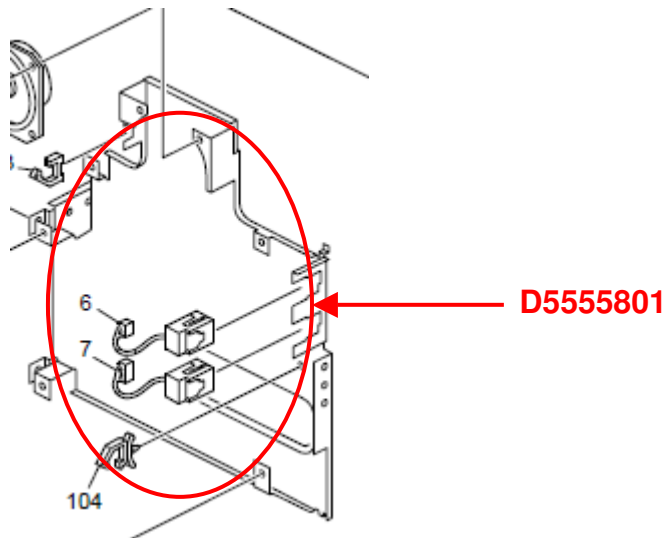
Old part number	New part number	Description	Q'ty	Int	Page	Index	Note
-	D5555801	Bracket: FCU	1	-	2	15

Change/Reason: The part shown below was missing from the Parts Catalog.

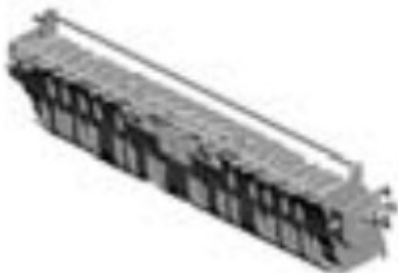
D1054506

Reason: To prevent damage to the duplex unit guide plate.

GUIDE PLATE:EXIT:DUPLEX:
ASS'Y
